U.S. FOREST SERVICE
RESEARCH NOTE
FPL-099
MARCH 1965

**RAISED, LOOSENEED, TORN,
CHIPPED, AND FUZZY
GRAIN IN LUMBER**

Forest Products Laboratory,² Forest Service
U.S. Department of Agriculture

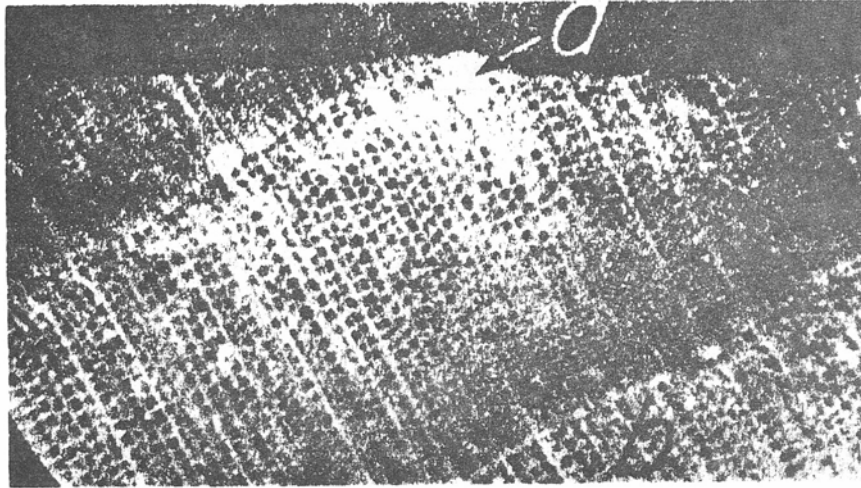
M 13214

Figure 1.--Springwood cells are crushed under the summerwood near the surface at (a) in an enlarged cross section of corrugated white fir. Note that the springwood cells (b) in the annual ring below are not crushed.

In flat-grain lumber, corrugation of the surface is due principally to a crushing of the hard summerwood into the softer springwood beneath it by the planer knives. The summerwood subsequently rises as the springwood cells underneath gradually resume their original shape. Figure 1 shows a magnified cross section of a piece of white fir with crushed springwood cells near the surface at a. This crushing force was not transmitted through the summerwood of the top annual ring to the springwood b of the ring below.

In the edge view of a flatsawn board (fig. 8), pressure at A on the pith side is applied to low density springwood supported first by springwood of increasing density and then by summerwood of even greater and increasing density, thus distributing the load without abrupt changes in microstress. At B, however, the load applied to the highest density summerwood is transmitted directly to the adjacent and weakest springwood cells, which may be crushed and ruptured--as was illustrated in cross section at a (fig. 1).

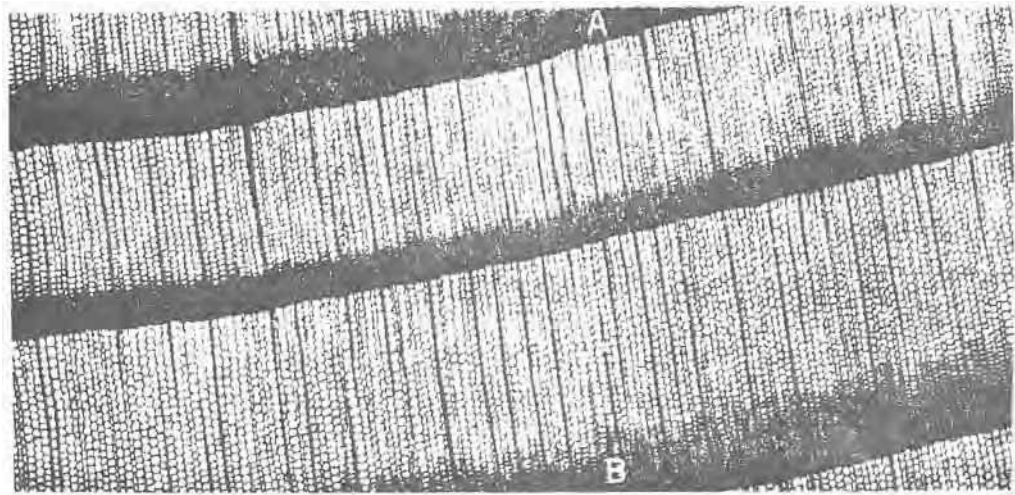
M 2281

On the pith side of a flat-grain board there is a sudden transition from the outermost and hardest part of the summerwood of an annual ring to the innermost and softest portion of the springwood of the annual ring underneath it, as at A

Figure 3.--Enlarged cross section of a thin Douglas-fir board (See text).

in the upper side of the board (fig. 3). This hard portion of the summerwood, where it wines to the surface in thin edges, offers the maximum resistance to cutting, and the soft springwood underneath offers the least resistance to indentation; hence, a maximum crushing of summerwood into springwood occurs at that point.

On the bark side of the board, it is the inner and softer portion of the summerwood that diminishes to an edge where the summerwood band intersects the surface at B (fig. 3). This comparatively soft portion of the summerwood is underlain by the harder portion of the springwood band of the same annual ring, as in the lower side of the board in figure 3. Consequently, the summerwood at that point does not offer as much resistance to cutting, and the springwood offers more resistance to indentation. Farther to the right along the lower surface of figure 3, where the summerwood is both harder and thicker, the stresses caused by the pounding of the planer knives are partly absorbed and more evenly distributed before they reach the softest portion of the springwood beneath. As a result, crushing does not usually take place on the bark side of the board.

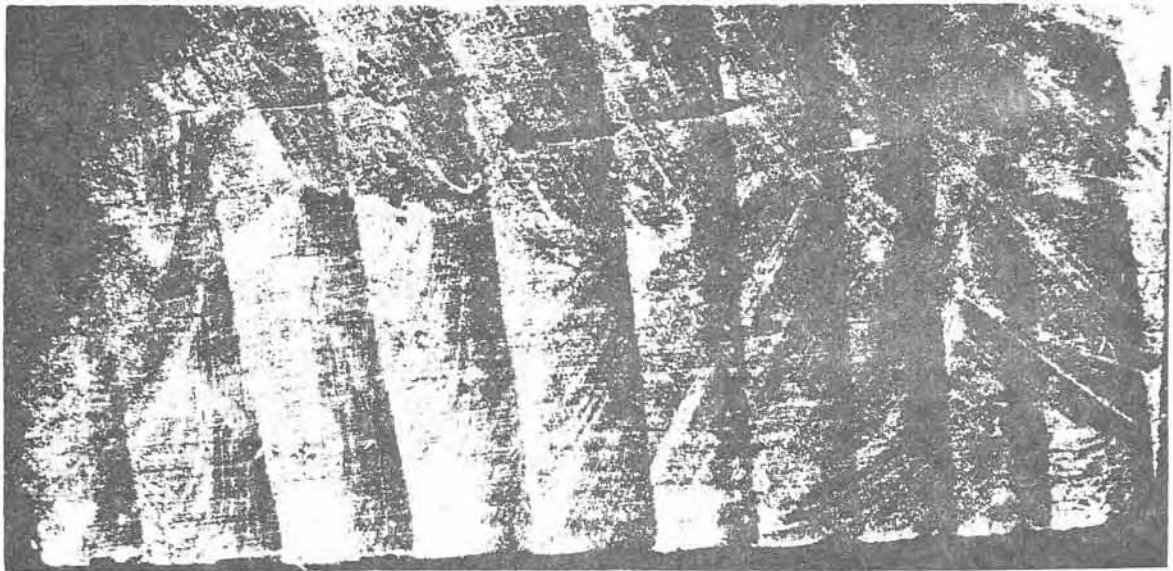
M 13200

Figure 4.--Corrugation on a edge of dried, edge-grain, Douglas-fir board dressed while at high moisture content.

In edge-grain lumber, a difference in tangential shrinkage between springwood and summerwood causes corrugated surfaces: summerwood shrinks more than the springwood. Hence, if edge-grain lumber is dressed when it is at a relatively high moisture content, the summerwood bands will recede below the level of the springwood bands as the lumber dries, giving the surface a "washboard" appearance (fig. 4). If dry edge-grain lumber is surfaced and later allowed to absorb moisture, the summerwood will stand out above the springwood and the washboard appearance will again result.

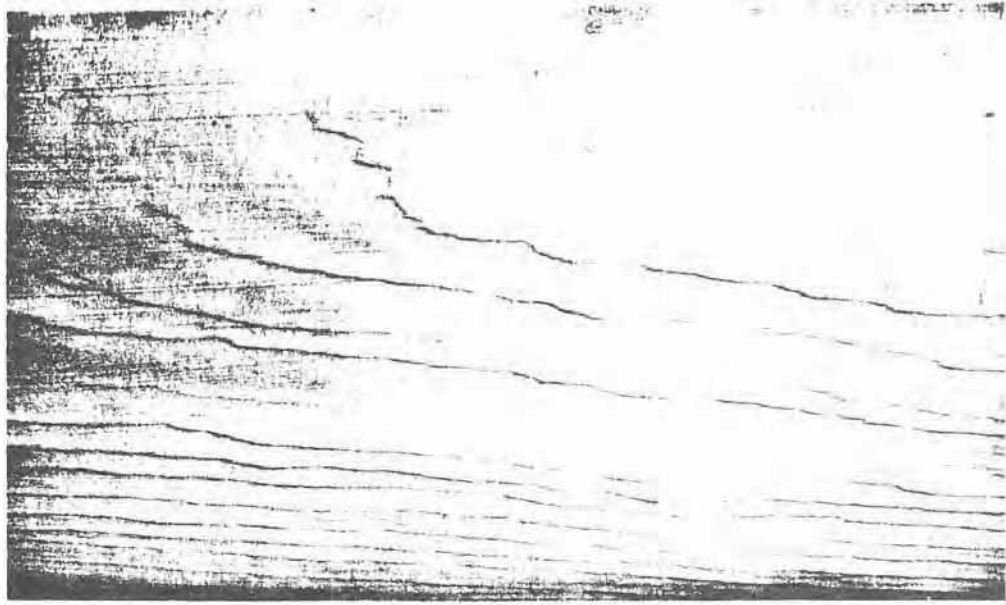
M 13201

Figure 5.--Grain pattern shows through coating of paint on southern pine board.

The amount of raised grain evidently can be reduced by sharpening planer knives properly and then keeping them sharp. Further, the surface of the lumber should not be allowed to change appreciably in moisture content. For outside work, the second suggestion cannot be applied because wood exposed to the weather will change in moisture content, even when painted (fig. 5).

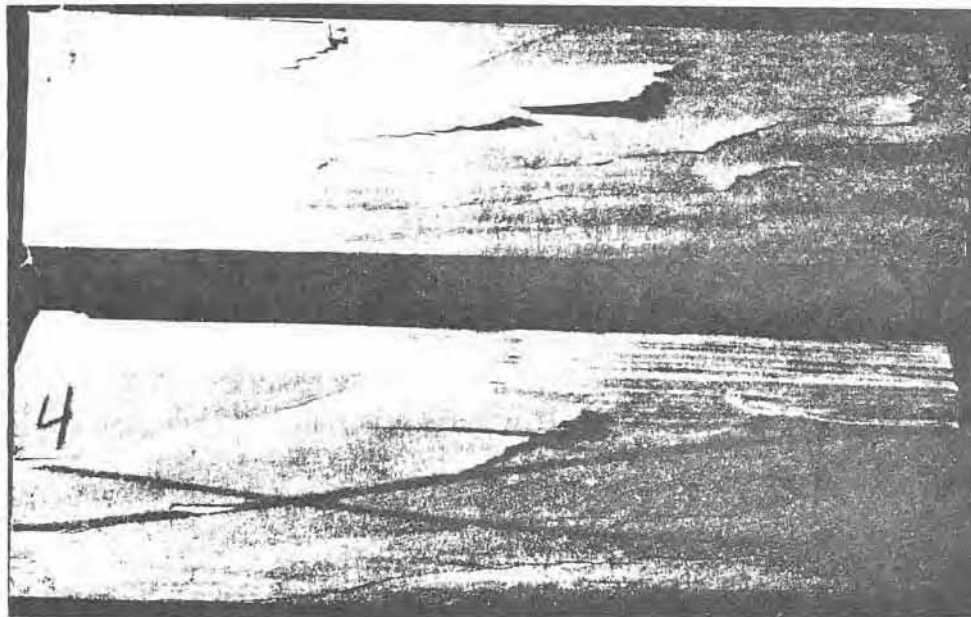
M 36024

Figure 6.--Window sash stiles of western white pine with loosened grain on the pith side.

Pronounced shrinkage stresses are developed where springwood adjoins summerwood, because the springwood tends to shrink less transversely and more longitudinally than the summerwood. The stress resulting from this difference in shrinkage is localized at the boundary between annual rings, where the transition between springwood and summerwood is very abrupt. It is at the tips of the annual rings that the largest and most uniform flat expanses of springwood and summerwood occur near the surface; these portions develop the greatest differential shrinkage stresses when the moisture content of the surface changes. Therefore, separation usually takes place first at the tips of the summerwood bands, and then along the edges where the summerwood comes to the surface (fig. 6).

To minimize shelling of growth layers--which occurs especially in softwoods--follow the same precautions recommended to reduce corrugation of the surface. Again, for outside work, keeping the moisture content of the surface nearly constant is not so practical as maintaining the planer properly. Whenever pattern lumber is worked, the bark side--unless it has prohibitive defects--should be made the face side.

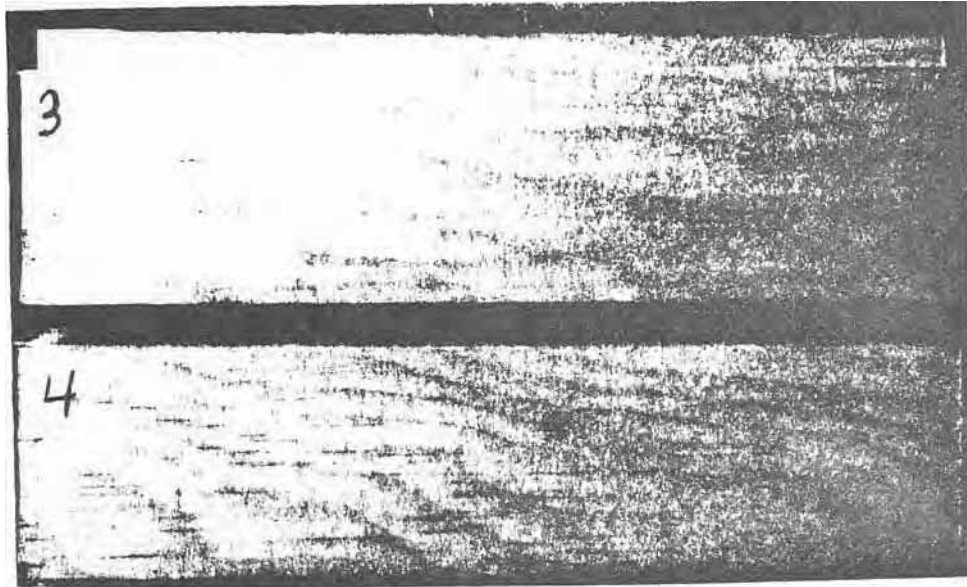
M 36023

Shelling of the annual rings is much more pronounced on the pith side than on the bark side of flat-grain lumber (fig. 7). This difference is related to the

Figure 7.--Loosened grain absent on the bark side of the same piece shown in figure 6.

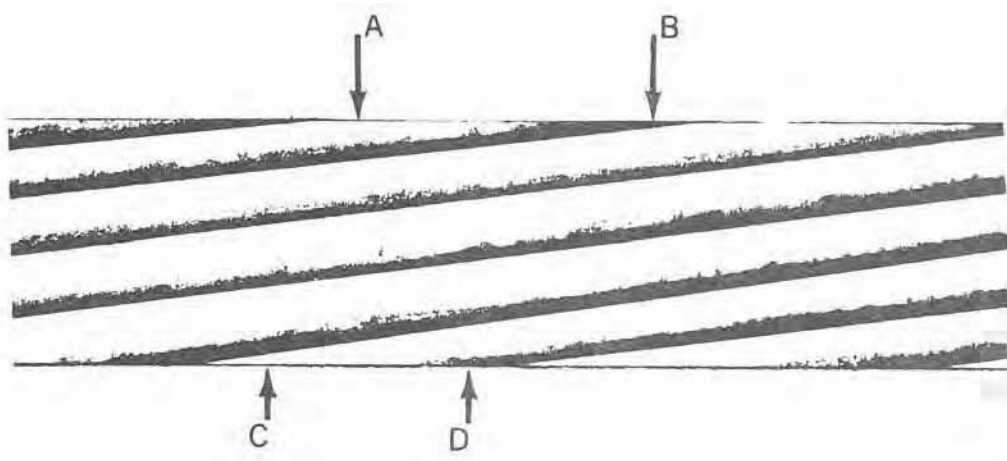
M 124 968

Figure 8.--Schematic edge view of flatsawn board illustrating microstress differences that often cause shelling. (see text).

When pressure is applied to the bark side at C (fig. 8), a low density springwood is supported by the highest density summerwood of the adjacent underlying growth ring. As the load point moves to D, the surface becomes increasingly dense and underlying support decreases in density gradually, not abruptly. The greater longitudinal shrinkage of springwood causes failure at the interface between adjacent rings; subsequently the shrinkage differential between the springwood and summerwood of the loosened ring causes it to curl away from the underlying stock (fig. 9). In addition, the curvature of the annual rings makes it easier to bend an annual layer of growth away from the surface on the pith side, just as it is easier to bend a quill point inward than outward (fig. 10, b).

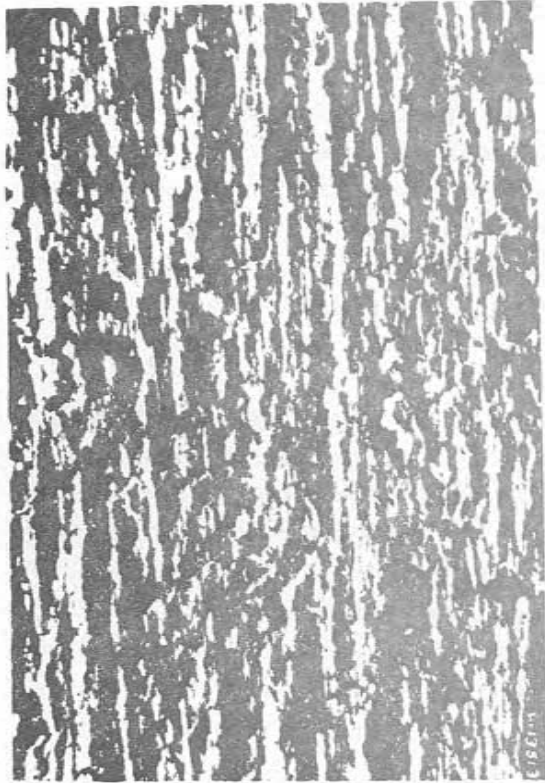
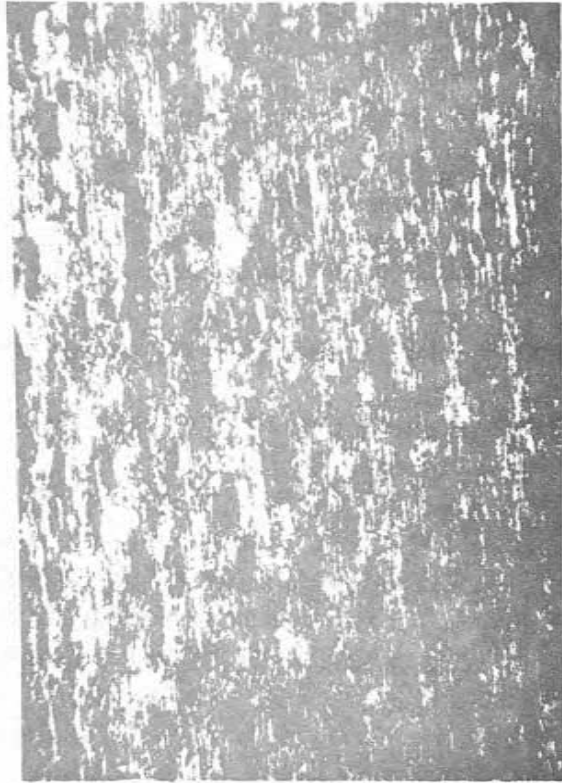
M 107 368

The type of raised grain in which the fibers fuzz up aggravates wood finishers because the projecting fibers make it difficult to secure a smooth finish. Figure 12 shows projecting fibers on the surface of a sanded piece of wood. Some species of wood fuzz up more than others, and, in general, the hardwoods are more troublesome in this respect than the softwoods. Even in wood of the same species there is considerable variation in the smoothness of surface that may be obtained under identical working conditions. The tendency for the fibers to fuzz up becomes more pronounced with increasing moisture content. This is particularly true in ring-porous species such as the oaks, where groups of fibers may be pressed into the large pores during machining or sanding operations.

Sanding is responsible for more fuzzing than planing because the grains of sand tear up parts of fibers (fig. 12, top), whereas the planer more frequently cuts through the fibers and consequently leaves fewer loose ends sticking up (fig. 12, bottom). However, under certain conditions, especially a high moisture content, some types of wood fuzz up badly under the planer knives. This fuzzing can sometimes be reduced by feeding the board through the machine so that the knives cut with the grain, as with chipped grain.

Figure 12.--Upper, sanded surface of a mahogany board with numerous projecting fibers; lower, planed surface of same board.

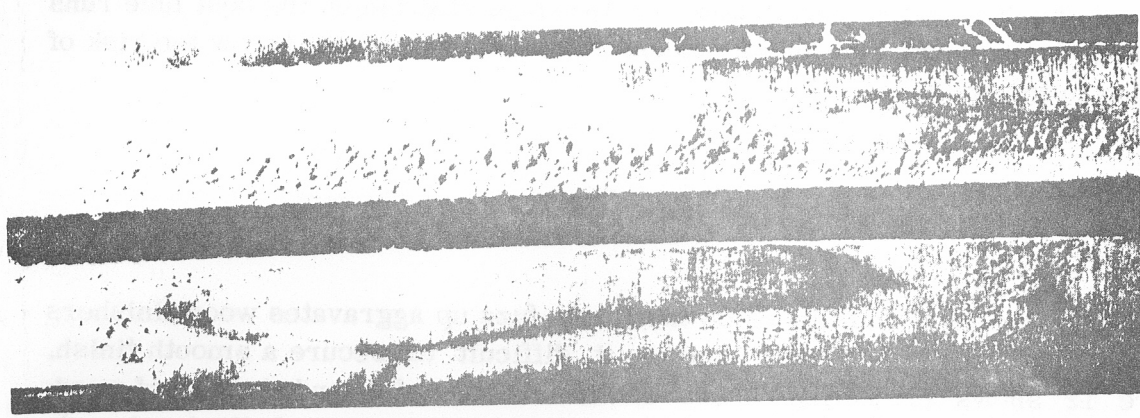
M 82192

Studies of a number of broad-leaved species reveal that fuzziness is associated with an abnormal type of wood known as tension wood.³ Tension wood occurs most prominently on the upper sides of leaning broad-leaved trees. The tension wood fibers frequently cause unusual behavior of lumber surfaces. Projecting fibers were common on sawed surfaces of lumber and on veneer surfaces in which tension wood was detected by microscopic examination. Figure 13 shows a sawed surface of aspen lumber with such groups of projecting fibers. Some planed or shaped surfaces also had zones of torn grain in the parts that included tension wood. Examinations of surfaces with projecting fibers and torn grain

Figure 13.--Projecting groups of fibers indicate areas of tension wood on aspen boards.

showed that tension wood fibers tended to be torn partly loose instead of being cut clean by saw teeth or knives of cutting heads. Groups of these fibers held together tenaciously in lengths of 1/4 inch to as much as 3/4 inch. When aspen and cottonwood lumber was planed in a green or even an air-dried condition, severe tearing of surface fibers was relatively common.

There is no rule-of-thumb by which material with tension wood can be rejected. Nevertheless, valuable material and some labor can be saved by practical selections of lumber and veneer with respect to tension wood. Whether material is to be rejected depends on the kind of end products, the amount of labor required in processing, and the possible salvage value of the rejected material.
