U.S.D.A. FOREST SERVICE
RESEARCH PAPER
FPL 169
1972

APPALACHIAN HARDWOODS FOR PALLETS

CORRELATION BETWEEN SERVICE AND LABORATORY TESTING

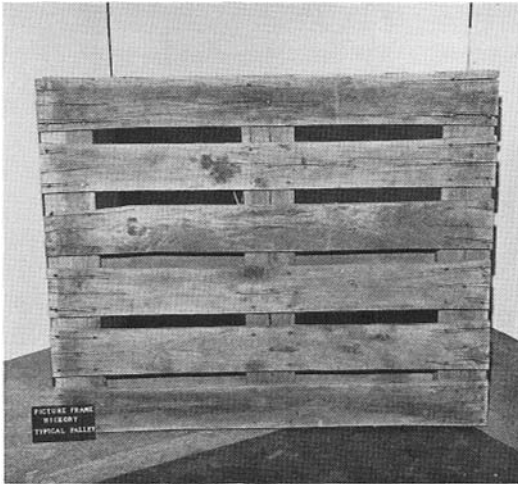
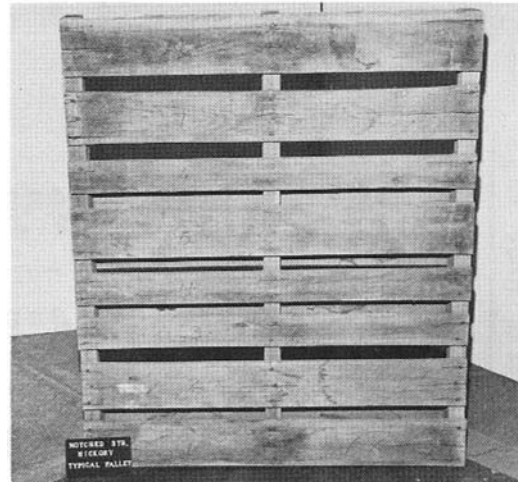
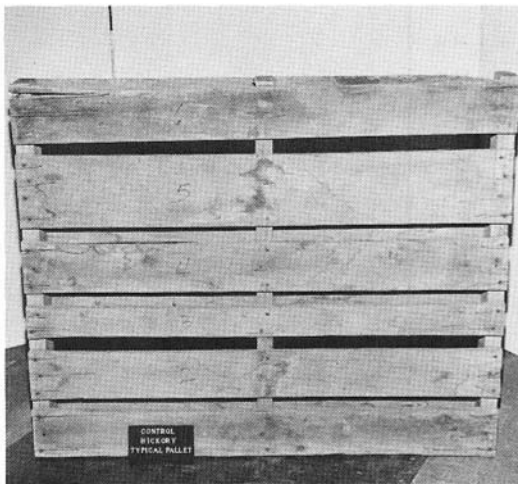
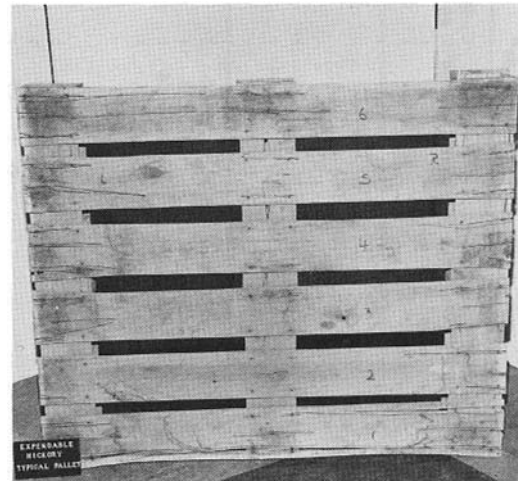
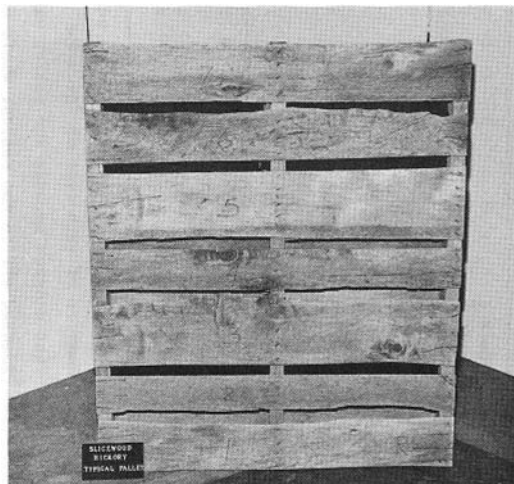
Figures 1 through 14 give the reader a visual impression about the condition of representative pallets before and after laboratory testing at FPL. The condition just after service of a typical hickory pallet of each style is shown in figures 1 through 5. Residual pallet performance capability could not be estimated by the visible degradation resulting from field service. A typical range of pallet conditions after service, progressing from worst to best, that existed in each set is shown in figures 6, 1, and 7.

Typical hickory pallets after 4 years of service (untested by FPL).

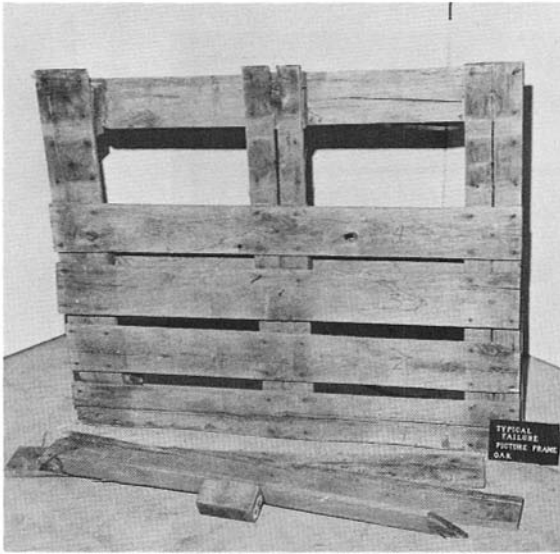
Figure 8.--An oak, picture-frame pallet.
(M 138 570-11)

Some of the failure patterns after testing are shown in figures 8 through 14. By nature of their construction, picture-frame pallets resisted racking best, and they usually failed by separation of deckboards as shown in figure 8. Less rigid forms of pallet construction often underwent severe racking during the testing (fig. 11); this produced loose joints and hastened destruction of the pallets.

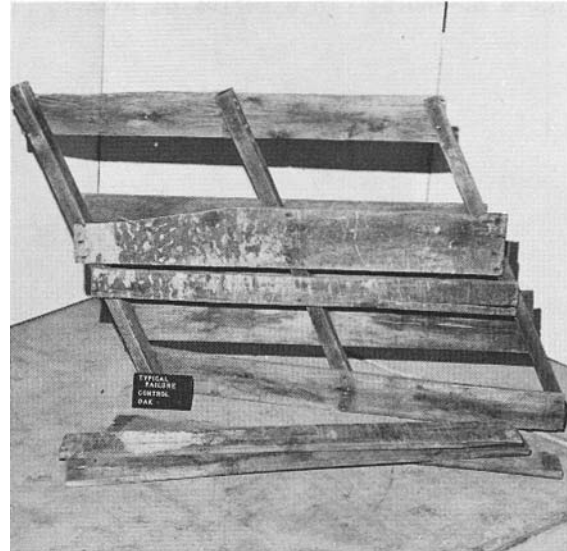
Figure 11.--An oak, three-stringer (control) pallet showing racked condition at failure.
(M 138 570-4)

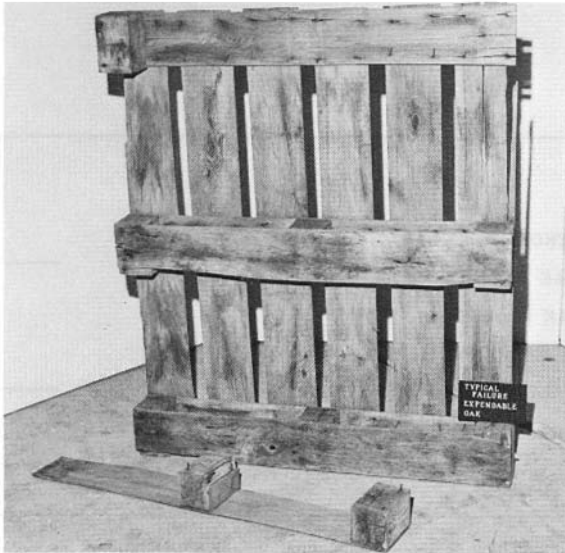
Figure 12.--An oak, MIL-P-26966 (expendable) pal let. (M 138 570-8)

The nature of the failures appeared to be definitely related to the species of lumber used to make the pallets. For example, the relative presence of splits at failure is shown for oak and yellow-poplar pallets, respectively, from the same construction-type group in figures 12 and

14. The pallets made from both species had similar checks shortly after construction, but the checks in the yellow-poplar pallets elongated much more rapidly.

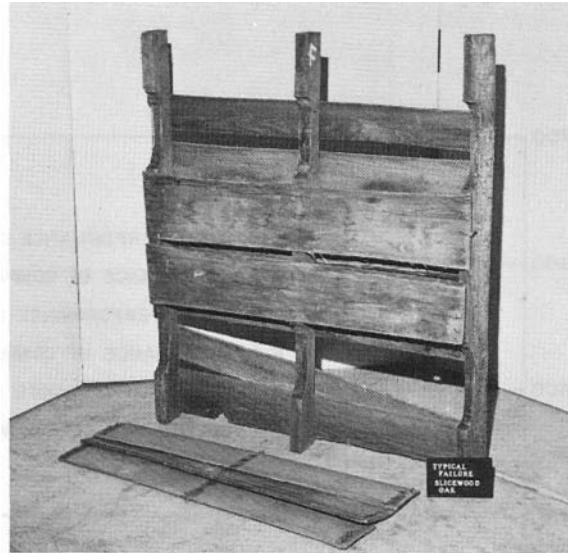
Figure 13.--An oak slicewood (expendable) pal let. (M 138 570-1)

Typical failure patterns of pallets after revolving drum testing.
