STRESSED SKIN PANEL PERFORMANCE

*AFTER
TWENTY-FIVE
YEARS
OF
SERVICE*

By OTTO C. HEYER, Engineer, and R. F. BLOMQUIST¹, Chemist

FOREST PRODUCTS LABORATORY²
U. S. DEPARTMENT OF AGRICULTURE, FOREST SERVICE

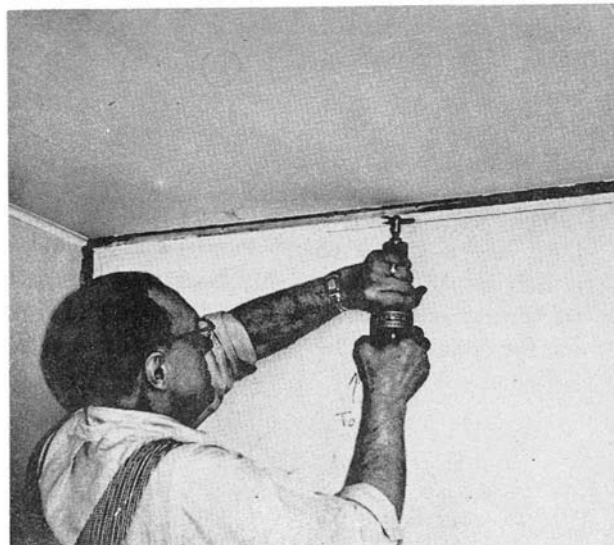
M 125 905

Figure 5.--Cutting edges of inside panel surface for removal from the wall.

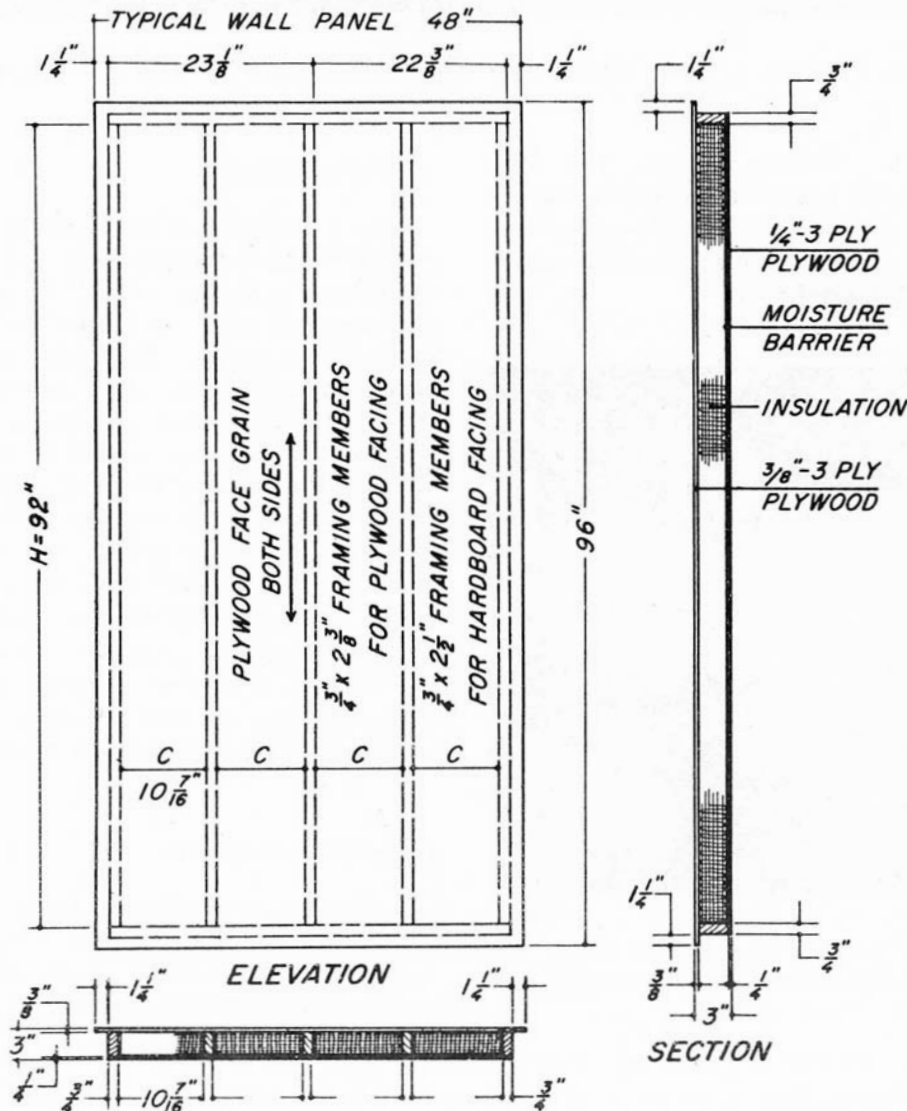
M 127 611

Figure 6.--Construction details of replacement panel. One panel utilized 1/4-inch plywood as the interior facing and 3/8-inch plywood as the exterior facing. The other panel utilized 1/4-inch hardboard as interior and exterior facings.

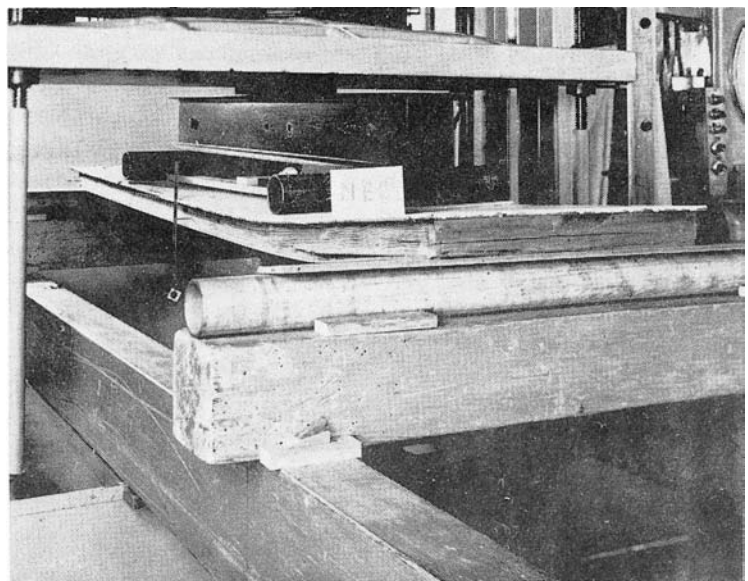
M 122 557

Figure 9.--Final failure of half panel removed from northeast corner of the experimental prefabricated house. Failure consists of a tension failure of framing member and horizontal shear maximum load was 284 pounds per square foot. This is a standard method of testing wall panels with load applied at the quarter point of the span.

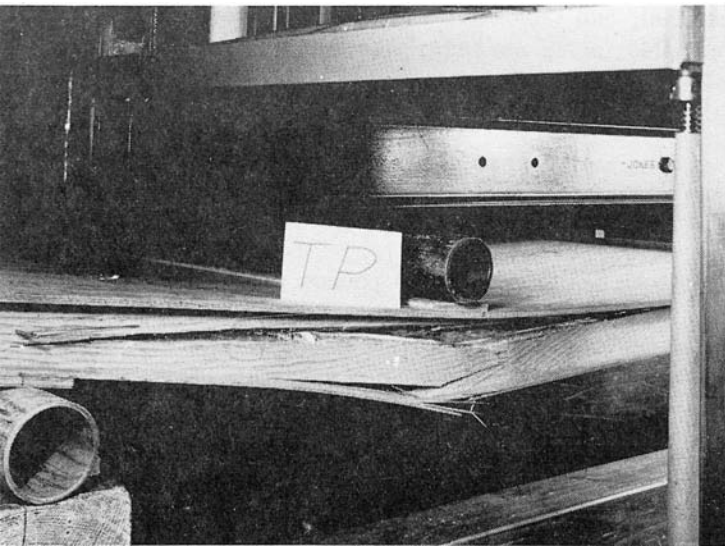
M 122 512

Figure 10.--Final failure of prototype panel, similar in construction to replacement panel, using plywood facings. Failure consists of a tension failure in framing member and horizontal shearing of the framing member. Maximum load was 239 pounds per square foot.

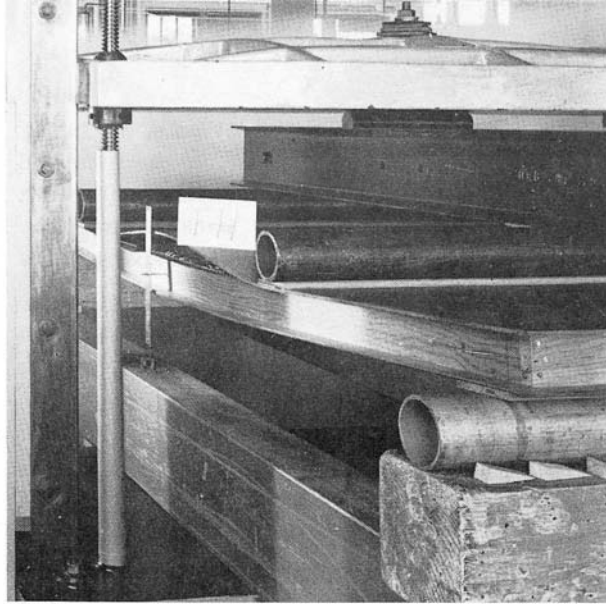
M 122 513

Figure 11.--Final failure of prototype panel, similar to replacement panel, using hardboard facing. Failure consisted of buckling of compression facing. Maximum load was 247 pounds per square foot.

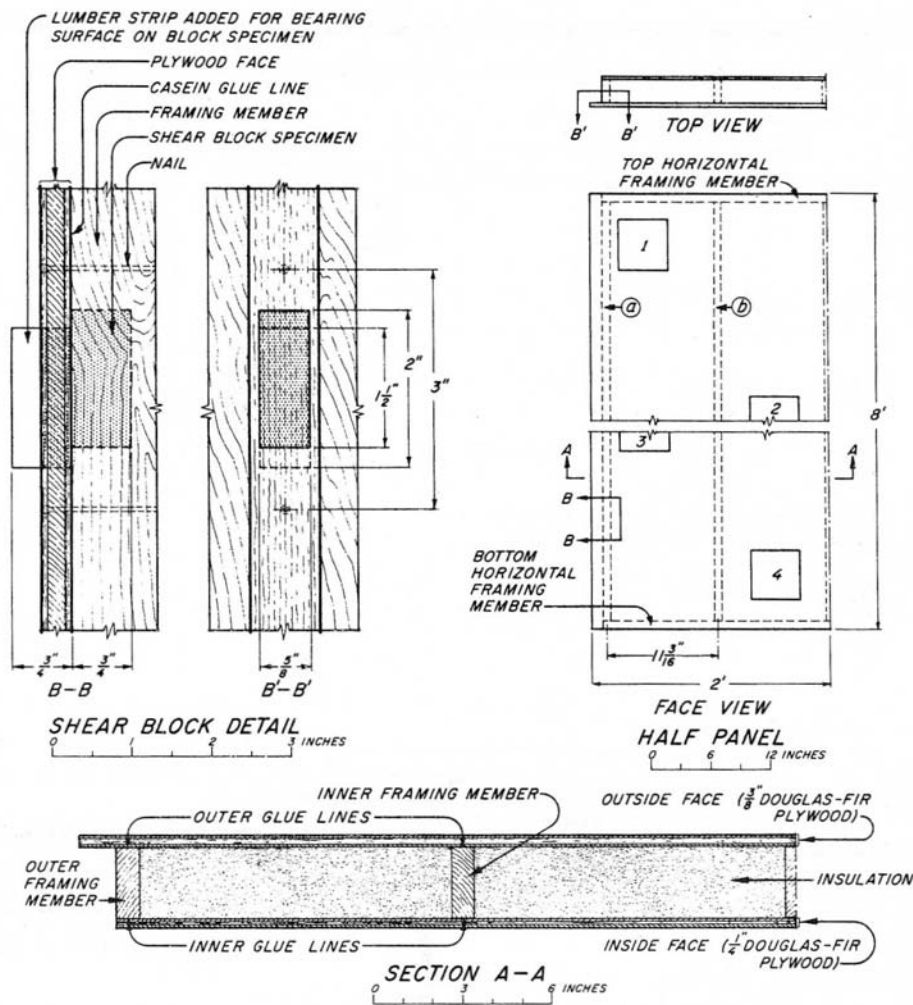
M 124 032

Figure 12.--Construction details and sampling of the wall panel portion that was removed from the experimental house for evaluating the quality of the glue bonds. Numbers 1 to 4 indicate approximate locations of plywood samplings, and letters a and b indicate the framing members from which structural bond specimens were taken.
