Research  
Paper  
FPL-RP-509

# The Mormon Creek Bridge

## Performance After Three Years

William J. McCutcheon

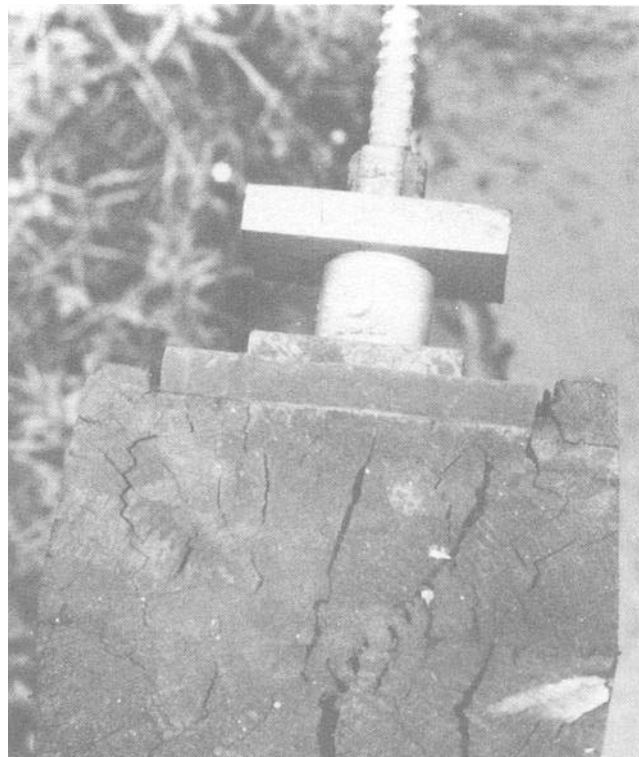
The most notable characteristic of the bridge was extreme crushing of the original two-piece, spiked, Douglas Fir stress blocks (Fig. 6). Some bearing plates were completely embedded in the blocks. Because of this crushing, minimum force levels could not be maintained in the rods. In July 1989, most of the

*Figure 6—Crushing of Douglas Fir block. Force in these rods is being monitored by a load cell.*

The loss of stressing force was excessive with the original Douglas Fir glulam blocks. The blocks, which distribute the forces to the bridge trusses, were not adequate for their task. Crushing was severe directly under the bearing plates; blocks were sometimes crushed by more than 1 in. (Fig. 6). Since the Red Oak blocks have replaced the Douglas Fir blocks, the retention of force has been much better. All four monitored rods are still above their minimum target force values.

Thus, the original compressive stresses in the Douglas Fir blocks were at the full allowable dry-use value and 50 percent above the wet-use value. Given that the moisture content of the bridge is well above 20 percent, the wet-use stresses are applicable. Thus, the poor performance of the Douglas Fir blocks is not surprising; the compressive stresses were not acceptable until the rod forces dropped to two-thirds of the nominal forces.

original Douglas Fir blocks were removed and replaced with temporary softwood blocks, and the entire bridge was restressed.

One-piece glulam Red Oak blocks were fabricated as permanent replacements and installed in October 1989. Again, the entire bridge was restressed. The Red Oak blocks are performing significantly better than the original Douglas Fir blocks. There is little evidence of crushing beneath the bearing plates. However, some local crushing has occurred beneath two of the blocks, in the sides of the trusses.

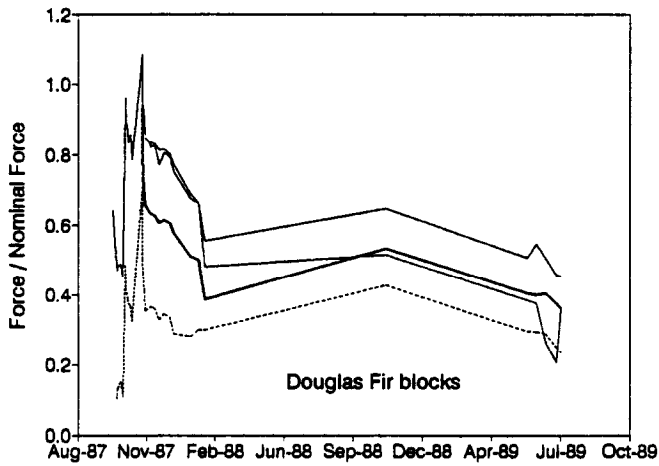
During the first 2 years, through July 1989, three of the four rods being monitored fell below the target minimum of 40 percent of their initial force values, and the fourth rod was barely above that minimum (Fig. 7). Since installation of the Red Oak blocks and

Figure 7—Rod forces with Douglas Fir blocks. Two 1-in. half-width rods (light solid lines), one 1-in. full-width rod (dashed line), and one 1-1/4-in. half-width rod (heavy solid line) were monitored.

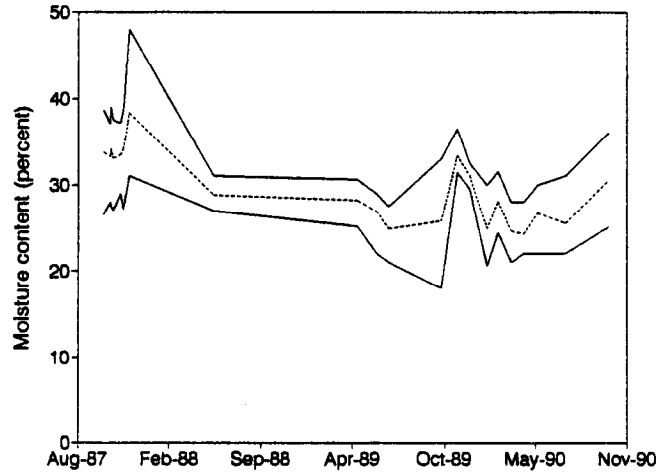
Figure 9—Moisture content of bridge. Solid lines indicate extremes; dashed line, average.

Overall, drying of the bridge has been minimal (Fig. 9). At bridge installation, the moisture content readings were between 27 and 39 percent, with an average of 34 percent; by the end of 1990, the range was 25 to 36 percent, with an average of 31 percent. However, this last reading reflects a winter rise in moisture content, which has occurred in three of the four winters since the bridge was constructed.

Loss of moisture has been very gradual in the bridge. There has been a steady downward trend, with some seasonal rises and falls. The large sizes of the members and the fact that only their edges are exposed to the air undoubtedly account for this slow drying.

The equilibrium moisture content for the location of Mormon Creek is about 18 percent (Ritter 1980). Therefore, we can expect considerable additional, albeit very slow, drying. This probably will cause more loss of stressing force in the future.

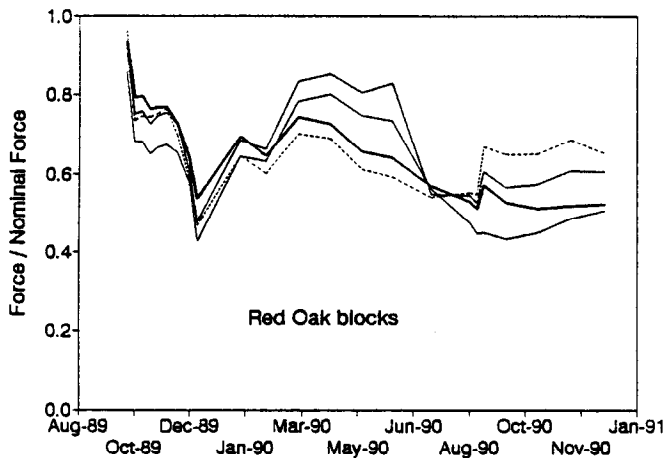
Figure 8—Rod forces with Red Oak blocks. See legend to Figure 7 for description of data.

restressing in October 1989, the force of the 1-in. rod being monitored has dropped from 60 kips to 28, 36, and 40 kips (47, 60, and 67 percent of nominal values). The force of the monitored 1-1/4-in. rod has dropped from 120 to 60 kips (50 percent) (Fig. 8).

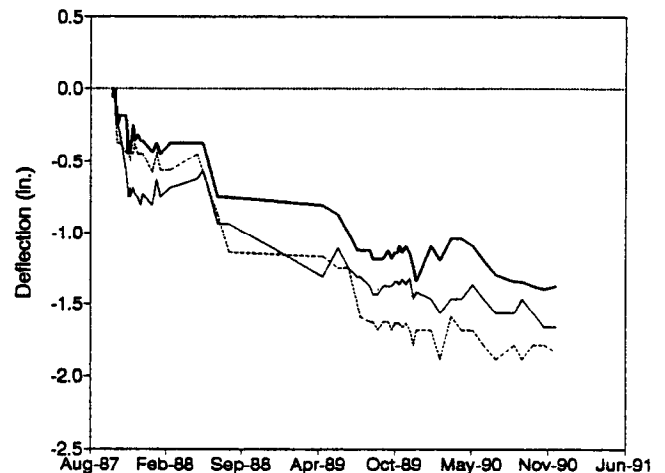
Figure 10—Loss of camber under bridge centerline (heavy solid line), downstream edge (light solid line), and upstream edge (dashed line).

Most bridge deflection occurred in the first year after construction (Fig. 10). In September 1988, the loss of camber at midspan was 0.7 in. at the centerline and 1.0 and 1.1 in. at the edges. Additional deflection has occurred in the past 2 years, but at a slower rate. The stringlines registered 1.4, 1.5, and 1.8 in. at the end of 1990. The initial camber in the bridge was 2.3 in., so some positive camber still exists.

Most deflection occurred during the first year after construction. Since then, the deflection curves have become almost level. There is still some positive camber in the bridge. The magnitude of this long-term deflection is about the same as that of the elastic deflection under design loading.

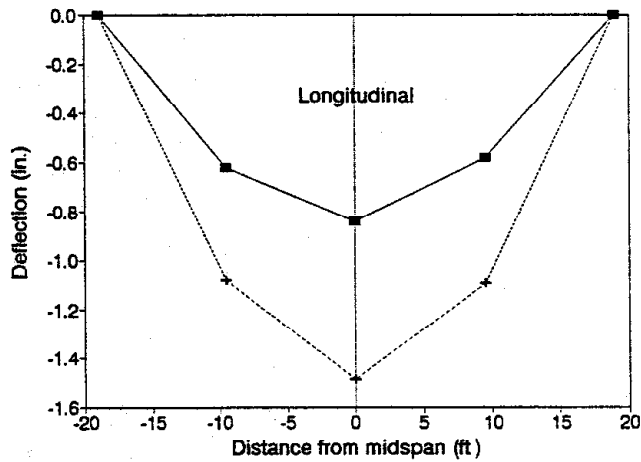
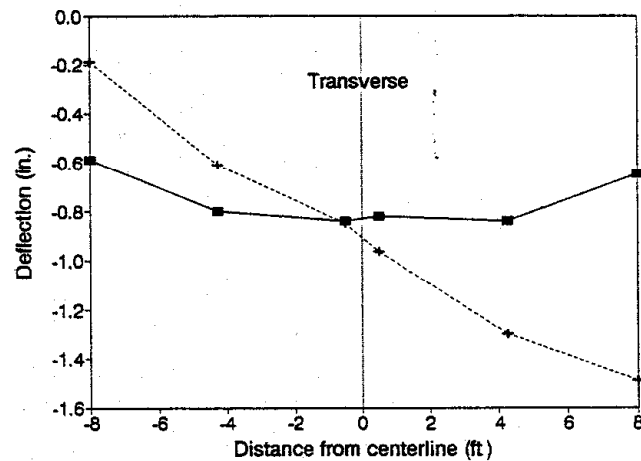
Figure 11—Longitudinal and transverse deflection profiles of 1987 load test. Longitudinal profile shows centerline deflection with truck centered (solid line) and edge deflection with truck at edge (dashed line). Transverse profile shows midspan deflection with truck centered (solid line) and at edge (dashed line). Gross weight of truck was 84,760 lb.

In the 1987 load test, the gross vehicle weight was 84,760 lb, distributed to three axles. The deflection curves from that test are presented in Figure 11. The maximum deflection with the truck centered was 0.8 in. This compares to a theoretical deflection of 1.1 in. (Oliva and Dimakis 1988). With eccentric

loading, the maximum deflection was 1.5 in. at the edge of the bridge.

The load test results (Figs. 11, 12) demonstrate that the bridge deck is behaving as a plate. In particular, the transverse profiles illustrate lateral distribution of the wheel loads. The results of the load tests are summarized in Table 2. The 1987 deflections of 0.8 and 1.5 in. correspond to span/ deflection ratios of approximately 590 and 310, respectively. Considering the weight and configuration of the test vehicle, the deflections should be about 27 percent greater than would occur with a standard American Association of State Highway and Transportation Officials (AASHTO) HS-20 vehicle, which has a gross weight of 72,000 lb. This translates to HS-20 deflections of 0.63 and 1.18 in. and span/deflection ratios of 740 and 400, respectively.

The apparently large difference in the edge deflections between the two tests, despite nearly equal loads, and the opposite slopes of the transverse profiles are attributable to the fact that in 1987, the rear tires of the test vehicle were against the downstream curb; in 1988, the rear tires were about 1 ft away from the upstream curb.

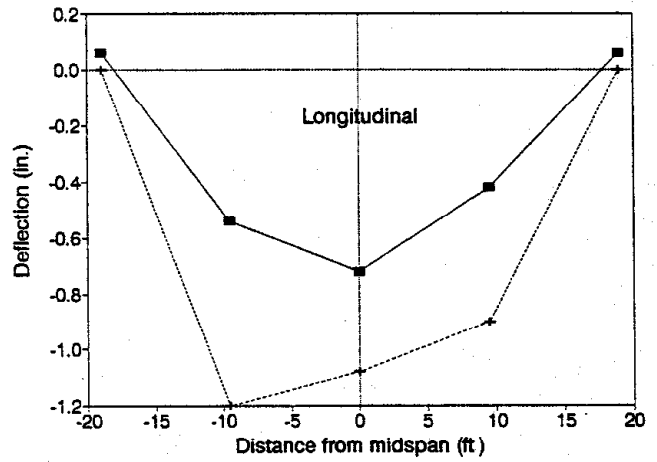
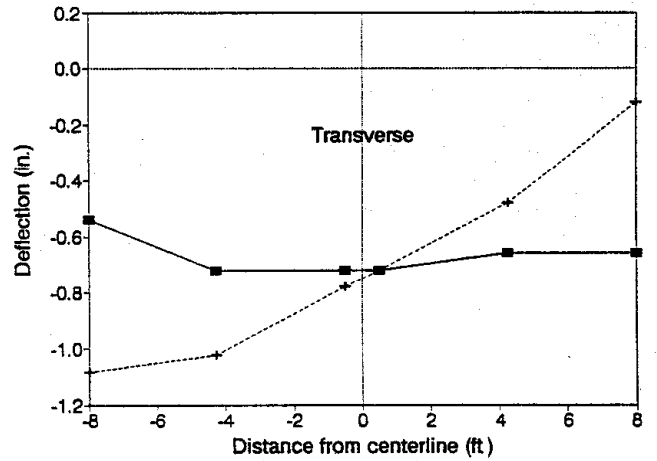
Figure 12—Longitudinal and transverse deflection profiles of 1988 load test. See legend to Figure 11 for description of data. Gross weight of truck was 82,240 lb.

The 1988 truck weighed 82,240 lb, only slightly less than the 1987 truck. The maximum deflection with the truck on the centerline was 0.7 in.; with eccentric loading, the maximum deflection was 1.2 in. (Fig. 12).

The 1988 deflections of 0.7 and 1.2 in. give span/ deflection ratios of 670 and 390, respectively. The deflections in this case are about 23 percent greater than would be obtained with an HS-20 vehicle. The corresponding HS-20 deflections are 0.57 and 0.98 in. and span/deflection ratios are 820 and 480.
