Damage Assessment of a Full-Scale Six-Story Wood-Frame Building Following Triaxial Shake Table Tests

Abstract: In the summer of 2009, a full-scale midrise wood-frame building was tested under a series of simulated earthquakes on the world's largest shake table in Miki City, Japan. The objective of this series of tests was to validate a performance-based seismic design approach by qualitatively and quantitatively examining the building's seismic performance in terms of response kinematics and observed damage. This paper presents the results of detailed damage inspections following each test in a series of five shake table tests, and explains their qualitative synthesis to provide design method validation. The seismic test program had two phases. Phase I was the testing of a seven-story mixed-use building with the first story consisting of a steel special moment frame (SMF) and stories 2–7 made of light-frame wood. In Phase II, the SMF was heavily braced such that it effectively became an extension of the shake table and testing was conducted on only stories 2–7, making the building a six-story light-frame multifamily residential building instead of a mixed-use building. All earthqu

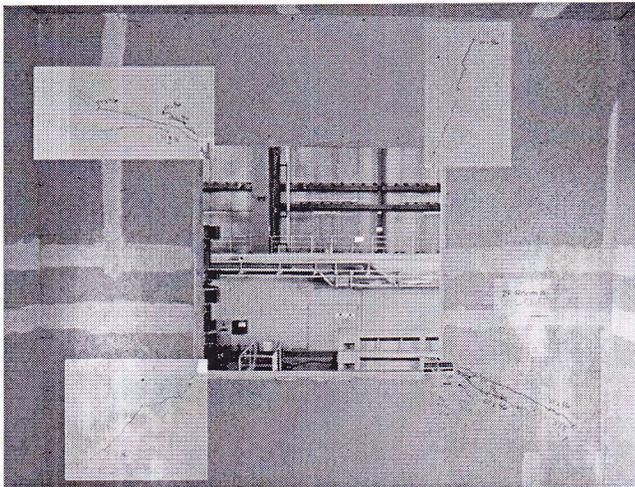
**Fig. 6.** Example of cracking propagation from the corners of a window opening after five simulated earthquake tests

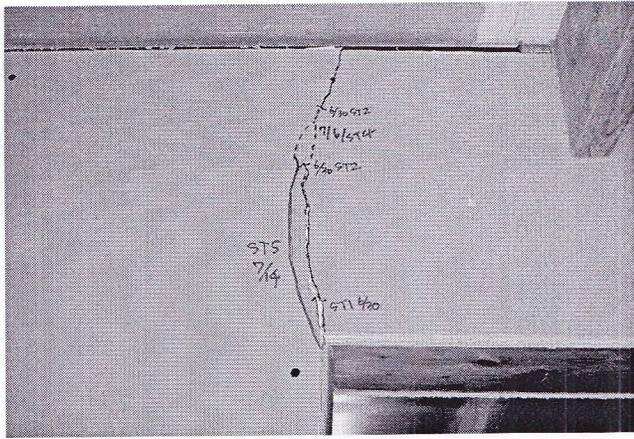
The final test [Seismic Test 5 (ST5)] in the Capstone test program was a maximum credible earthquake (MCE) level corresponding to a 2%/50-year event, statistically giving a return period of approximately 2,500 years. In ST5, crack propagation from the top corner of an opening connected to another crack propagation from a GWB screw. This was observed for walls that experienced the largest interstory drifts, i.e., near 3%, but not all. An example of this type of damage is shown in Fig. 14. In some places a crushed corner was observed, as shown in Fig. 15. A more interesting occurrence was the substantial cracks that were observed to be new and not propagating from existing cracks from the previous tests. This only occurred as a result of ST5 and an example is shown in Fig. 16.

Fig. 16. New crack on Wall 2A, Story 7 (over door opening) after Seismic Test 5

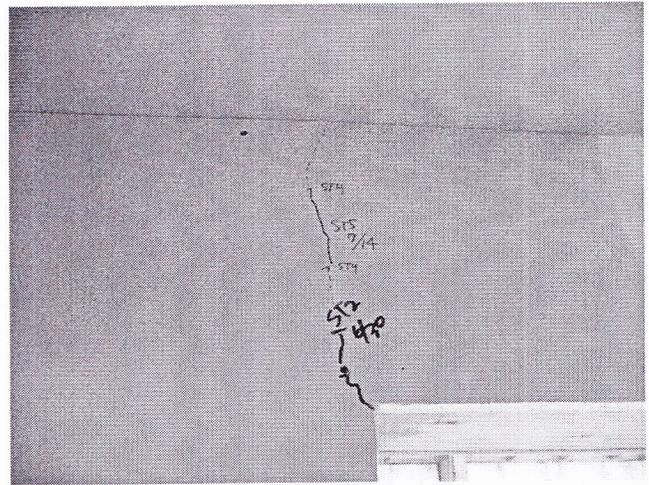
Fig. 19. Story 6, Wall E1; cracks develop all the way through panel after Seismic Test 5

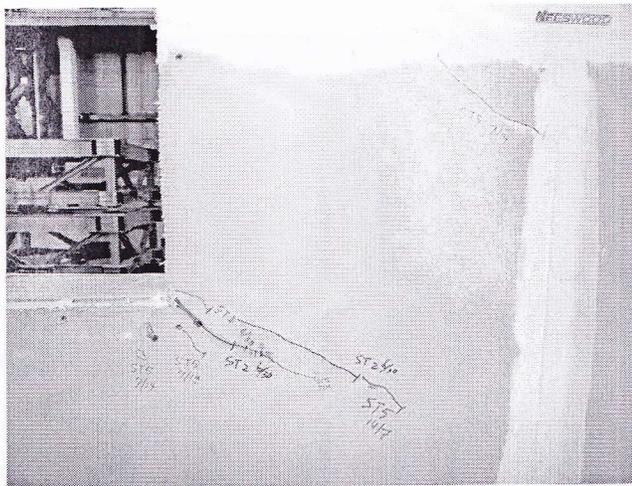
An effort is made here to qualitatively correlate damage with drift. Initially, Story 2 had a smaller interstory drift during each of the tests than Story 6 (Tables 2 and 3), yet the amount of damage was about the same at both stories. Figs. 17 and 18 show very typical damage for Story 2 after ST5. Fig. 17 shows some light spalling, but in general the cracks did not extend all the way to the panel seam or nearby wall corners. Fig. 18 shows two cracks failing to

Fig. 17. Wall E1; cracks did not extend all the way to the panel edge after Seismic Test 5

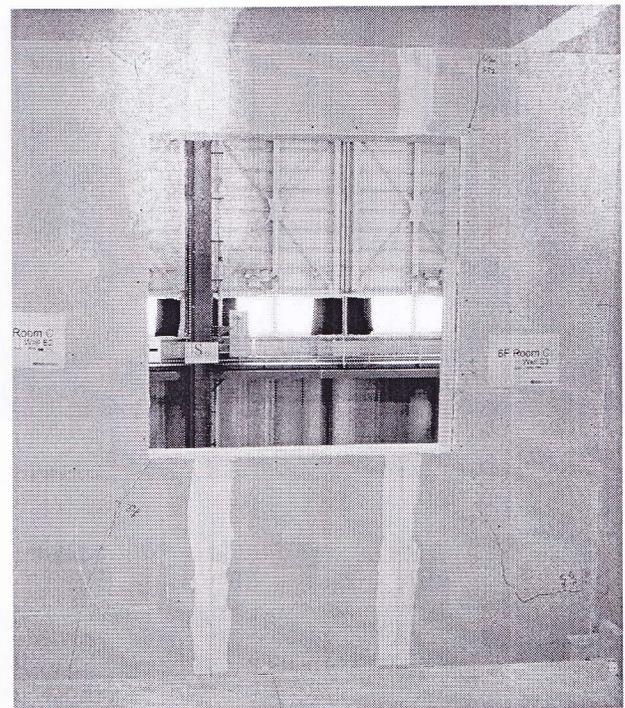
Fig. 20. Story 6, Wall E2; cracks develop all the way through panel for all corners after Seismic Test 5

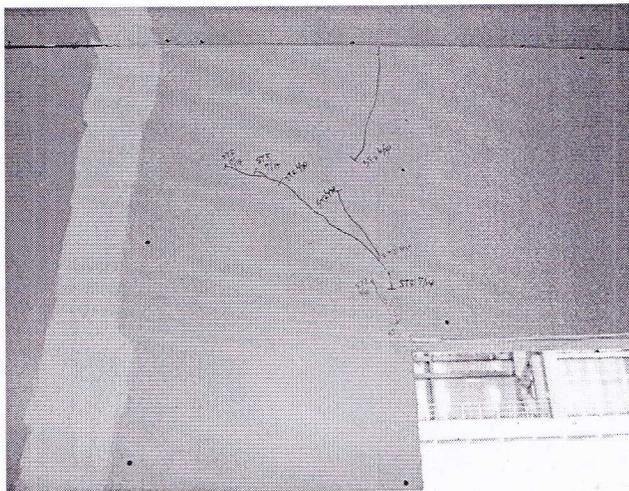
Fig. 18. Story 2, Wall E2; cracks failing to connect together after Seismic Test 5

connect following ST5 at Story 2. For some of the damaged GWB in this study, cracks tended to propagate until they connected to another crack, particularly when there was significant interstory drift caused by a combination of shear and bending. This was typical on lower stories of the building because the overall interstory drifts were lower. Comparatively, consider Story 6 following the series of five shakes. The cracks tended to propagate all the way through the panel as shown in Fig. 19. Fig. 20 shows this from a full-panel vantage point. Further, in Story 6, crushing of the panel corners was more routinely observed, as shown in Fig. 21. Most of the damage in lower stories was attributed to shear deformation,

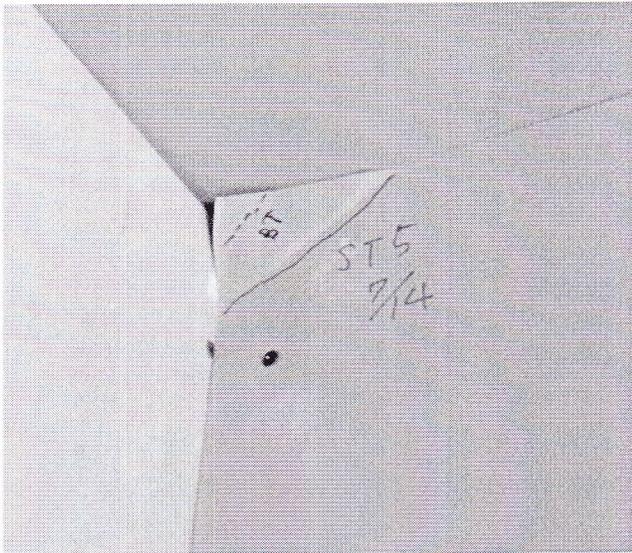
Fig. 21. Crushing of corners also seen at Story 6, Wall E5 after seismic test

whereas in upper stories the damage was attributed to a combination of shear and bending.
