STUDIES OF COMPRESSION FAILURES AND THEIR DETECTION IN LADDER RAILS

No. 1733

FOREST PRODUCTS LABORATORY
MADISON 5 WISCONSIN

MAXON Y. PILLOW, Wood Technologist

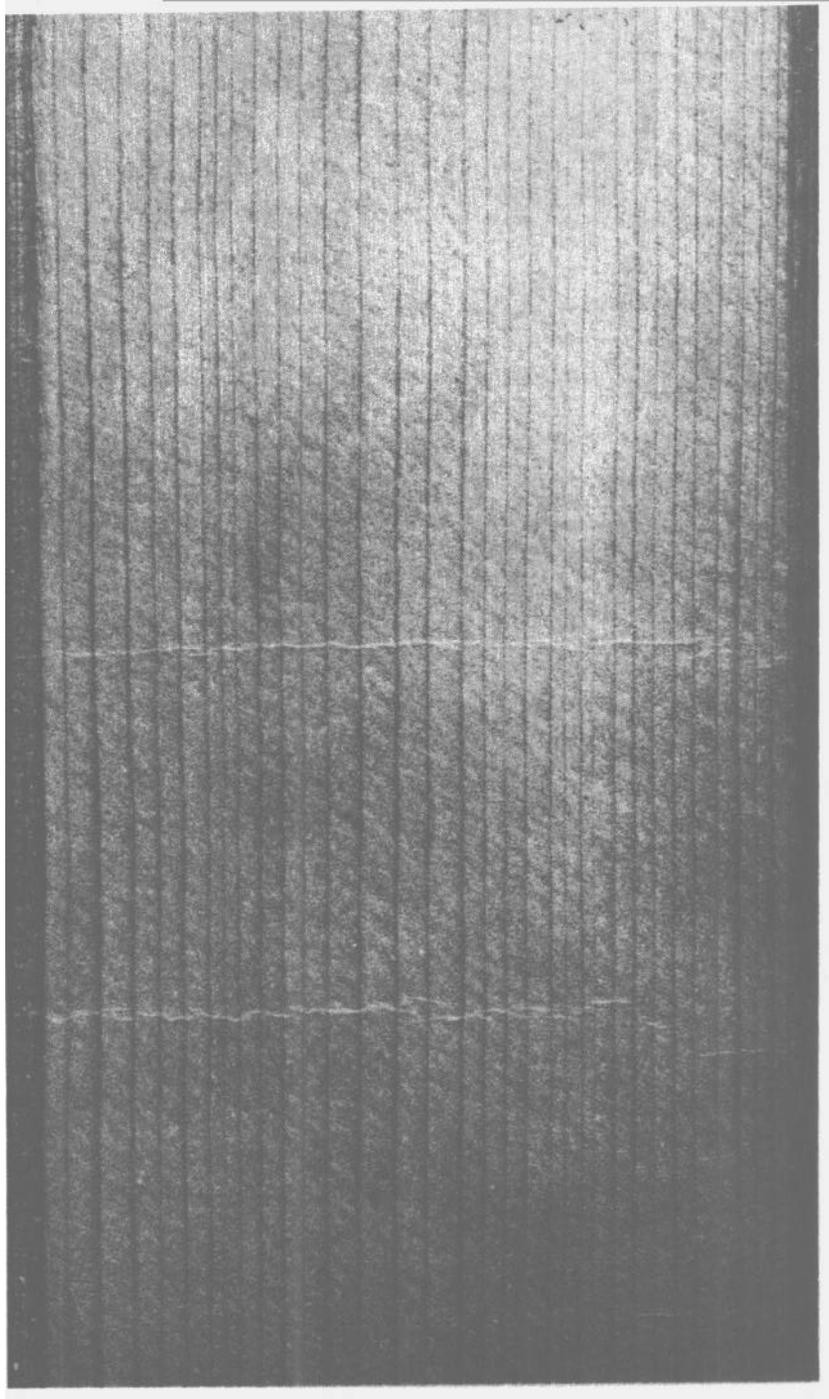
Figure 1.--Compression failures in spruce lumber that are visible as lines across the grain. Slightly magnified.
ZM 80312 F

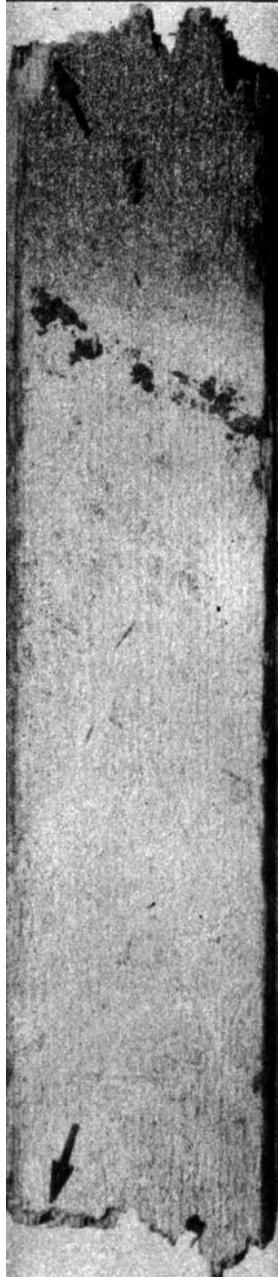
Two breaks due to compression failures occurred about 1 foot apart in one ladder rail (fig. 2), while in another ladder both rails had broken simultaneously at the

same rung insertion because of compression failures in both rails. In the rails of both of these ladders, the compression failures were too small to be detected by ordinary visual inspection of the sides and edges of the rails. Their presence, nevertheless, was indicated by areas of broken fibers that extended across several annual rings on end-grain surfaces (fig. 3) that were cut from near the failures of each of the rails.⁴ Thus, the abrupt fractures across the grain of the rails were found to occur at compression failures already present in the wood, and the presence of these defects was indicated in nearby parts of the rail by fiber breakage in end-grain surfaces, although they were not detected by ordinary visual inspection of other surfaces.

Figure 2.--Side view of a ladder rail that failed in two places at approximately the same time because compression failures were present prior to the ultimate breaks in tension, which are indicated by arrows.
ZM 80313 F

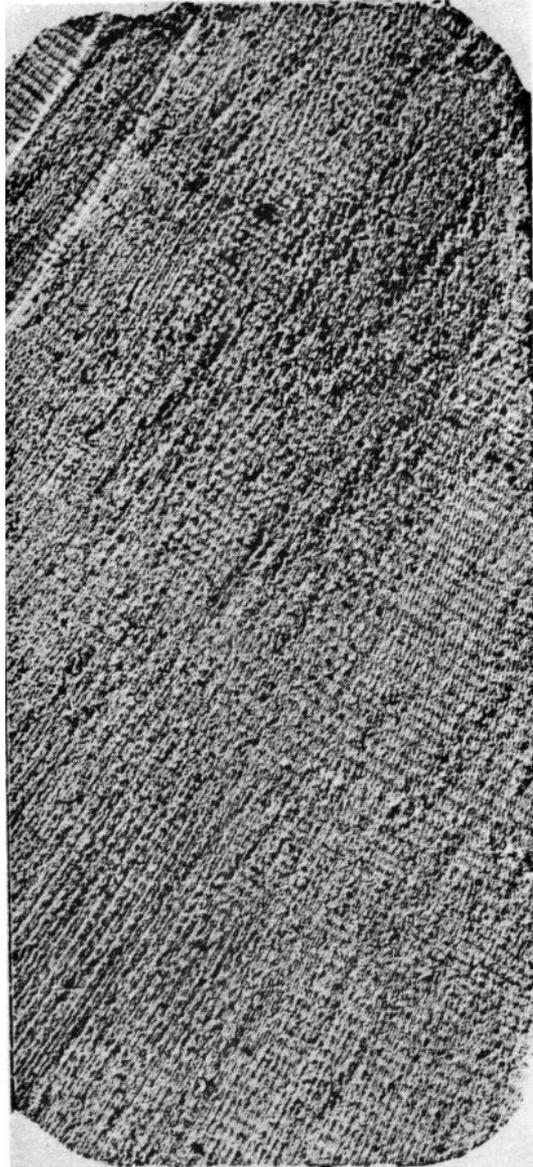
Figure 3.--Cross section of a ladder rail showing fiber breakage that indicates the presence of compression failures.
Z M 80314 F

The known information on occurrence and effects of compression failures demonstrates that a ladder rail having fiber breakage on one or both ends is likely to be hazardous to safety of life and property. Therefore, ladder rails having fiber breakage at either end, such as is shown in figures 3, 6, and 7, are not considered safe.

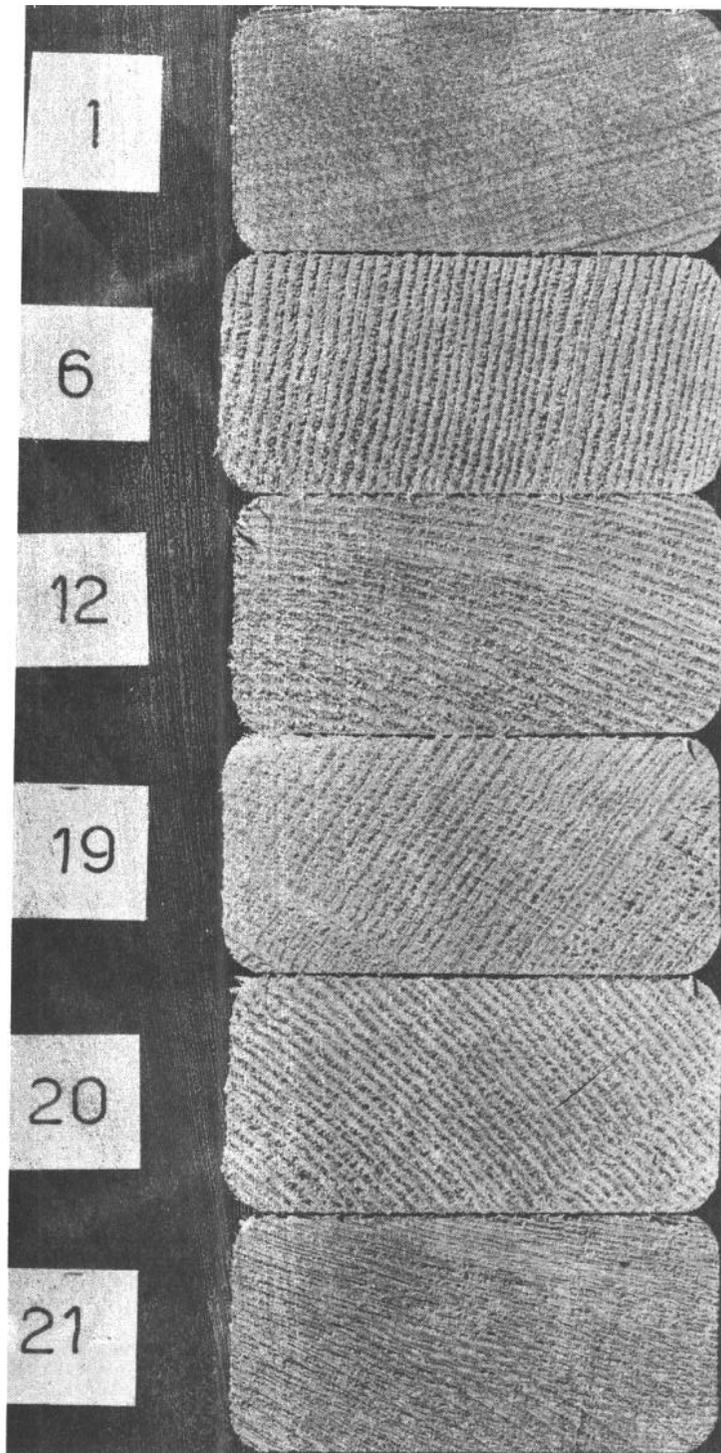
Figure 4.--Cross sections of ladder-rail samples that showed no fiber breakage.
Z M 80315 F

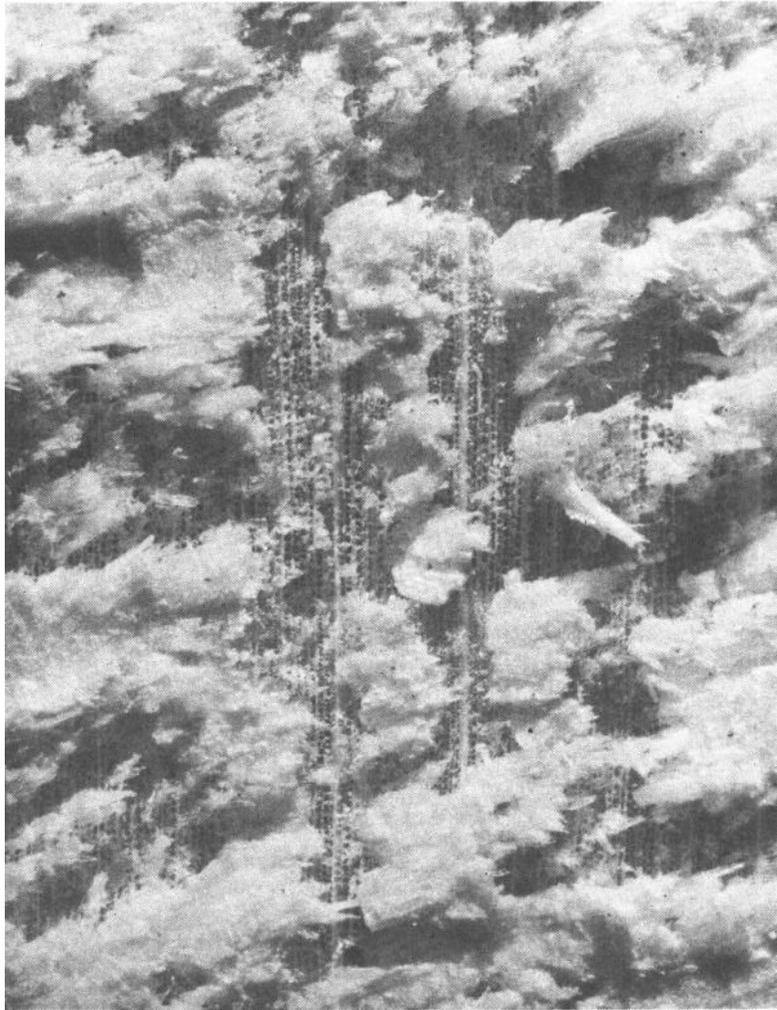
Examinations at low magnification (20X) of end-grain surfaces with fiber breakage showed that cells of the wood had been broken off cleanly rather than having been cut and pushed to one side by the saw teeth (fig. 5). This breakage occurred in radially oriented areas that frequently extended across both springwood and summerwood of two or more annual rings. The saw cut obviously must be made close to compression failures to cause such fiber breakage. The occurrence of fiber breakage at both ends of the ladder rails and at frequent distances along their lengths indicated that compression failures were closely spaced and uniformly distributed throughout some of the ladder rails being studied (fig. 6).

Figure 5.--Photomicrograph of fiber breakage due to compression failures, showing areas of cleanly broken fibers interspersed by groups of other fibers cut by the saw teeth and pulled to one side. x20.
Z M 80316 F

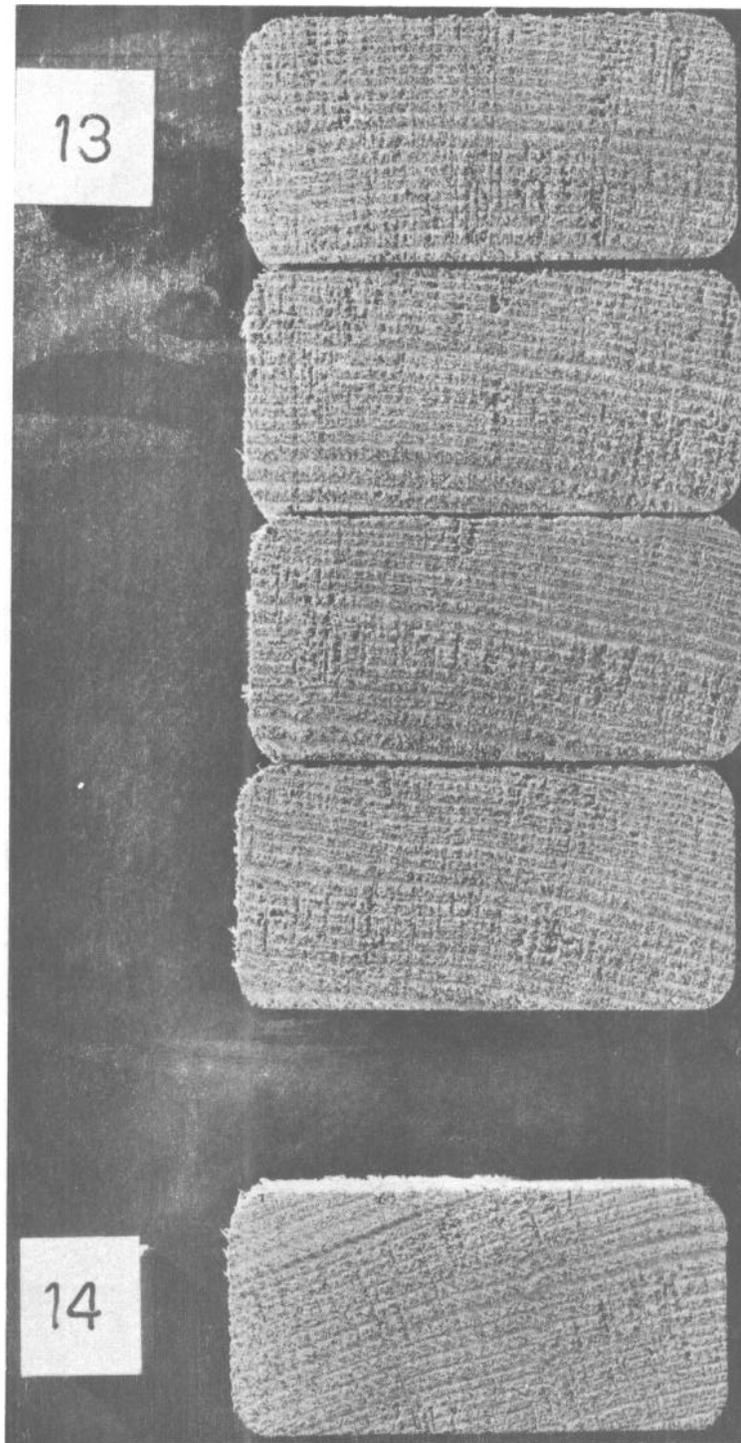
Figure 6.--Four cross sections cut at about 2-foot intervals from one end (13) and one from the opposite end (14) of a 16-foot ladder rail, all showing fiber breakage caused by the presence of compression failures.
ZM 80317 F

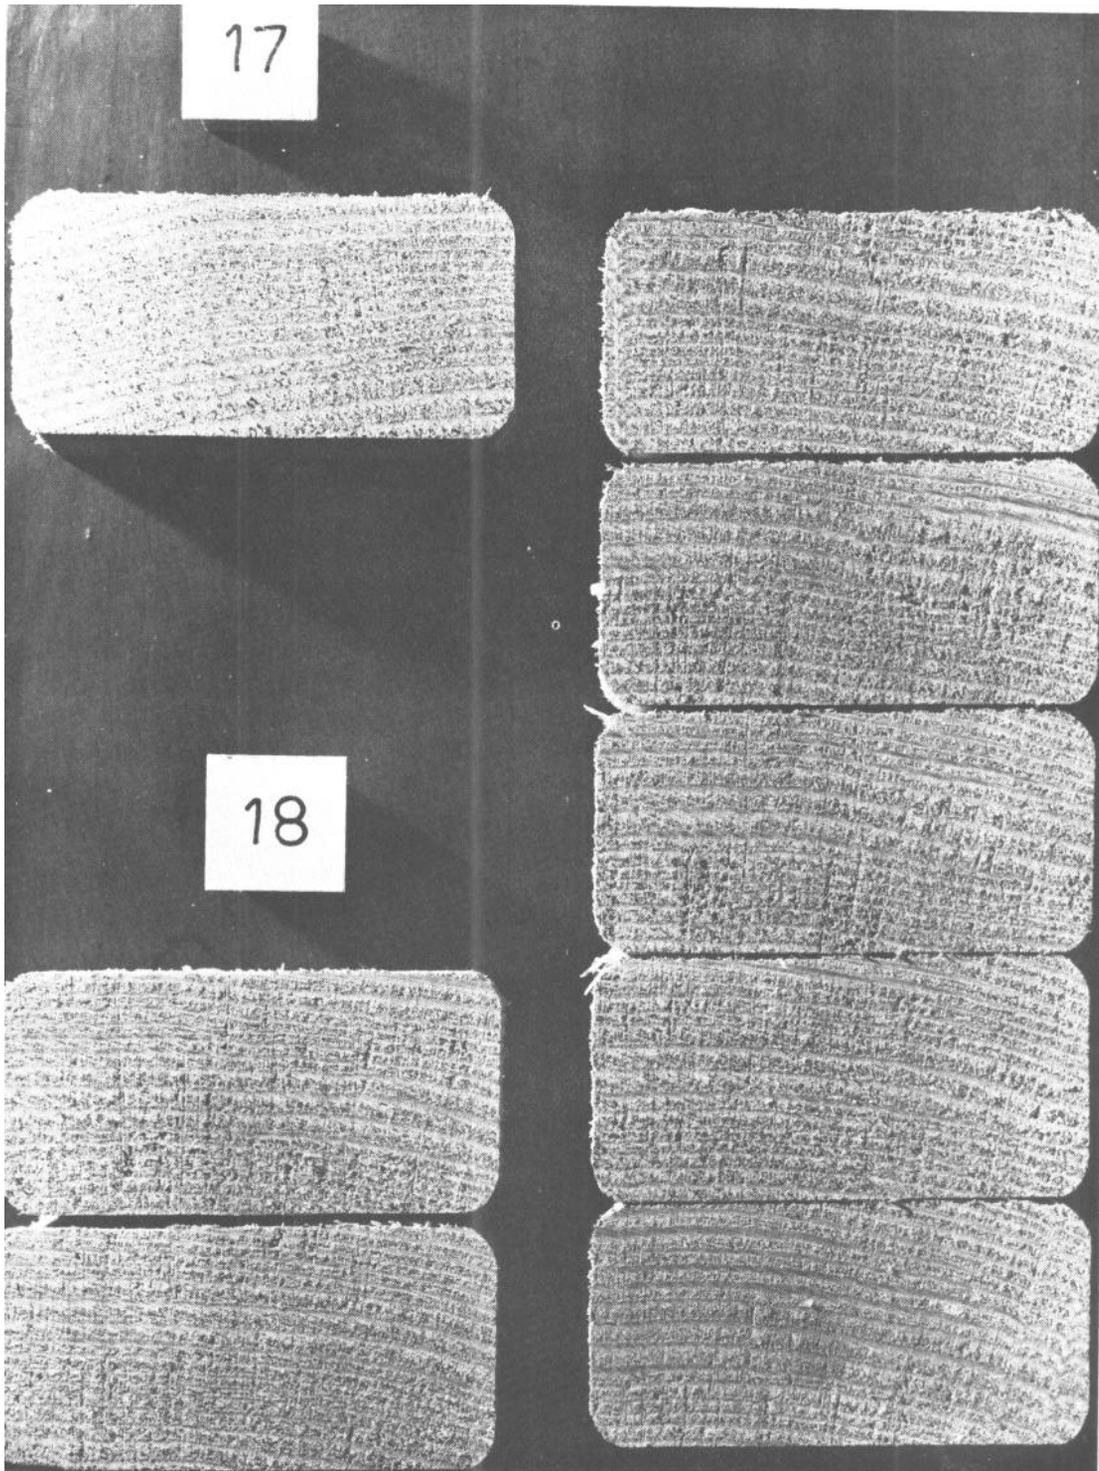
Figure 7.--Cross sections from a ladder rail cut at about 2-foot intervals, all of which show fiber breakage to lesser or greater extents, indicating the presence of uniformly distributed compression failures along the length.
ZM 80318 F

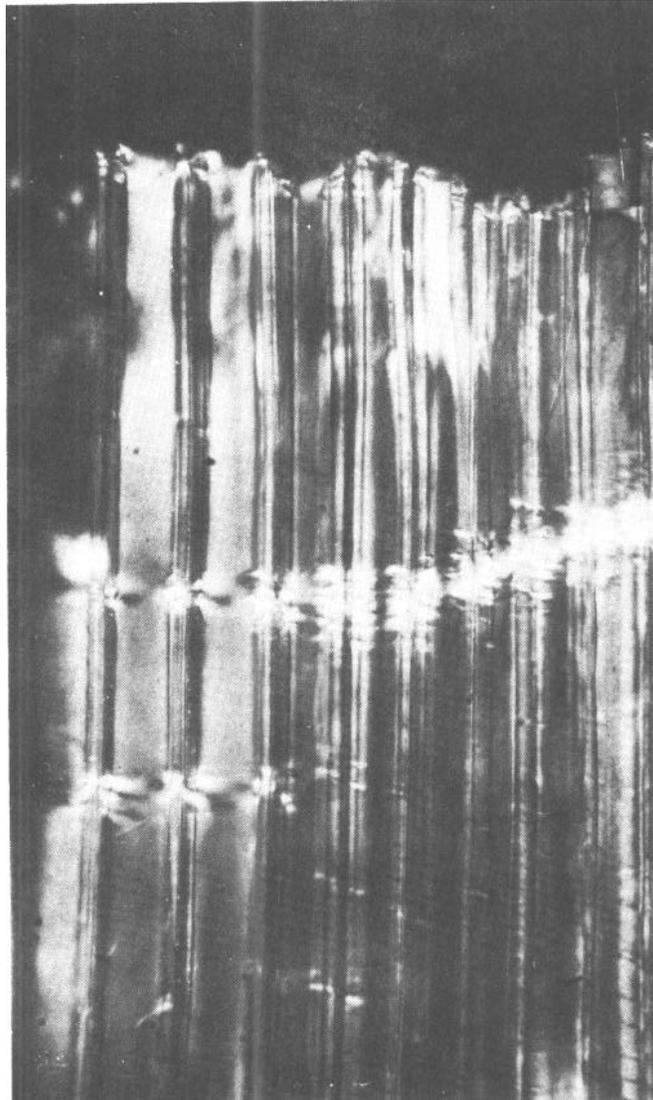
Figure 11.--Photomicrograph of a brittle break in tension that occurred at a compression failure already present before the piece ultimately broke. X450 by polarized light.
M 80321 F

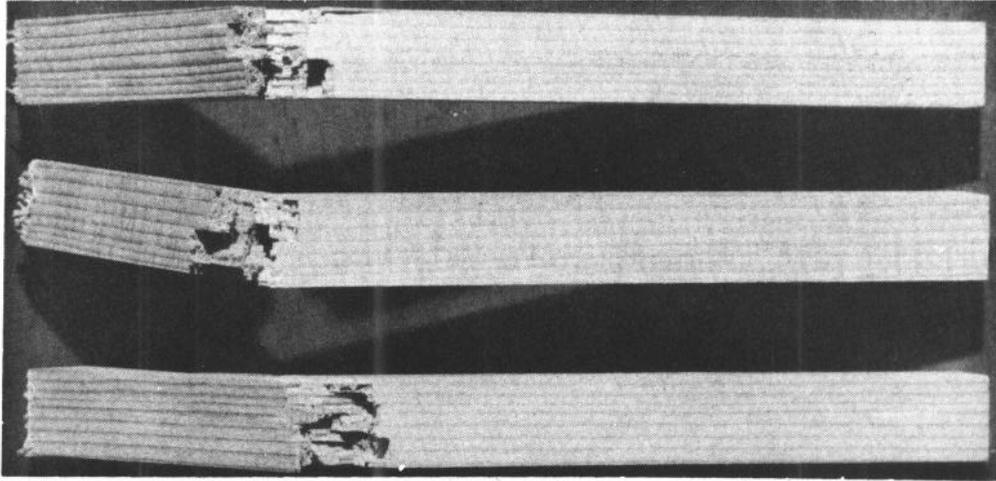
Types of failure. --Toughness specimens of this study, and also of previous studies of causes of brashness,² have shown that abrupt or brittle breaks across the grain are very frequently caused by compression failures present before the ultimate fractures occurred. Examination of such brittle fractures by high-power magnification has shown that many occurred at compression failures (fig. 11). The specimens from samples having fiber breakage on end-grain surfaces had characteristically brittle failures in contrast to the splintering failures of specimens from samples without fiber breakage (figs. 12, 13, and table 1).

Figure 12.--Brittle breaks across the grain of toughness-test specimens from a ladder-rail sample that showed fiber breakage on end-grain surfaces.
Z M 80322 F

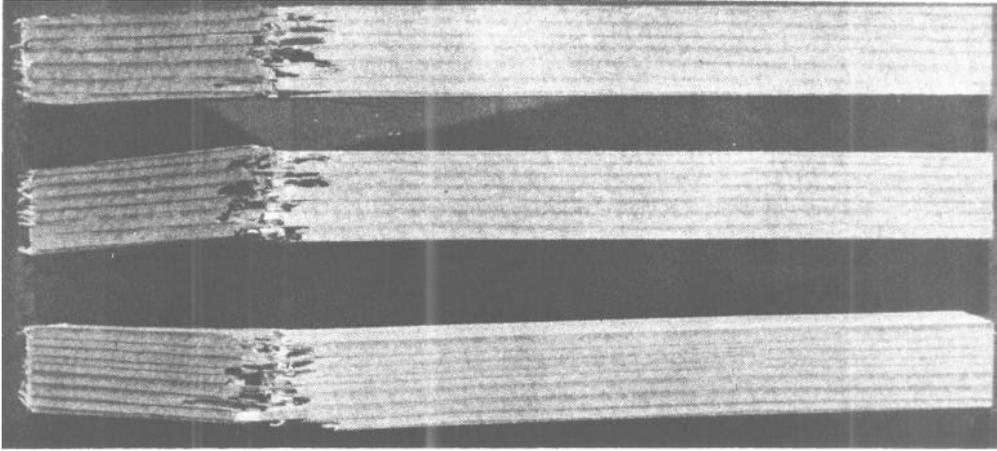
Figure 13.--Splintering toughness-test failures of specimens from sample without fiber breakage on end-grain surface.
Z M 80323 F

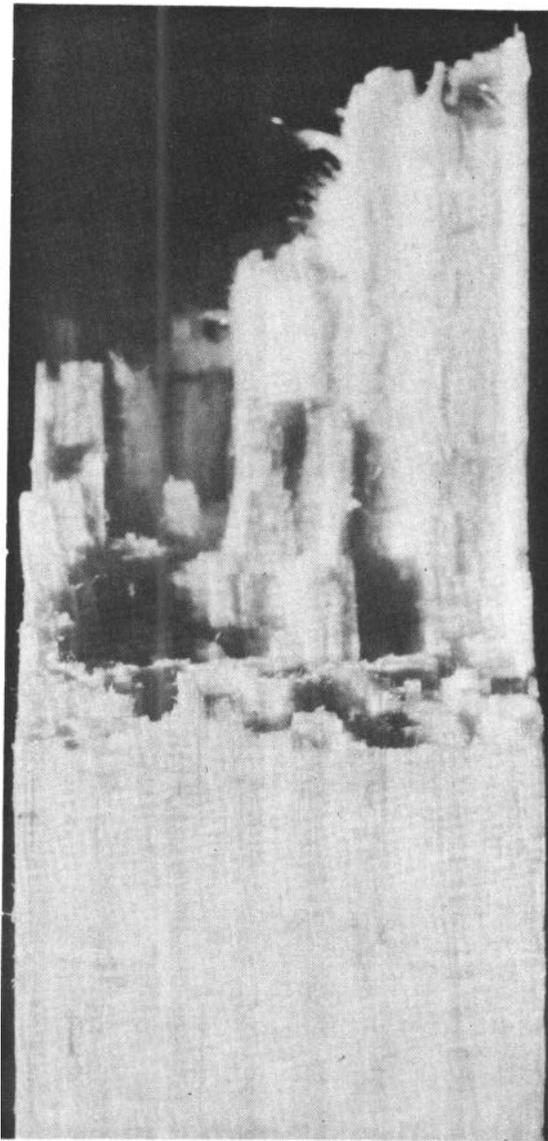
Figure 14.--Steplike break in a toughness-test specimen that is characteristic of a fracture through several compression failures already present before the ultimate break occurred. X5 photographed by reflected light.

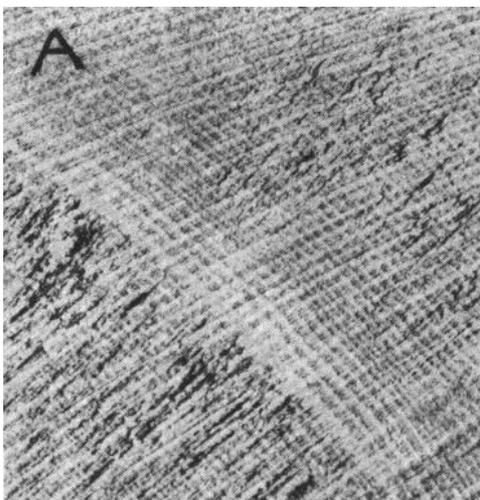
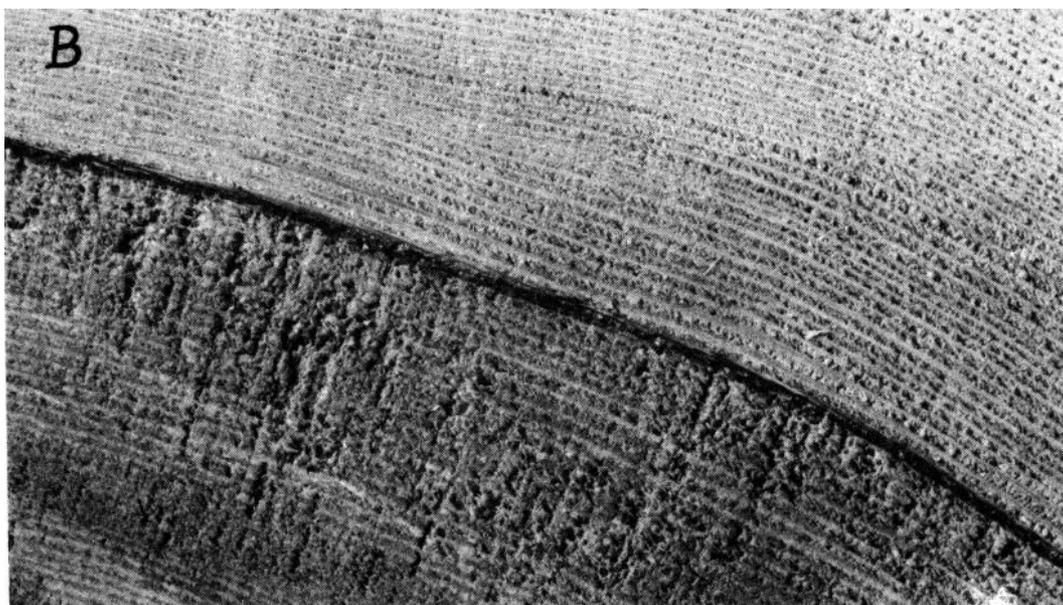
Figure 15.--End-grain surfaces of Sitka spruce lumber showing fiber breakage: A, distributed across most of the surface; and B, in the part below the black line in comparison to wood free from this characteristic above the line.

Observations at plants manufacturing ladder rails showed that careful inspection of end-grain surfaces for fiber breakage is a practical means of detecting compression failures. Such inspections can be made on sawed lumber in large sizes intended for resawing to ladder-rail dimensions, provided that the ends are sawed with reasonable smoothness. Exclusion of pieces showing fiber breakage in rough-lumber sizes will result in some saving in manufacturing costs (fig. 15, A). Lumber having that characteristic confined to only part of the cross section sometimes can be resawed so as to salvage the remainder that is suitable for ladder-rail material (fig. 15, B).
