Research
Paper
FPL-RP-642

Acoustic Tomography for Decay Detection in Red Oak Trees

Xiping Wang
R. Bruce Allison
Lihai Wang
Robert J. Ross

August 2007

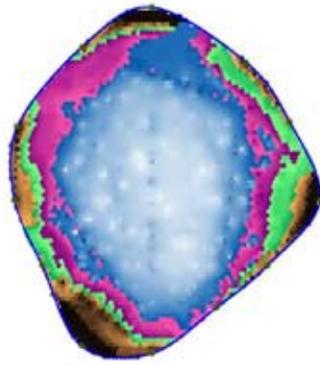
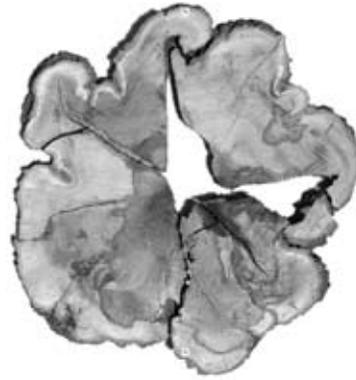
(a) Lower section (10-cm elevation)

After being cut down, tree #307 was found to have heartwood decay at all three elevations. Laboratory examination confirmed the presence of white-rot decaying fungus. The decay was less severe in the upper cross section (200-cm elevation), but it increased as the elevation dropped. The decay was so extensive at the base section that part of the interior decayed wood fell off when the lower disk (10-cm elevation) was removed from the tree butt.

In addition to decay, major internal cracks were present in the cross sections of tree #307. The combination of extensive decay and large lateral cracks caused the base disk to fall into several pieces during transportation. The photographs of the disks show that lower and middle cross sections had multiple lateral cracks and the upper cross section had one large lateral crack.

Figure 2 shows comparisons of acoustic tomograms with photographs of the cross sections at three elevations. In the tomograms, the cross section was mapped into different color zones based on the distribution of acoustic velocities measured using the PiCUS tool. The dark-colored zones in the tomograms represent solid wood, and the light-colored zones represent decayed wood (the tomograms used green, violet, and blue to represent increasing degradation by decay). The tomograms clearly show a strong correspondence to the images of the disks. Extensive decay and radiating lateral cracks in the lower and middle cross sections were reflected by large light-color zones in the tomograms. The tomogram of the upper cross section accurately located the

position and orientation of the big lateral crack and heartwood decay.

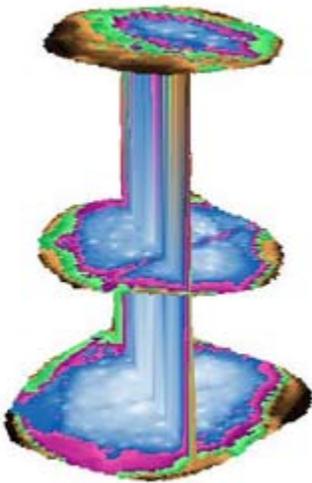
Figure 3. Three-dimensional tomogram for red oak tree #307.

Figure 3 is a three-dimensional tomogram of tree #307 that demonstrates the progressive changes of decay and macroscopic defects at different elevations. This clearly matches the transition of decay and cracks found in the disks. The massive rot at the lower part of the trunk indicated by light-colored zones in the tomograms supported our speculation that decay fungus originated from the root system. Root excavation to 30-cm depth at root collar revealed a lack of identifiable primary roots and a very heavy fibrous mat of adventitious roots closest to the trunk.

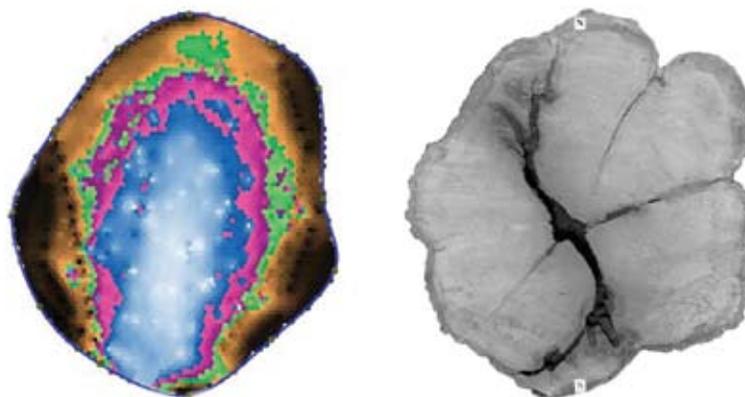
Figure 4 shows the comparison of acoustic tomogram with a photograph of the cross section for tree #123. The tomogram at 100-cm elevation showed a large light-colored area with an elliptical shape, suggesting extensive heartwood decay in the cross section. Subsequent resistance microdrilling into the cross section from the south side revealed a minimal depth of 38 cm into a cavity (Fig. 5). These observations seemed to support a conclusion that the lower stem of the tree had a serious internal decay problem. However, the cross-section image of the disk indicated otherwise. It was the big “snake” (S-shaped) crack, not the extensive heartwood decay, that triggered the large decay-indicating light-colored zones in the tomogram. Even the single microdrilling into the tree trunk at 100-cm elevation gave misleading information (decay positive) because the drill happened to be driven into the long snake crack, thus resulting in zero resistance in the profile chart (Fig. 5).

Figure 4. Comparison of acoustic tomogram and photograph of the cross section for red oak tree #123.

Take tree #123 as an example. The tomogram at 100-cm elevation showed possible extensive heartwood decay within the trunk. The light-color zone was in an elliptical shape and extended to the south edge. Visual inspection indicated bulging ribs and cracks on the south side with a surface strata fungal growth extending up the trunk. It seems that either decay or crack could be the dominating defect. To verify the nature of this light-color zone, the inspector could conduct resistance microdrilling testing at several locations near the suspect decay area. Figure 7 shows the resistance profile charts obtained using the IML-Resi measuring instrument (Instrumenta Mechanik Labor GmbH, Wiesloch, Germany) from three drilling locations (A, B, and C) in the south side of the tree. The resistance profiles indicated only minor cavities (3 to 5 cm) at these drilling paths, and most parts were actually solid. This suggested that large light-colored areas in the tomogram were primarily caused by big cracks oriented in north-south direction.

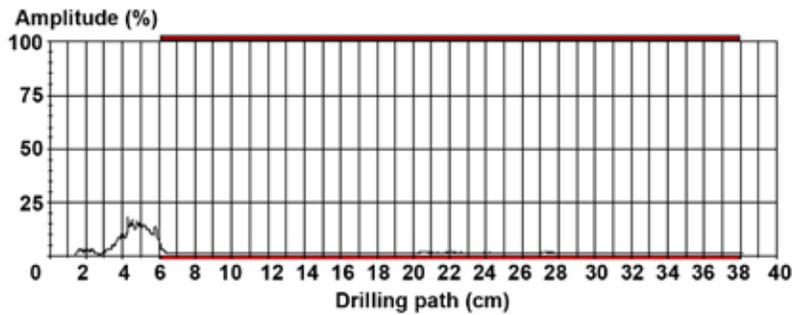
Figure 5. Resistance profile for red oak tree #123 (microdrilling into the tree trunk at 100-cm elevation from the south side).

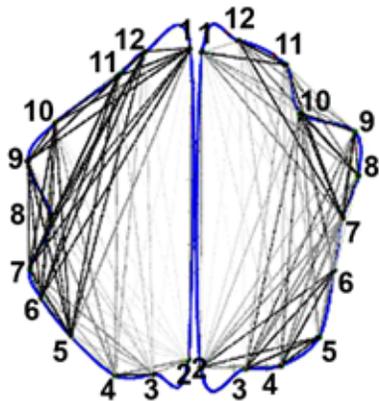
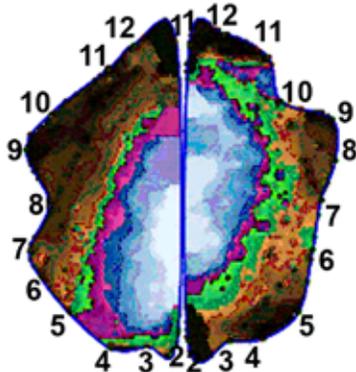
The two red oak trees we tested in this project had a circumference of 269 cm (tree #123) and 345 cm (tree #307), which is equivalent to an average diameter of 86 cm (tree #123) and 110 cm (tree #307), assuming a round shape. During field measurements on the trees, we used all 12 sensors available for each tomogram. The distance between adjacent sensors was about 22 to 29 cm. After trees were felled, we employed a different sensor arrangement to reconstruct tomograms from the disk of tree #123. In this laboratory evaluation, we reduced the distance between adjacent sensors in half by placing all 12 sensors at one half side of the disk each time (Fig. 6a). By measuring two half disks (east half and west half), we constructed two half tomograms for the cross section. Figure 6b shows the image of two half tomograms combined together, representing the complete cross section of the disk.

Comparing two half tomograms taken on the disk to the tomogram taken on the tree, we found that the light-colored decay shadow was not thinned as the distance between adjacent sensors reduced. Overall, the decay shadow in the combined two half tomograms matches the shadow in a single tomogram taken on the tree. This indicated that the crack effect might not be a resolution problem and cannot be solved by just increasing the number of sensors placed on the trees.

Figure 6. Two half tomograms for red oak tree #123 at 100-cm elevation.

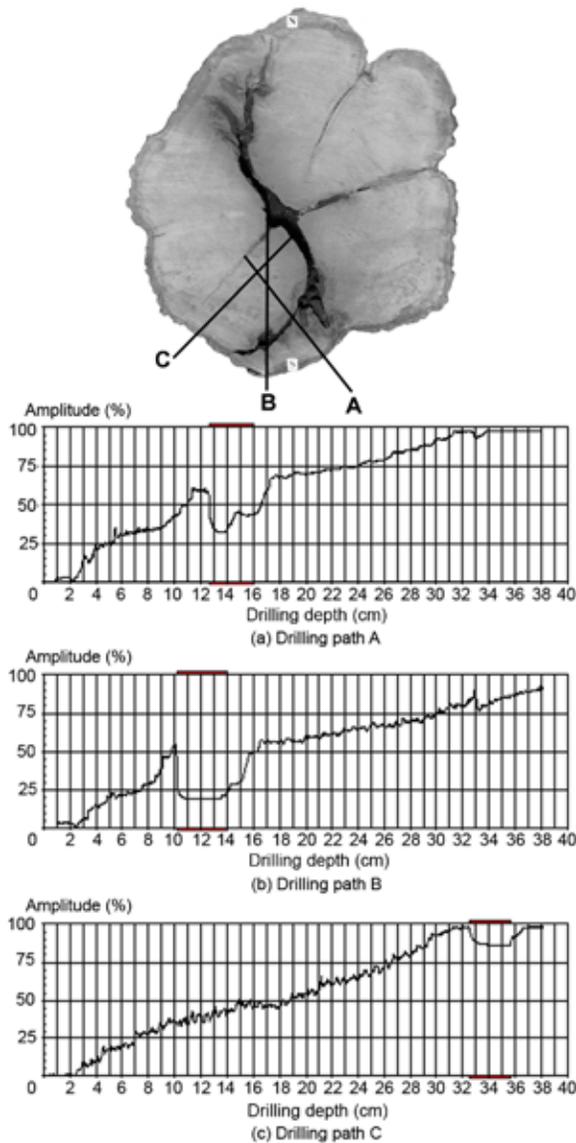
Figure 7. Resistance profile for verifying the tomogram of red oak tree #123 at 100-cm elevation. A, B, and C show the drilling path orientations.
