Development of a Tornado Safe Room Door from Wood Products

Door Design and Impact Testing

Research Paper
FPL-RP-686

September
2016

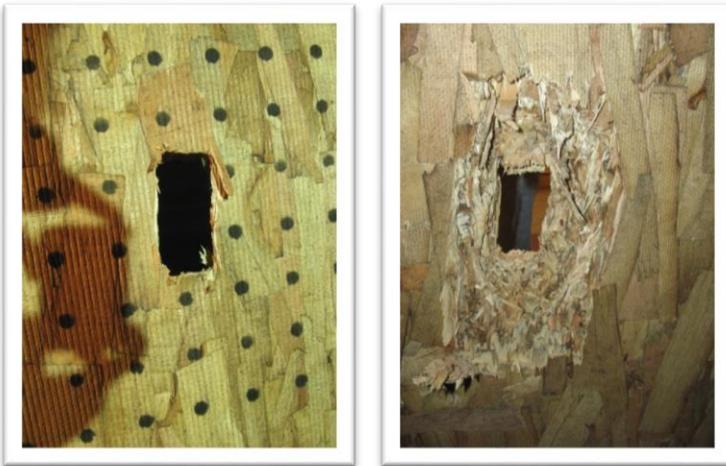
Door number	Door construction	Missile speed (mph)	Front penetration (in.)	Permanent door deflection (in.)	Door perforated? (Y/N)	Observed damage	Passed test? (Y/N)	Additional notes
1	1-3/4-in. LSL	103.5	Full	-	Y	Wall pierced by missile	N	3-in. bearing on vertical edges, horizontal edges free

L to R: Impact damage to front of door, impact damage to back of door.

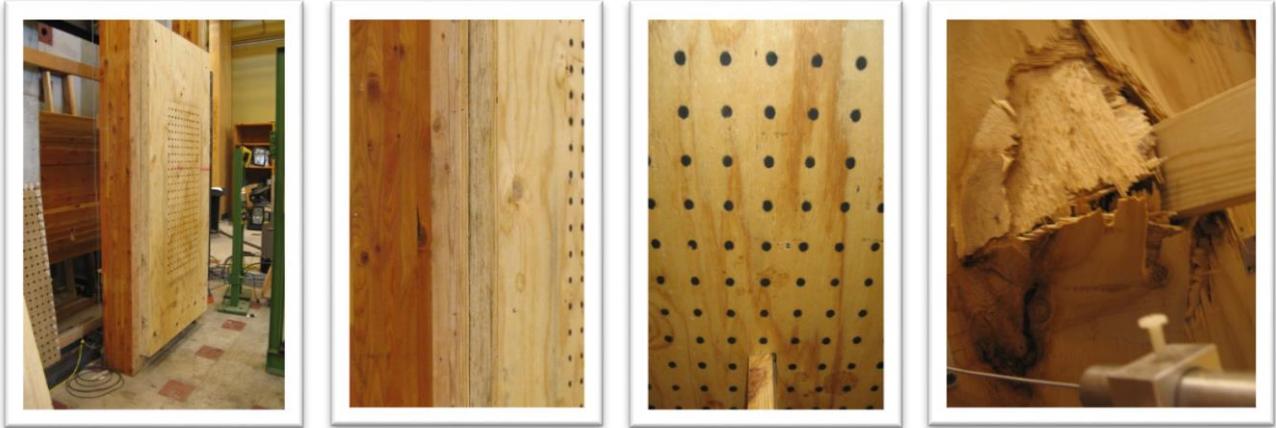
Door number	Door construction	Missile speed (mph)	Front penetration (in.)	Permanent door deflection (in.)	Door perforated? (Y/N)	Observed damage	Passed test? (Y/N)	Additional notes
2	1-3/4-in. LSL, 23/32-in. plywood both sides	102.3	Full	-	Y	Wall pierced by missile	N	3-in. bearing on vertical edges, horizontal edges free

L to R: Door prior to test, edge detail of door, missile embedded in front of door, impact damage to back of door.

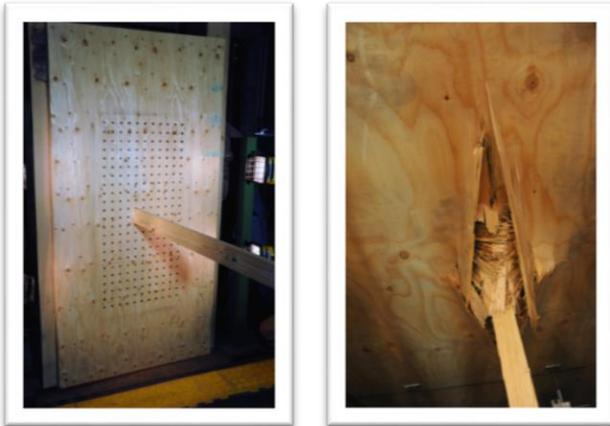
Door number	Door construction	Missile speed (mph)	Front penetration (in.)	Permanent door deflection (in.)	Door perforated? (Y/N)	Observed damage	Passed test? (Y/N)	Additional notes
3	Two sheets of 1-1/4-in. LVL glued and nailed	104.4	Full	-	Y	Wall pierced by missile	N	3-in. bearing on vertical edges, horizontal edges free

L to R: Front of door after impact, damage to back of door.

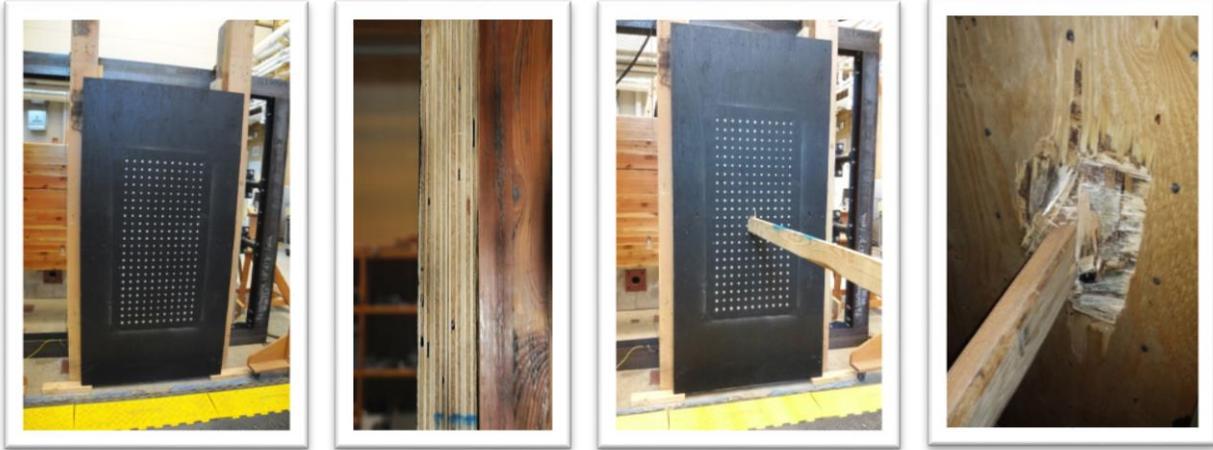
Door number	Door construction	Missile speed (mph)	Front penetration (in.)	Permanent door deflection (in.)	Door perforated? (Y/N)	Observed damage	Passed test? (Y/N)	Additional notes
4	Four sheets of 23/32-in. plywood, nailed	102.0	Full	-	Y	Wall pierced by missile	N	3-in. bearing on vertical edges, horizontal edges free

L to R: Door prior to test, edge detail of door, missile embedded in front of door, impact damage to back of door.

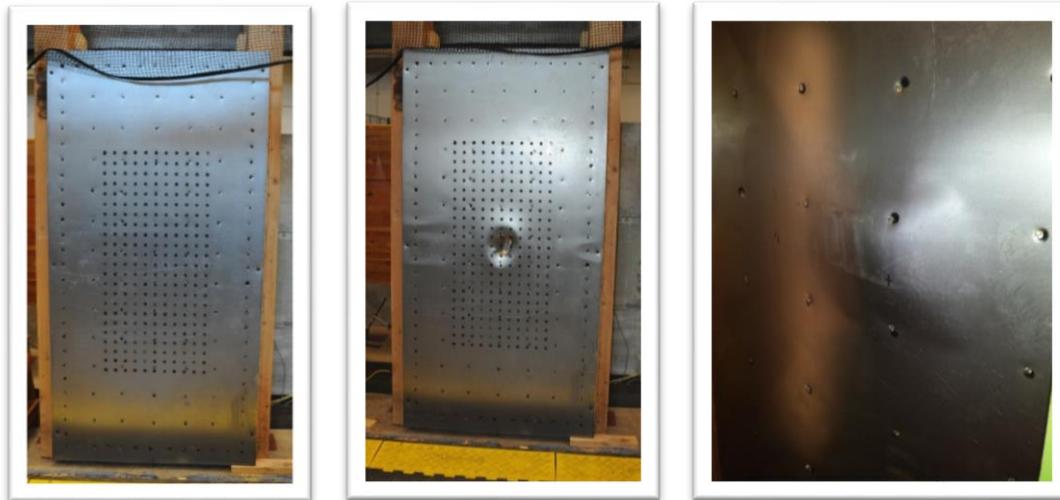
Door number	Door construction	Missile speed (mph)	Front penetration (in.)	Permanent door deflection (in.)	Door perforated? (Y/N)	Observed damage	Passed test? (Y/N)	Additional notes
5a	3-1/2-in. LSL with 18-gauge steel sheeting nailed both sides	102.2	2.6	2.3	Y	Front steel sheet torn at impact location	Y	Rear steel sheet intact

L to R: Door prior to test, impact damage to front of door, impact damage to back of door.

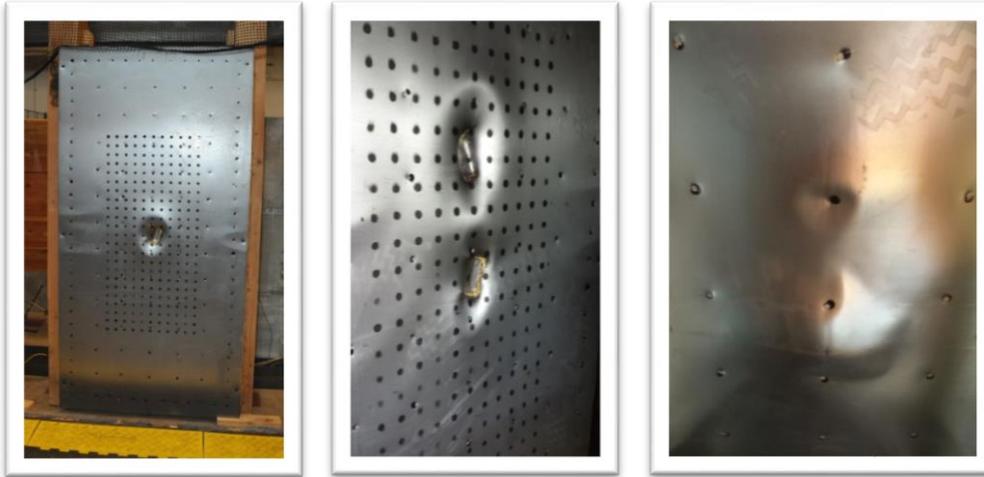
Door number	Door construction	Missile speed (mph)	Front penetration (in.)	Permanent door deflection (in.)	Door perforated? (Y/N)	Observed damage	Passed test? (Y/N)	Additional notes
5b	3-1/2-in. LSL with 18-gauge steel sheeting nailed both sides	102.5	3.6	2.5	N	Front steel sheet torn at impact location	Y	Second shot on door 5, rear steel sheet intact

L to R: Door prior to test, impact damage to front of door, impact damage to back of door.

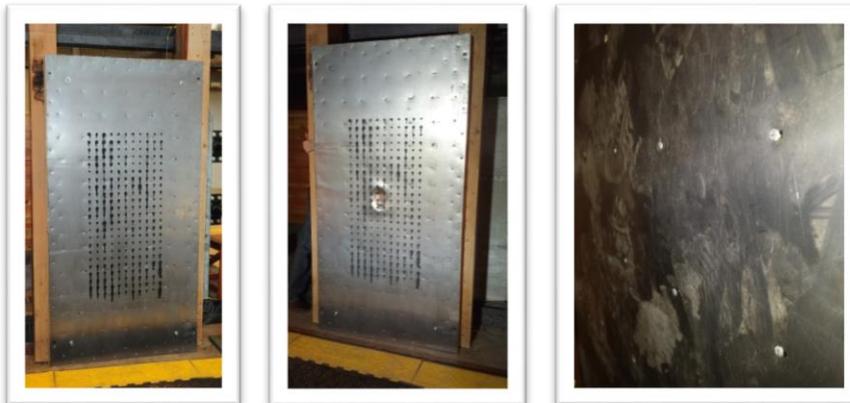
Door number	Door construction	Missile speed (mph)	Front penetration (in.)	Permanent door deflection (in.)	Door perforated? (Y/N)	Observed damage	Passed test? (Y/N)	Additional notes
6	Two 1-1/4-in. LVL panels with one sheet 23/32-in. plywood between, 18-gauge steel sheeting nailed both sides	101.5	0.8	0.6	N	Front steel sheet torn at impact location	Y	Rear steel sheet intact

L to R: Door prior to test, impact damage to front of door, impact damage to back of door.

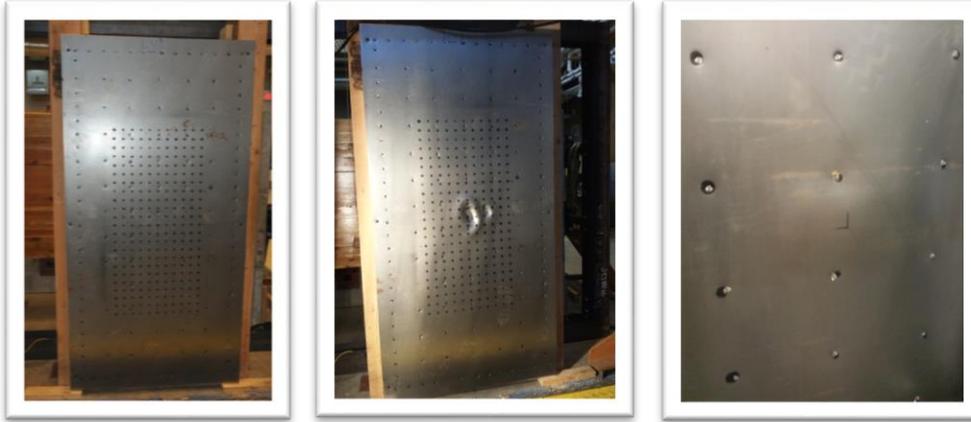
Door number	Door construction	Missile speed (mph)	Front penetration (in.)	Permanent door deflection (in.)	Door perforated? (Y/N)	Observed damage	Passed test? (Y/N)	Additional notes
7a	Two 1-1/4-in. LVL panels with 18-gauge steel sheeting nailed both sides	101.1	0.5	0.6	N	Front steel sheet torn at impact location	Y	Rear steel sheet intact

L to R: Door prior to test, impact damage to front of door, impact damage to back of door.

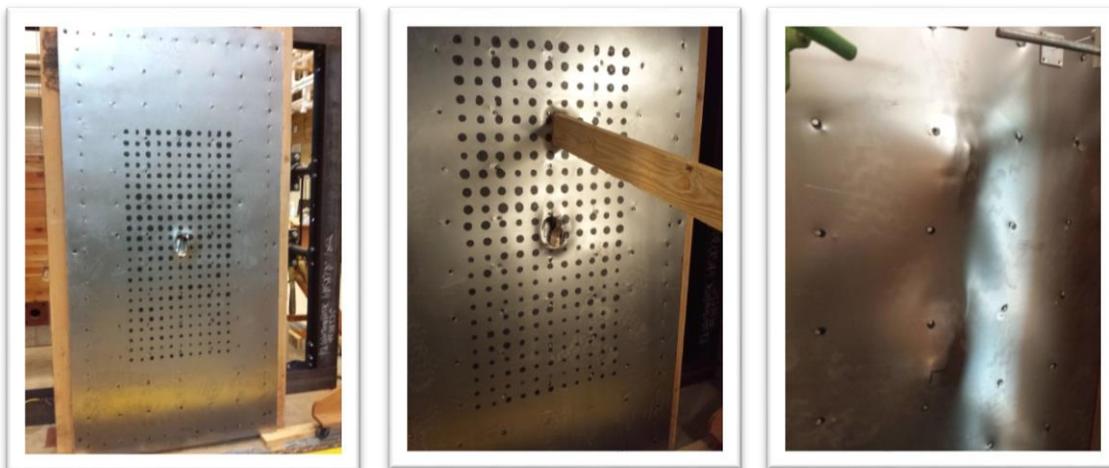
Door number	Door construction	Missile speed (mph)	Front penetration (in.)	Permanent door deflection (in.)	Door perforated? (Y/N)	Observed damage	Passed test? (Y/N)	Additional notes
7b	Two 1-1/4-in. LVL panels with 18-gauge steel sheeting nailed both sides	102.1	1.0	1.2	N	Front steel sheet torn	Y	Second shot on door 7, rear steel sheet intact

L to R: Door prior to test, impact damage to front of door, impact damage to back of door.

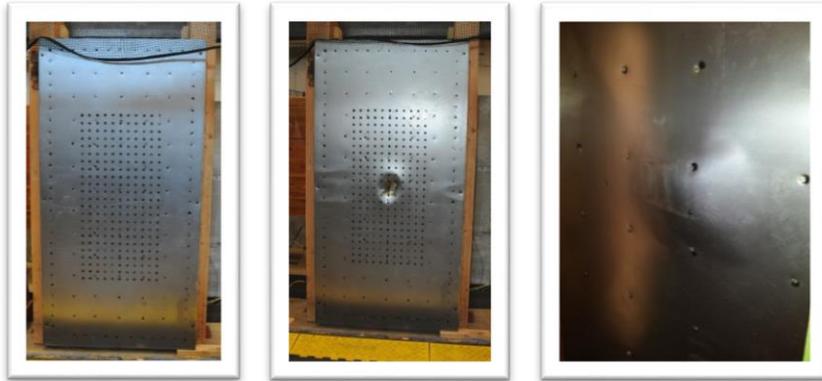
Door number	Door construction	Missile speed (mph)	Front penetration (in.)	Permanent door deflection (in.)	Door perforated? (Y/N)	Observed damage	Passed test? (Y/N)	Additional notes
8a	Four sheets of 23/32-in. plywood, 18-gauge steel sheeting nailed to both sides	102.3	1.0	1.4	N	Steel sheet on front face torn, some steel sheet buckling at location of impact	Y	Rear steel sheet intact

L to R: Front of door prior to impact, impact damage to front of door, impact damage to back of door.

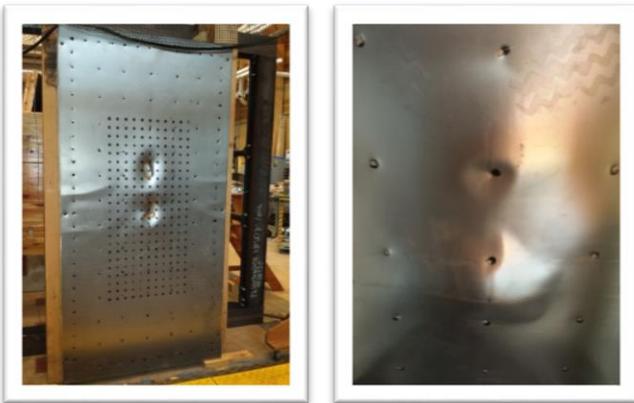
Door number	Door construction	Missile speed (mph)	Front penetration (in.)	Permanent door deflection (in.)	Door perforated? (Y/N)	Observed damage	Passed test? (Y/N)	Additional notes
8b	Four sheets of 23/32-in. plywood, 18-gauge steel sheeting nailed to both sides	102.2	1.3	1.4	N	Steel sheet on front face torn, some steel sheet buckling at location of impact	Y	Second shot on door 10, rear steel sheet intact

L to R: Impact damage to front of door, impact damage to back of door.

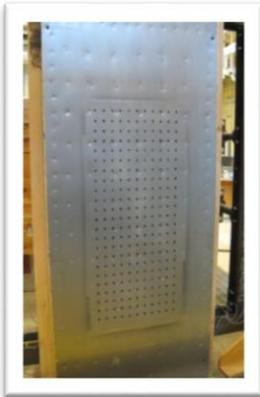
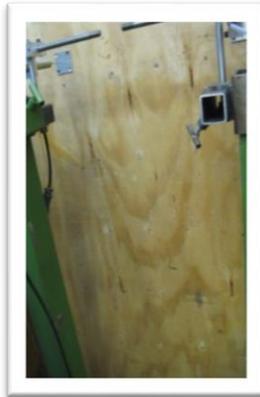
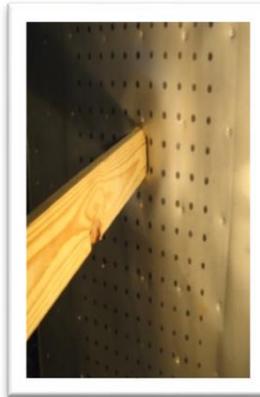
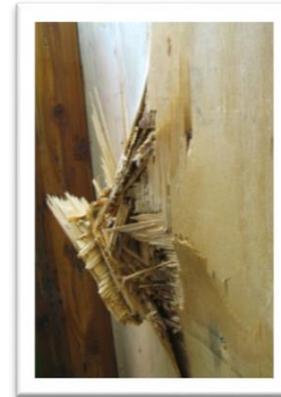
Door number	Door construction	Missile speed (mph)	Front penetration (in.)	Permanent door deflection (in.)	Door perforated? (Y/N)	Observed damage	Passed test? (Y/N)	Additional notes
9a	Four sheets of 23/32-in. plywood, 18-gauge steel sheeting nailed to front face only	102.0	Full	-	Y	Missile pierced steel sheet	N	Large splinters of plywood extended more than 3 in. from back of wall, minimal debris created

L to R: Front of door prior to test, back of door prior to test, missile embedded in front of door, impact damage to back of door.

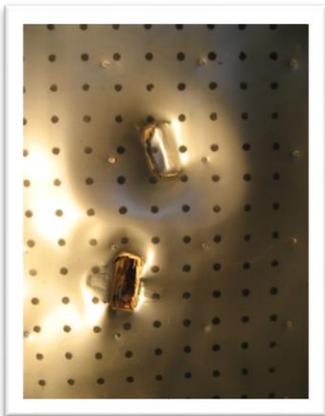
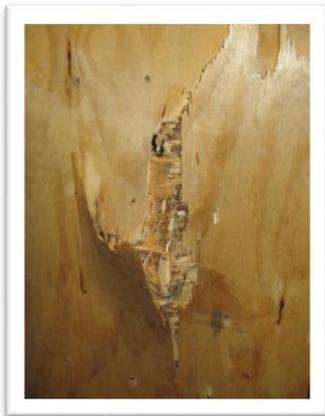
Door number	Door construction	Missile speed (mph)	Front penetration (in.)	Permanent door deflection (in.)	Door perforated? (Y/N)	Observed damage	Passed test? (Y/N)	Additional notes
9b	Four sheets of 23/32-in. plywood, 18-gauge steel sheeting nailed to front face	101.2	N	<3 in.	N	Steel sheet on front face torn, some steel sheet buckling at location of impact	Y	Second shot to door 8, shot 10 in. above previous impact location, no plywood splintering or debris created

L to R: Impact damage to front of door (top dent is second shot), impact damage to back of door.

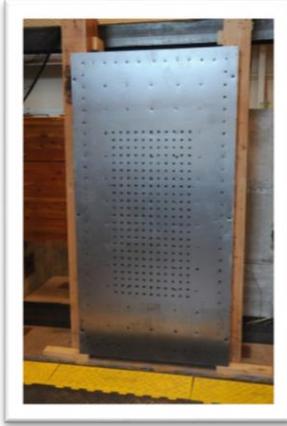
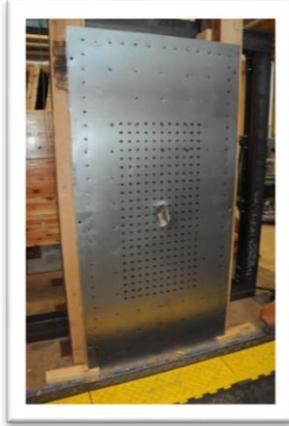
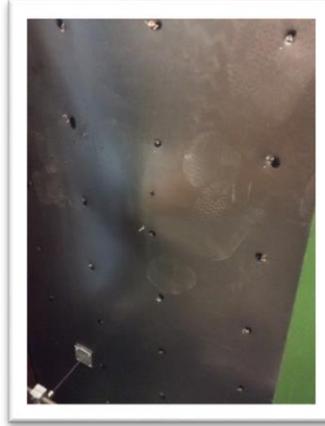
Door number	Door construction	Missile speed (mph)	Front penetration (in.)	Permanent door deflection (in.)	Door perforated? (Y/N)	Observed damage	Passed test? (Y/N)	Additional notes
10a	Four sheets of 23/32-in. plywood, 22-gauge steel sheeting nailed to both sides	105.6	2.5	1.4	N	Steel sheet on front face torn, some steel sheet buckling at location of impact	Y	Rear steel sheet intact

L to R: Front of door prior to impact, impact damage to front of door, impact damage to back of door.

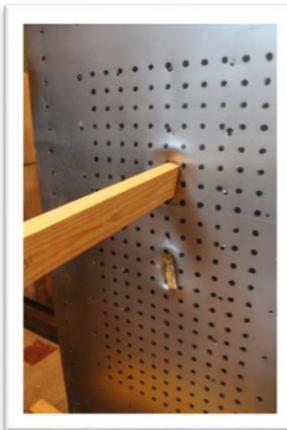
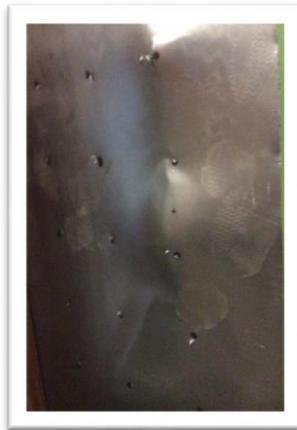
Door number	Door construction	Missile speed (mph)	Front penetration (in.)	Permanent door deflection (in.)	Door perforated? (Y/N)	Observed damage	Passed test? (Y/N)	Additional notes
10b	Four sheets of 23/32-in. plywood, 22-gauge steel sheeting nailed to both sides	102.3	-	1.5	N	Steel sheet on front face torn, some steel sheet buckling at location of impact	Y	Second shot on door 9, rear steel sheet intact

L to R: Impact damage to front of door, impact damage to back of door.

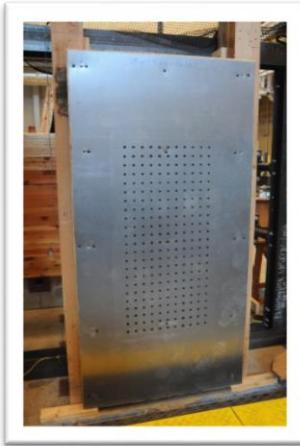
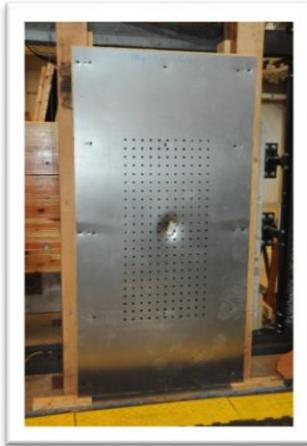
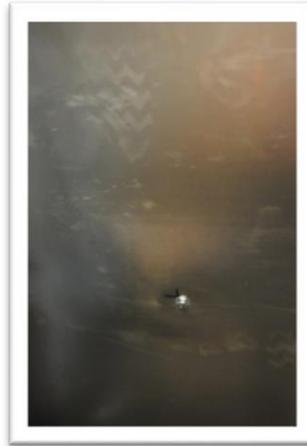
Door number	Door construction	Missile speed (mph)	Front penetration (in.)	Permanent door deflection (in.)	Door perforated? (Y/N)	Observed damage	Passed test? (Y/N)	Additional notes
11a	Four sheets of 23/32-in. plywood, 18-gauge steel sheeting bolted to both sides	101.5	1.8	1.2	N	Steel sheet on front face torn, some steel sheet buckling at location of impact	Y	Rear steel sheet intact

L to R: Front of door prior to test, impact damage to front of door, impact damage to back of door.

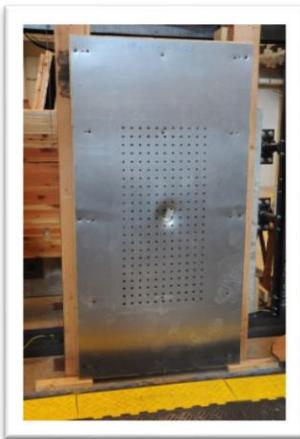
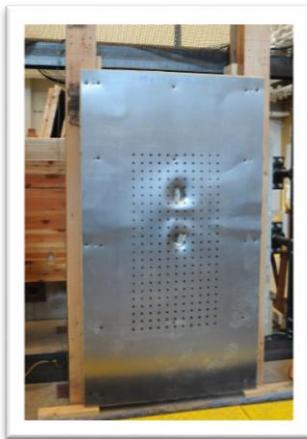
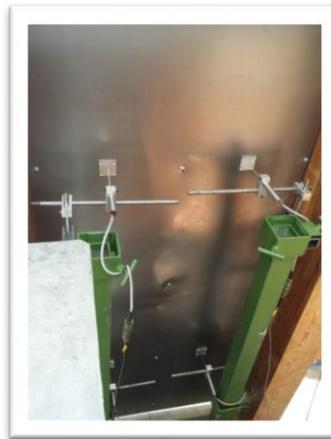
Door number	Door construction	Missile speed (mph)	Front penetration (in.)	Permanent door deflection (in.)	Door perforated? (Y/N)	Observed damage	Passed test? (Y/N)	Additional notes
11b	Four sheets of 23/32-in. plywood, 18-gauge steel sheeting bolted to both sides	101.8	1.5	1.3	N	Steel sheet on front face torn, some steel sheet buckling at location of impact	Y	Second shot on door 11, rear steel sheet intact

L to R: Front of door prior to test, impact damage to front of door, impact damage to back of door.

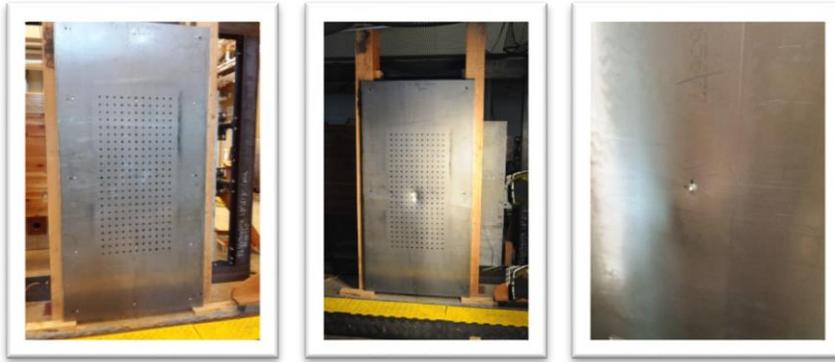
Door number	Door construction	Missile speed (mph)	Front penetration (in.)	Permanent door deflection (in.)	Door perforated? (Y/N)	Observed damage	Passed test? (Y/N)	Additional notes
12a	Four sheets of 23/32-in. plywood, 18-gauge steel sheeting bolted to both sides	100.8	0.8	0.9	N	Steel sheet on front face torn, some steel sheet buckling at location of impact	Y	Rear steel sheet intact

L to R: Front of door prior to test, impact damage to front of door, impact damage to back of door.

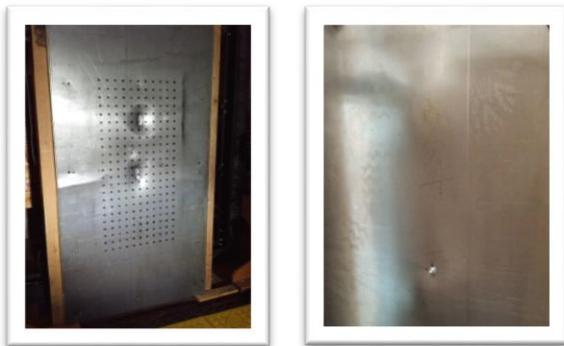
Door number	Door construction	Missile speed (mph)	Front penetration (in.)	Permanent door deflection (in.)	Door perforated? (Y/N)	Observed damage	Passed test? (Y/N)	Additional notes
12b	Four sheets of 23/32-in. plywood, 18-gauge steel sheeting bolted to both sides	101.3	1.8	1.3	N	Steel sheet on front face torn, some steel sheet buckling at location of impact	Y	Second shot on door 12, rear steel sheet intact

L to R: Impact damage to front of door, impact damage to back of door.

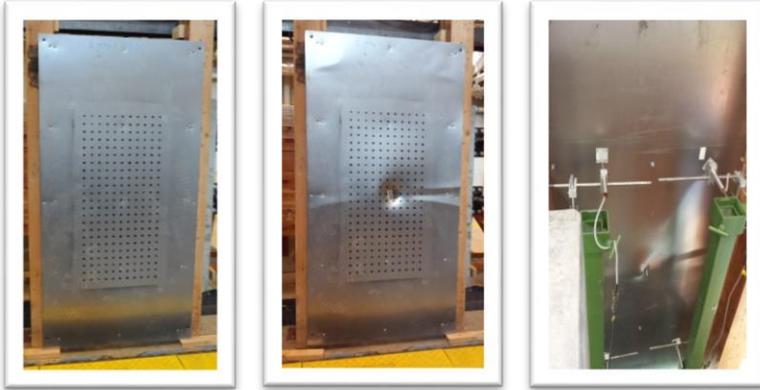
Door number	Door construction	Missile speed (mph)	Front penetration (in.)	Permanent door deflection (in.)	Door perforated? (Y/N)	Observed damage	Passed test? (Y/N)	Additional notes
13a	Two sheets of 23/32-in. plywood, 18-gauge steel sheeting bolted to both sides	102.1	2.0	2.1	N	Steel sheet on front face dented	Y

L to R: Front of door prior to test, impact damage to front of door, impact damage to back of door.

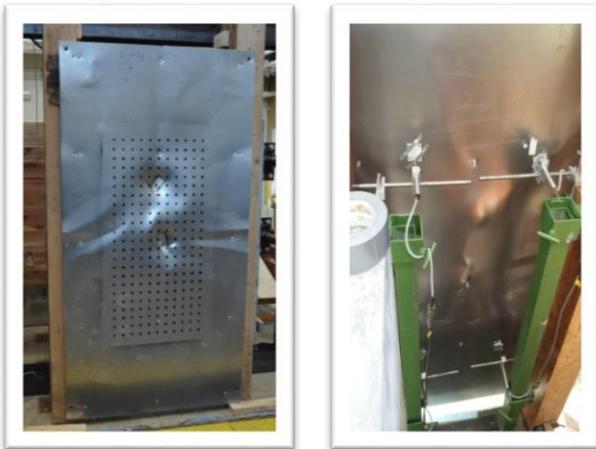
Door number	Door construction	Missile speed (mph)	Front penetration (in.)	Permanent door deflection (in.)	Door perforated? (Y/N)	Observed damage	Passed test? (Y/N)	Additional notes
13b	Two sheets of 23/32-in. plywood, 18-gauge steel sheeting bolted to both sides	101.3	1.6	2.4	N	Steel sheet on front face dented	Y	Steel sheet buckled but intact

L to R: Impact damage to front of door, impact damage to back of door.

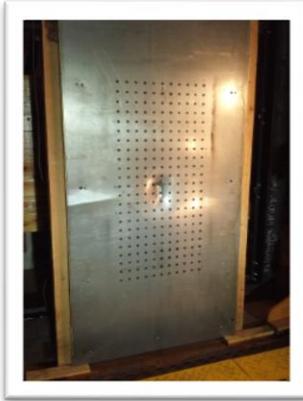
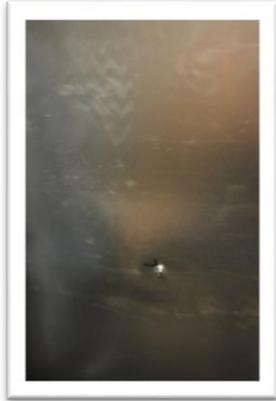
Door number	Door construction	Missile speed (mph)	Front penetration (in.)	Permanent door deflection (in.)	Door perforated? (Y/N)	Observed damage	Passed test? (Y/N)	Additional notes
14a	Two sheets of 23/32-in. plywood, 14-gauge steel sheeting bolted to both sides	102.7	1.0	0.9	N	Steel sheet on front face dented	Y	Missile shattered on impact

L to R: Impact damage to front of door, impact damage to back of door.

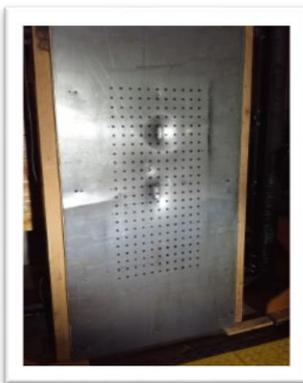
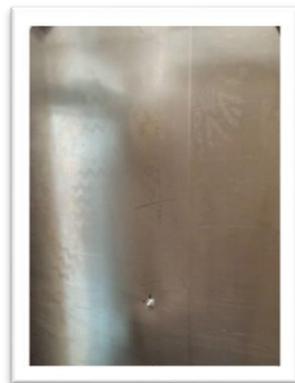
Door number	Door construction	Missile speed (mph)	Front penetration (in.)	Permanent door deflection (in.)	Door perforated? (Y/N)	Observed damage	Passed test? (Y/N)	Additional notes
14b	Two sheets of 23/32-in. plywood, 14-gauge steel sheeting bolted to both sides	101.9	0.9	0.5	N	Steel sheet on front face dented	Y	Missile shattered on impact. Permanent door deflection was a localized measurement in the area of the second shot.

L to R: Impact damage to front of door, impact damage to back of door.
