WOOD STRUCTURES SURVIVE HURRICANE CAMILLE'S WINDS

U.S.D.A. FOREST SERVICE
RESEARCH PAPER
FPL 123
OCTOBER 1969

U.S. Department of Agriculture
Forest Service
Forest Products Laboratory
Madison, Wis.

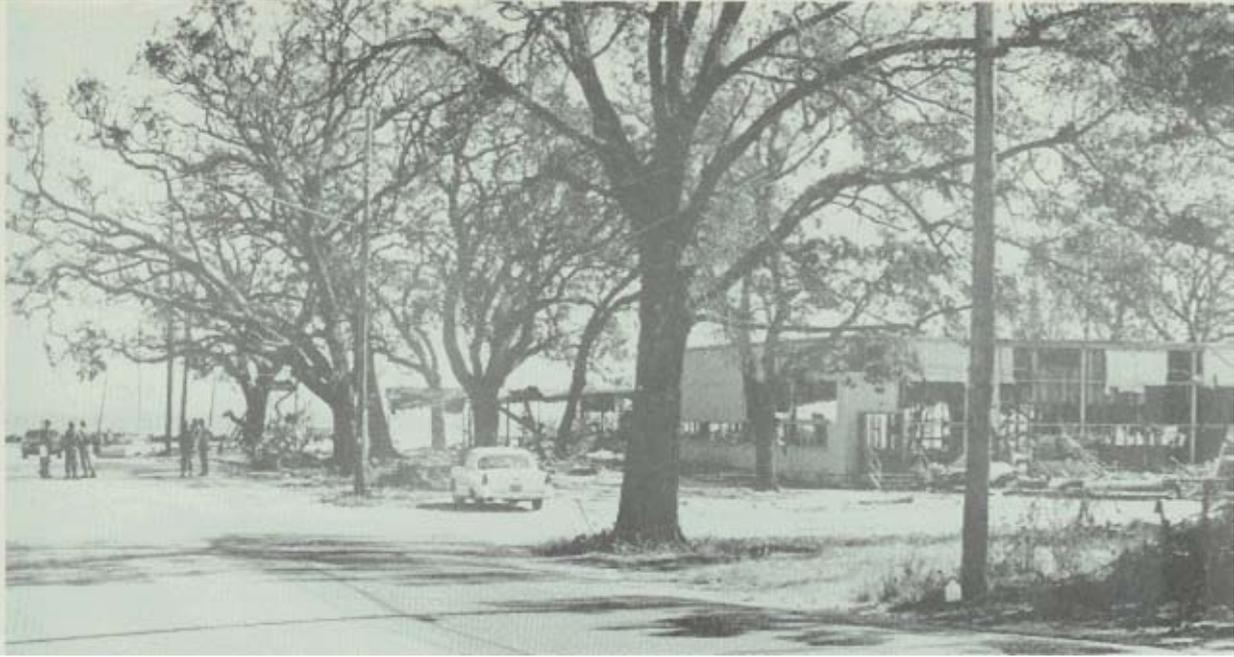
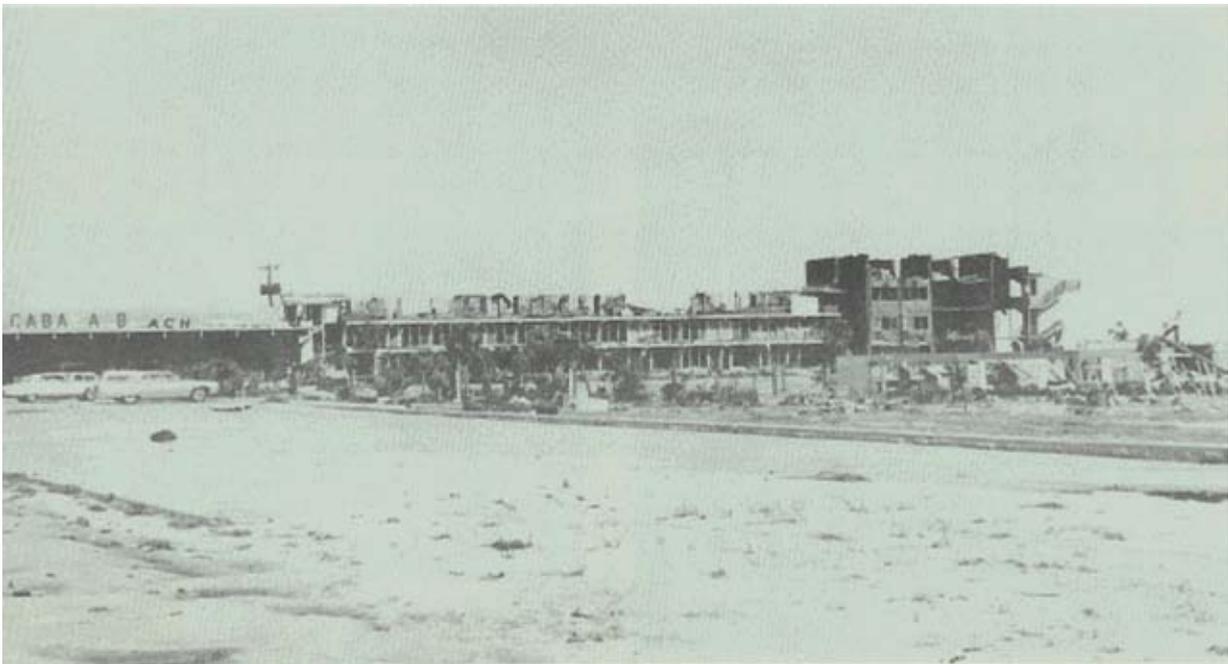
Large apartment buildings, restaurants, and shops were completely destroyed and the debris was washed inland. The few structures that remained were completely gutted (fig. 3). Where the buildings were not directly on the waterfront, the first floor framing frequently remained in place supporting the relatively undamaged second floor (fig. 4). The seaward end of one well-built apartment house was destroyed by wave action, while the rest of the building remained intact (fig. 5). These buildings were built directly on the ground instead of on piers as one might expect along shorelines in the hurricane zone.

Figure 3.--Waves, water, and wind completely destroyed buildings along the Coast and gutted the few that remained standing.

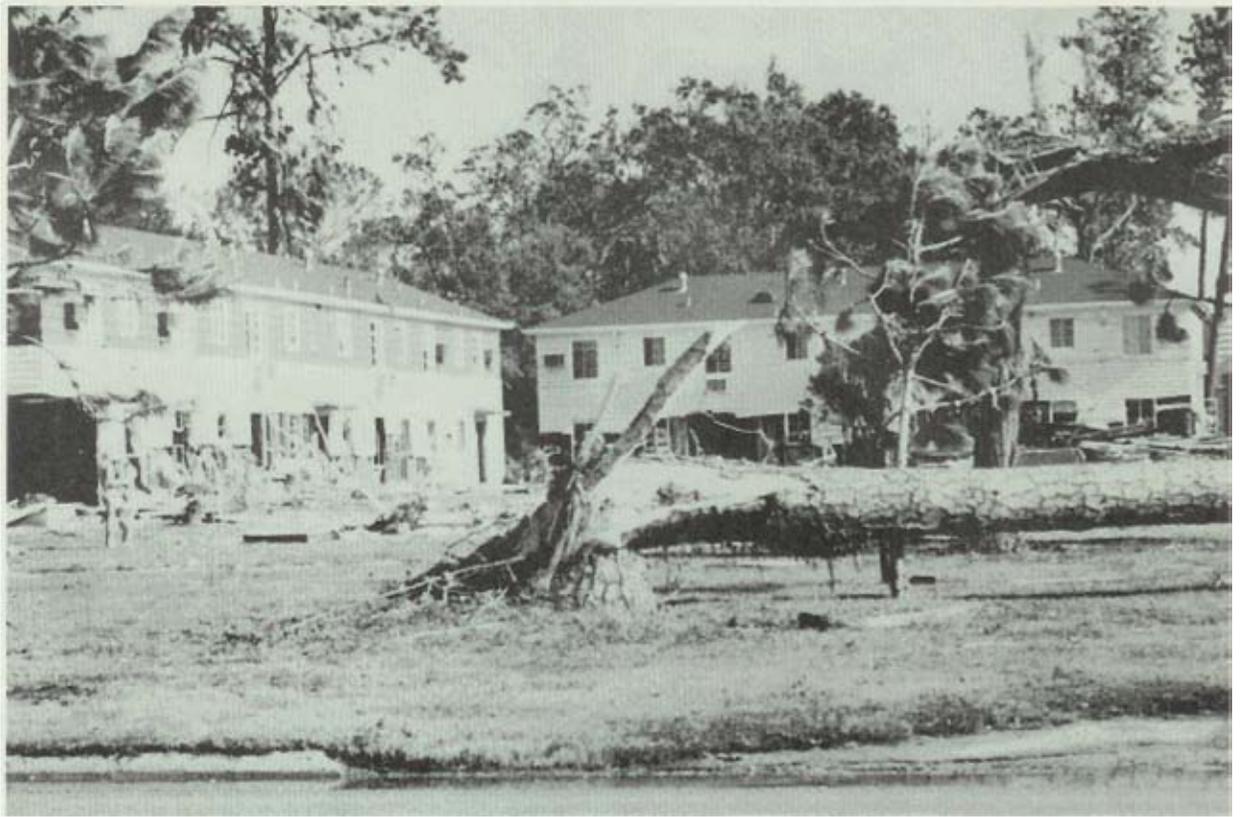
Figure 4.--First floor framing supporting undamaged second floor. M I37 083

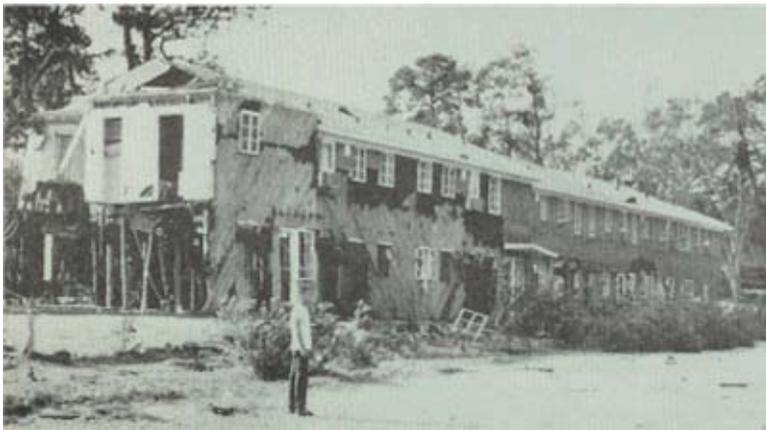
Figure 5.--Seaward end of this building took full force of wave; the rest of the structure remained intact.

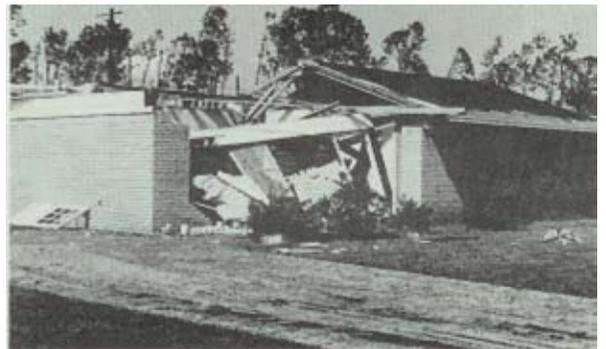
Flooding in the low areas slightly inland was a major cause of damage (fig. 6). The wave action backed water into the streams and drainage ditches so that water from the heavy rains could not drain. The contents of many homes were completely destroyed by water even though the house remained intact. Water about 6 feet deep passed through some of these houses, but apparently washed in gradually, without actual wave force.

Figure 6.--Houses in low inland area severely damaged by a combination of wind and water.

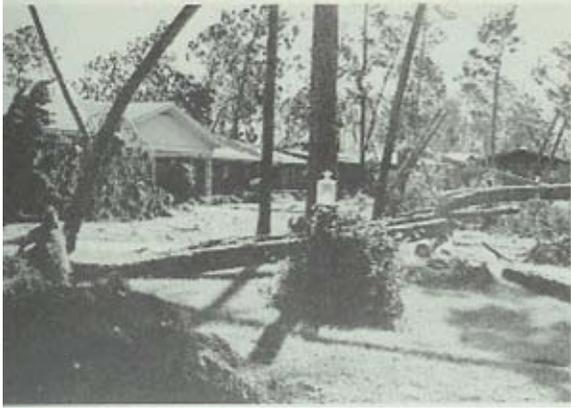
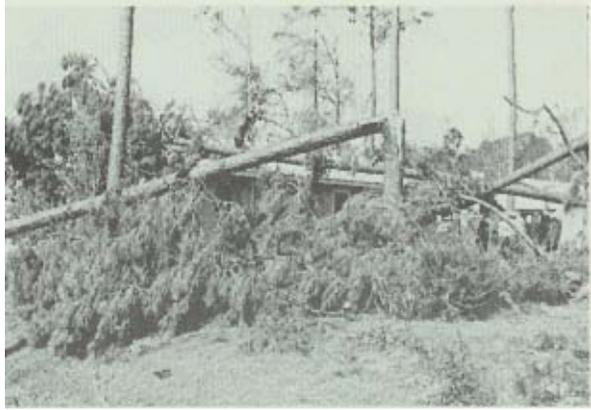
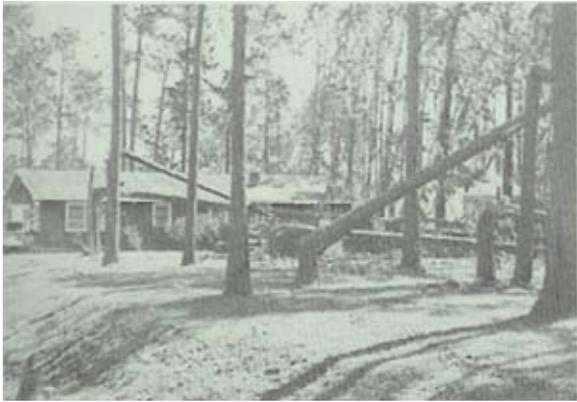
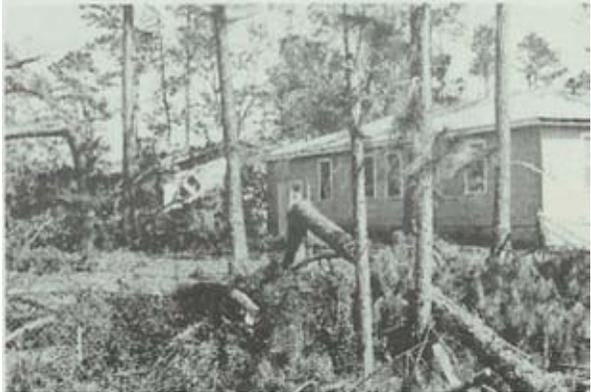
Figure 7.--Most observations of fallen trees indicated that buildings were spared or lightly damaged.

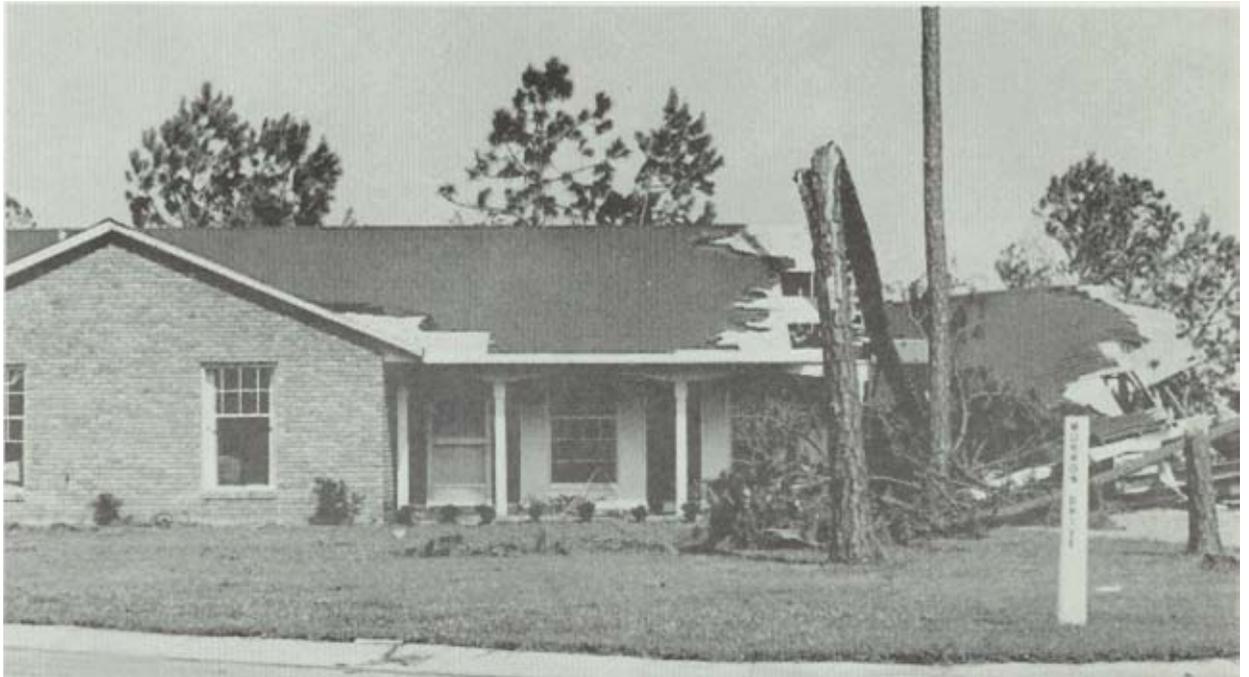
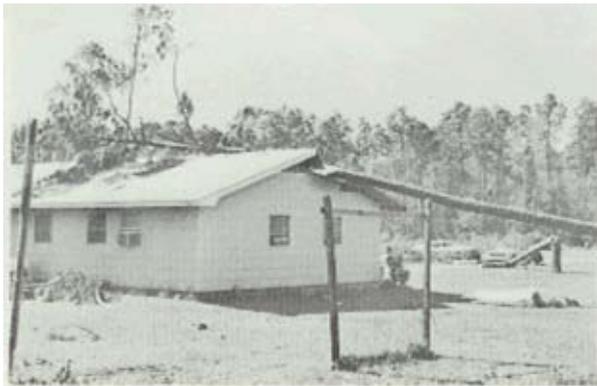
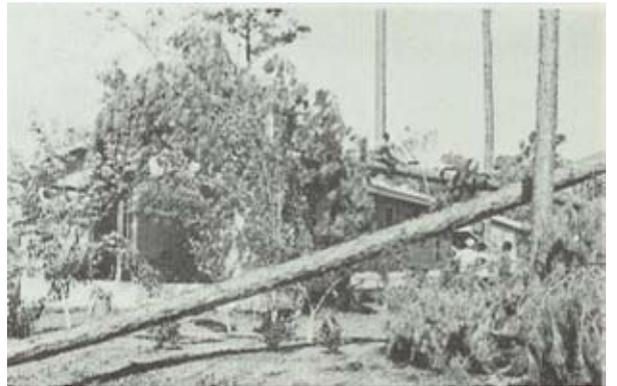
Figure 8.--Fallentrees that hit houses directly over a garage or carport opening did the greatest damage. Houses supported many trees without collapsing.

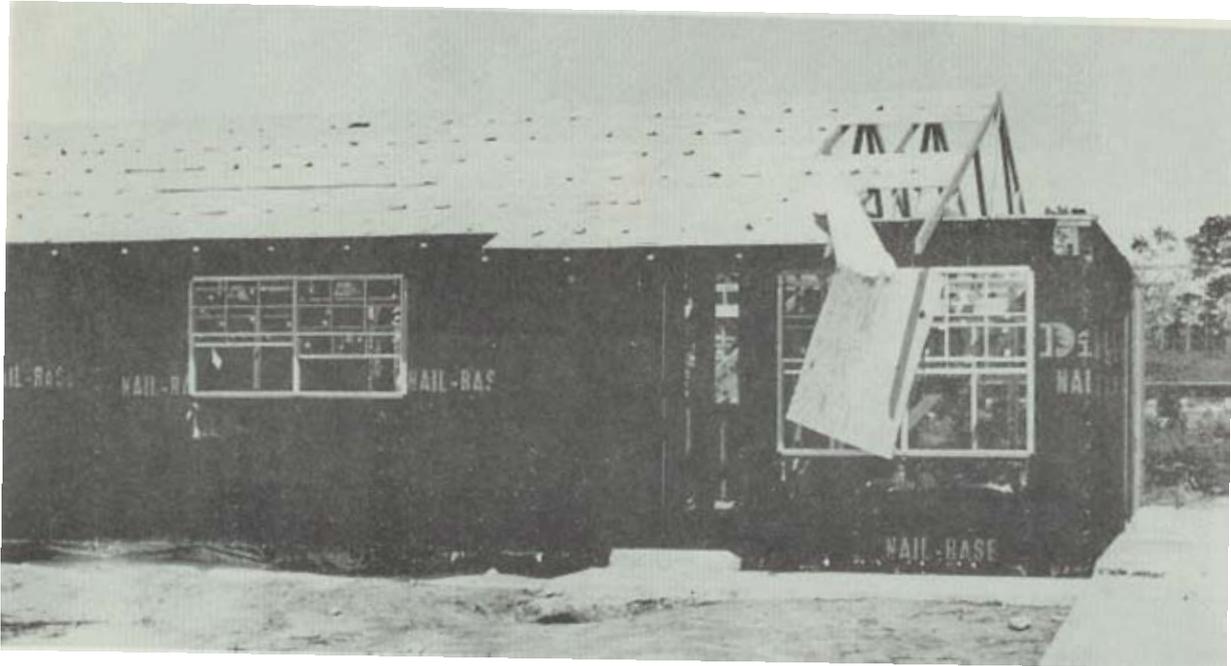
A

Figure 9.--Typical new construction in the hurricane area: A, trusses over wood-frame wall with fiberboard sheathing, partially damaged by wind; B, metal anchors tying roof to top plate used in a few cases; C, trusses nailed to top plate with three sixteenpenny nails.

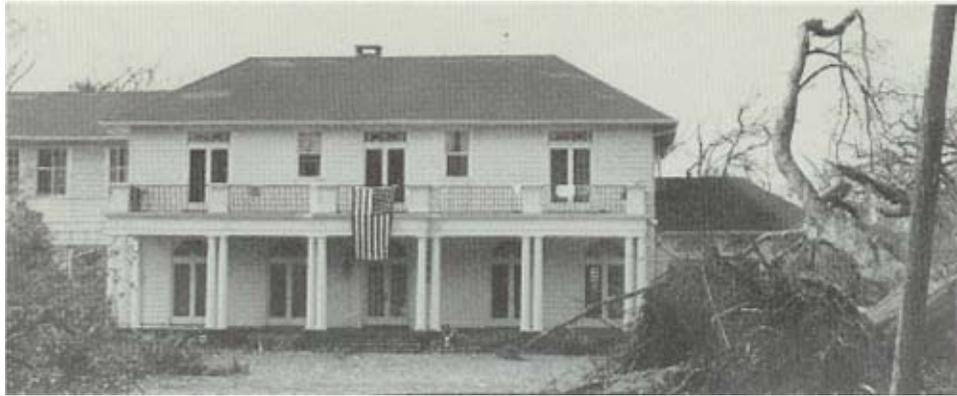
Figure 10.--A large wood-frame-house in Pass Christian that had very little damage.
MI 369965-AI-4

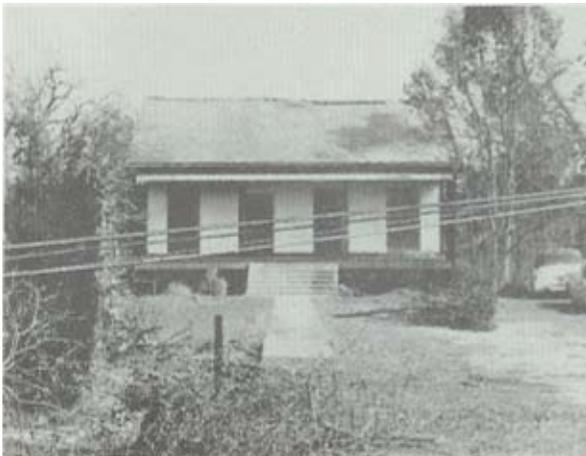
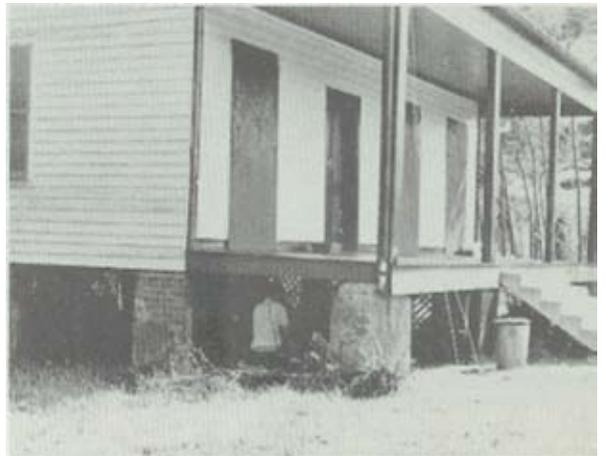
Figure 11.--Older house that was located in Pass Christian near the center of the storm,
yet came through the storm with little damage.
MI 36996-AI-6
MI 36996-AI-8

In some housing subdivisions located on higher ground, there was little damage. In Pass Christian, which was one of the hardest hit communities, there were many houses that stood like fortresses in this badly damages area (fig. 10). One home in Pass Christian that showed no evidence of special hurricane construction, for example, suffered very little damage (fig. 11). The plywood-shuttered windows saved this house from window breakage and much interior damage.

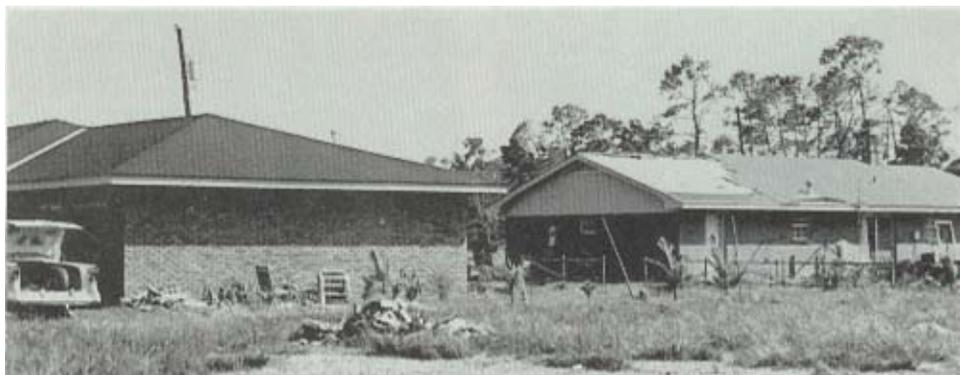
Figure 12.--Gable-end house with greater damage than nearby house with hip roof.
MI 36996-16

view several blocks of houses with alternative types of roof construction. In every case, there was much less damage to the hip roofs than to the gable roofs. Shingles and even some roof sheathing were frequently blown off the gable ends of houses when neighboring houses with hip roofs had little or no damage (fig. 12).

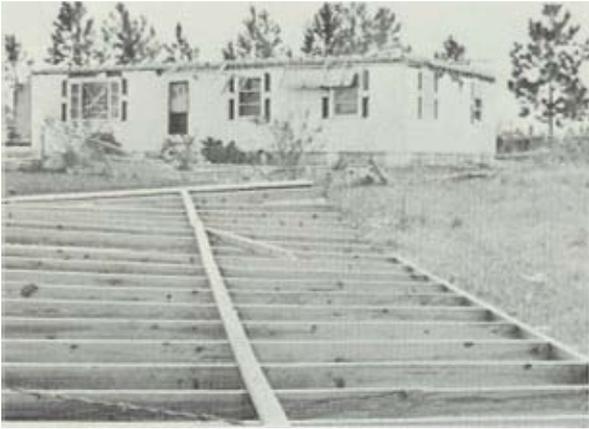
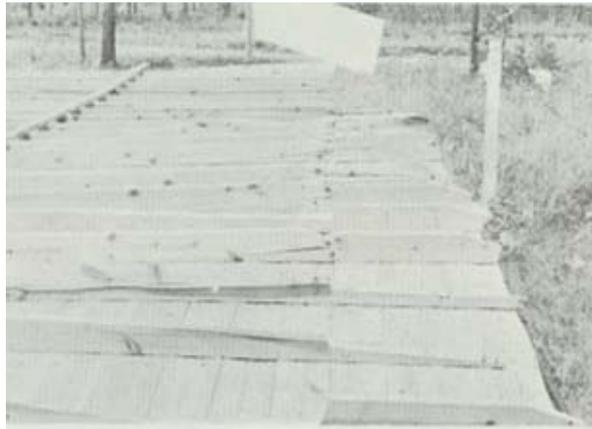
Figure 13.--This roof blown completely off the house had neither collar beams nor proper nailing of rafters to joists.
MI 36925-28
MI 36925-27

In rural areas 10 to 20 miles north of Gulfport there were a few isolated buildings that were completely destroyed by wind. These buildings had little protection from trees and other buildings which could account for greater wind damage. However, even in these exposed locations, houses that were nearly destroyed were found to be of substandard construction. One house that had severe damage was built without sheathing (fig. 13). Joints in the drop siding occurred at wall intersections. The walls of a corner room may have collapsed to cause the roof to leave the house; however, if the rafters had been properly nailed to the joists and tied together with collar beams, the house probably would have suffered only minor damage. Examination of the rafters showed they were toenailed to the top plate, but no more than one nail was used in securing a rafter to a joist where recommended practice is to use five tenpenny nails.

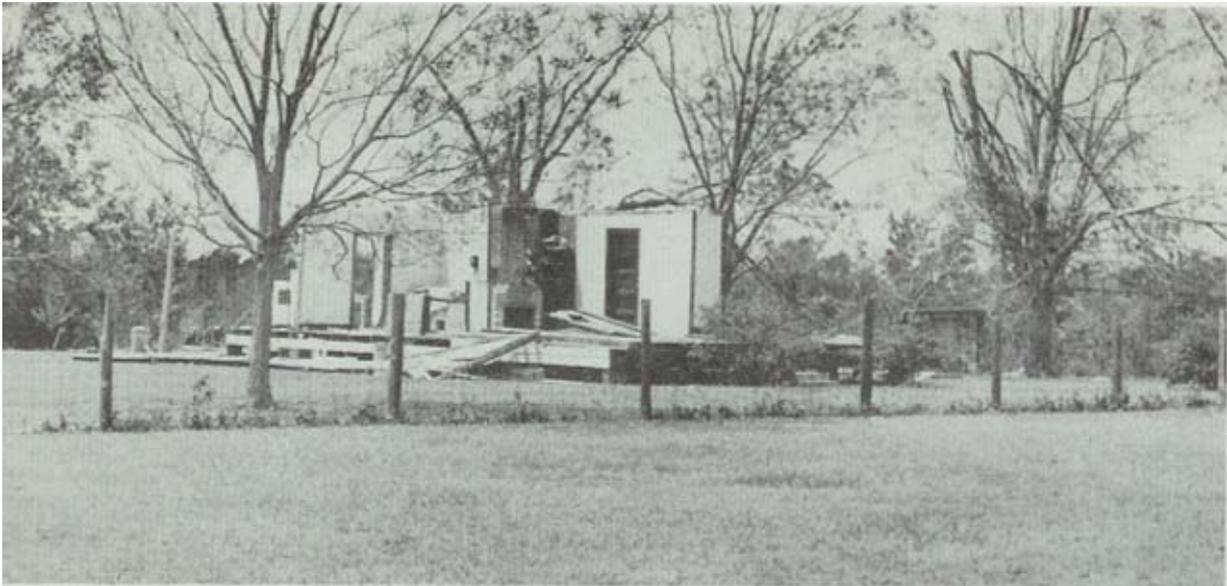
Figure 14.--Exploded house, with damage apparently caused by a hurricane-spawned tornado.
MI 36925-22

The only wood-frame house of the thousands observed in the hurricane area that was completely destroyed by the effect of wind alone appeared to be exploded (fig. 14). Since this type of destruction is usually associated with tornadoes, it is probable that a tornado spawned by the hurricane struck the house. Even though the walls and roof were gone, the floor and partitions did not move from the brick pier foundation. Other houses in the same area were not badly damaged.

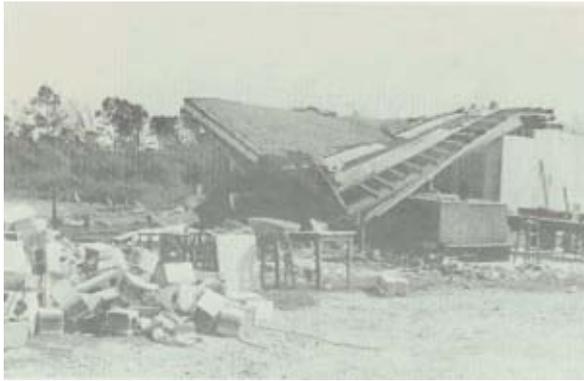
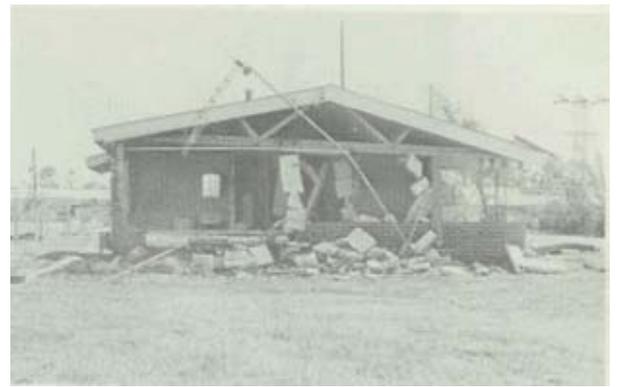
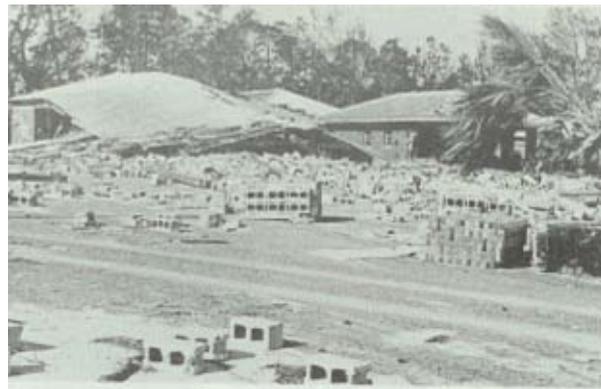
Figure 15.--Concrete block and brick masonry completely destroyed.

were many unreinforced concrete block and brick masonry buildings which were completely destroyed by the wind (fig. 15). Others in more protected locations were undamaged. Typical destruction was apparently due to masonry walls failing under vibrations and wind pressures, usually followed by roof structures separating and either collapsing or blowing away some distances. Some roofs with truss construction remained intact even though one supporting wall collapsed. One concrete block restaurant about 20 miles inland was completely destroyed, while a wood-frame house across the road had only shingle damage and damage from debris from the concrete block restaurant (fig. 16).

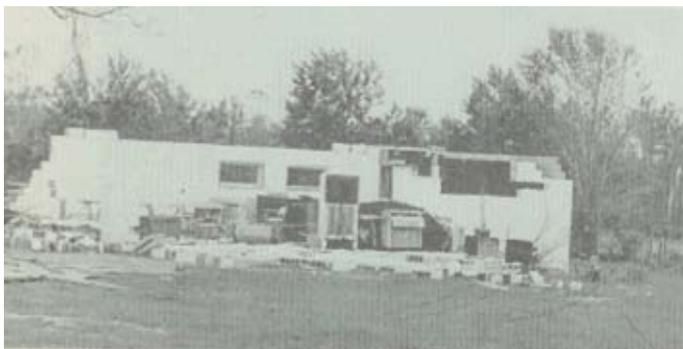
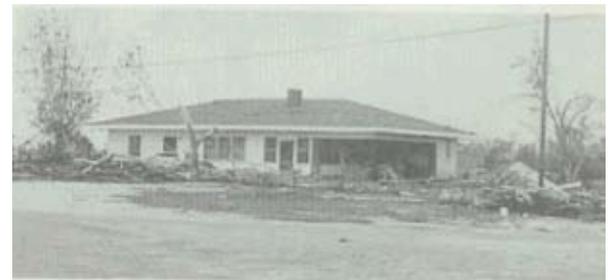
Figure 16.--Wind damage in unprotected rural area. **A**, concrete-block restaurant destroyed; **B**, wood-frame house across the road from restaurant was not seriously damaged.

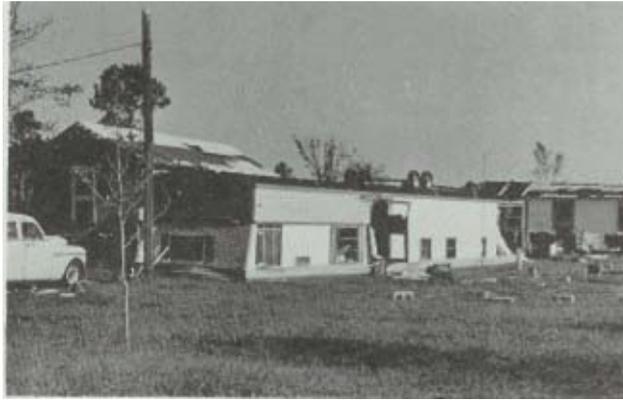
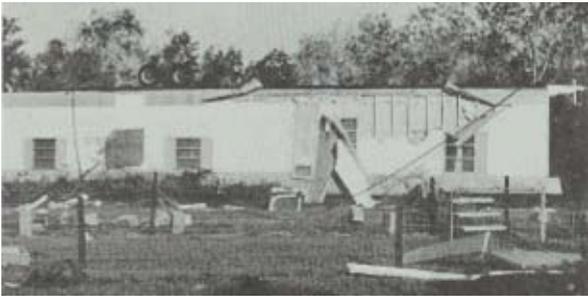
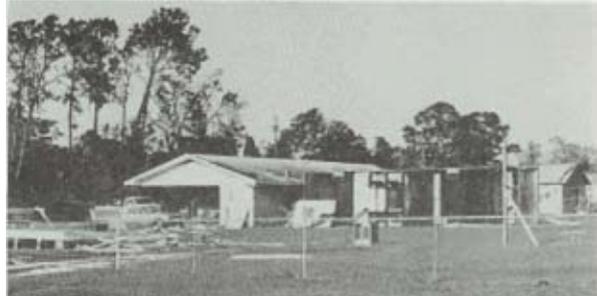
Figure 17.--Mobile homes overturned in areas where wood-frame houses were not seriously damaged. MI 36996-A2-13 MI 36996-A1-1 MI 36996-A2-7

Most mobile homes in unprotected areas were overturned and appeared to be nearly complete losses, whereas wood-frame houses in the same areas suffered only minor damage (fig. 17). Although mobile home damage was widespread, many mobile home courts located throughout the hurricane area had only minor damage. Where the courts were well screened by woods, and homes were quite close together, damage was usually only from falling trees. Apparently, wind must get a good clear shot at a mobile home before it will turn over. In a rural area about 15 miles inland, the isolated mobile home sitting on hilltops all were destroyed (fig. 18). In Gulfport there was one mobile home which had been tied down with ropes, and it withstood the storm, although mobile homes nearby were overturned (fig. 19).

It was not possible to judge how well mobile homes would have withstood damage if they had been rigidly attached to the ground. It would seem that a simple post foundation system of pressure-treated wood for mobile homes, to which the mobile home was firmly attached, would prevent a great deal of damage in hurricane zones.

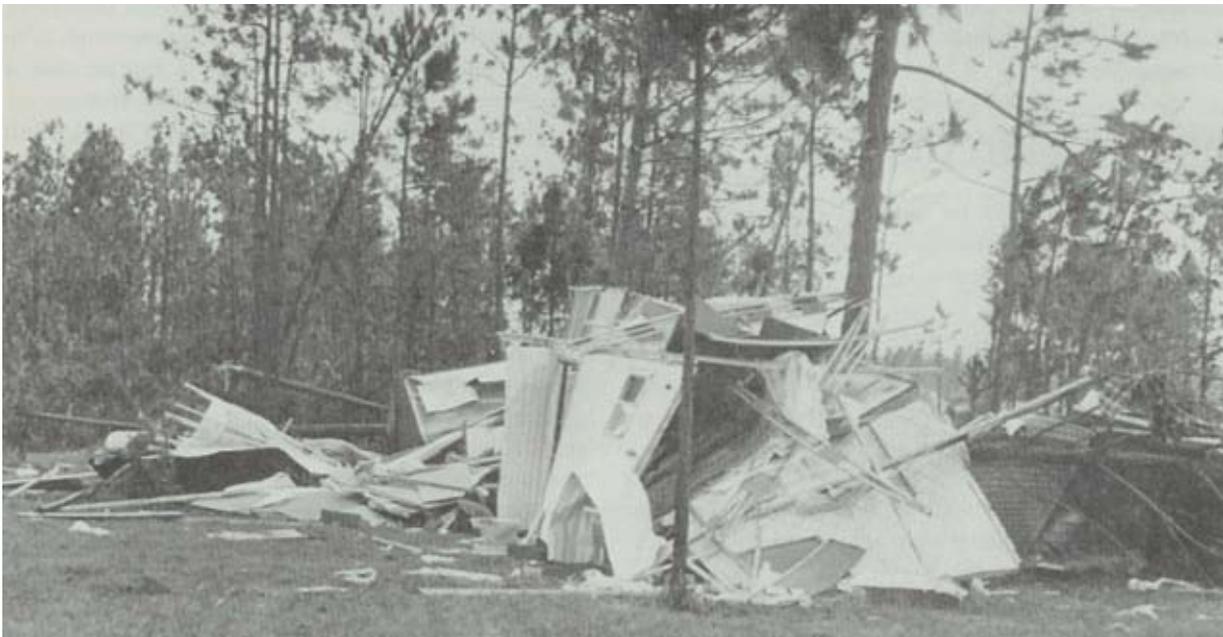
Figure 18.--Mobile home in unprotected area completely destroyed. Along a mile of country road, five homes were observed in this condition. MI 36925-30

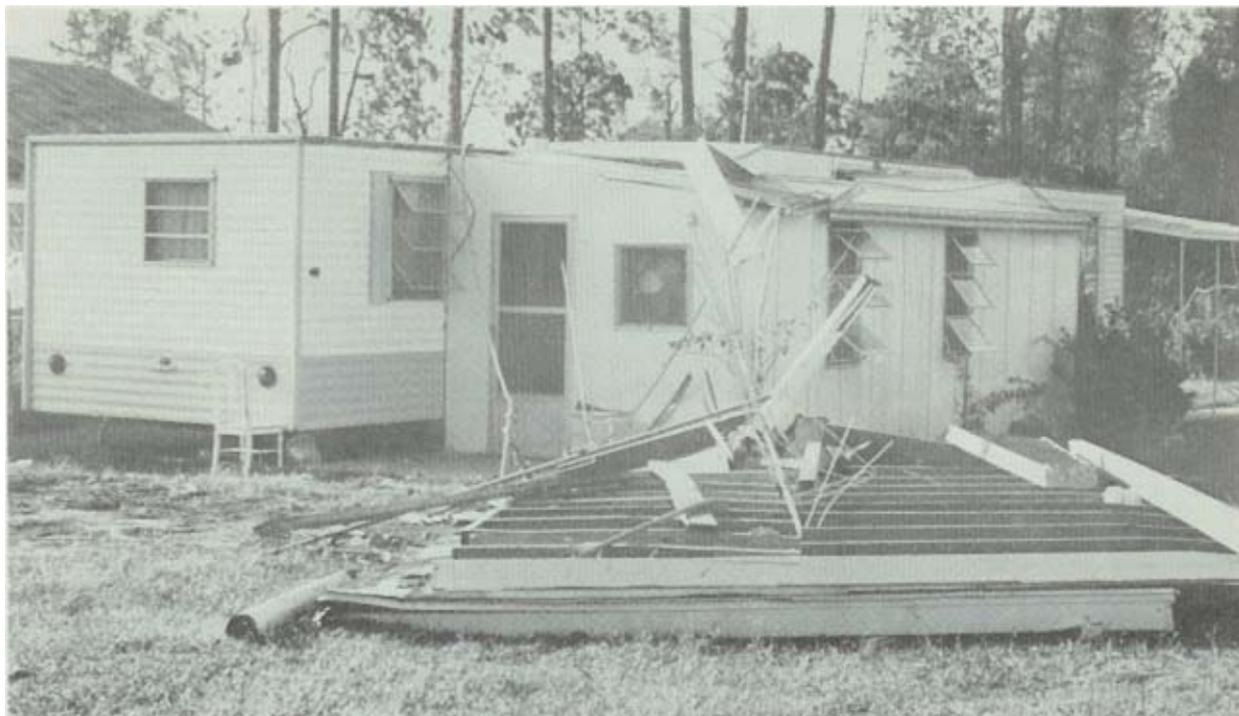
Figure 19.--Mobile home with heavy ropes tying it down to pipes driven into the ground. Two adjacent mobile homes were a total loss. MI 36996-A2-12
