STRESSED SKIN PANEL PERFORMANCE

*AFTER
TWENTY-FIVE
YEARS
OF
SERVICE*

By OTTO C. HEYER, Engineer, and R. F. BLOMQUIST¹, Chemist

FOREST PRODUCTS LABORATORY²
U. S. DEPARTMENT OF AGRICULTURE, FOREST SERVICE

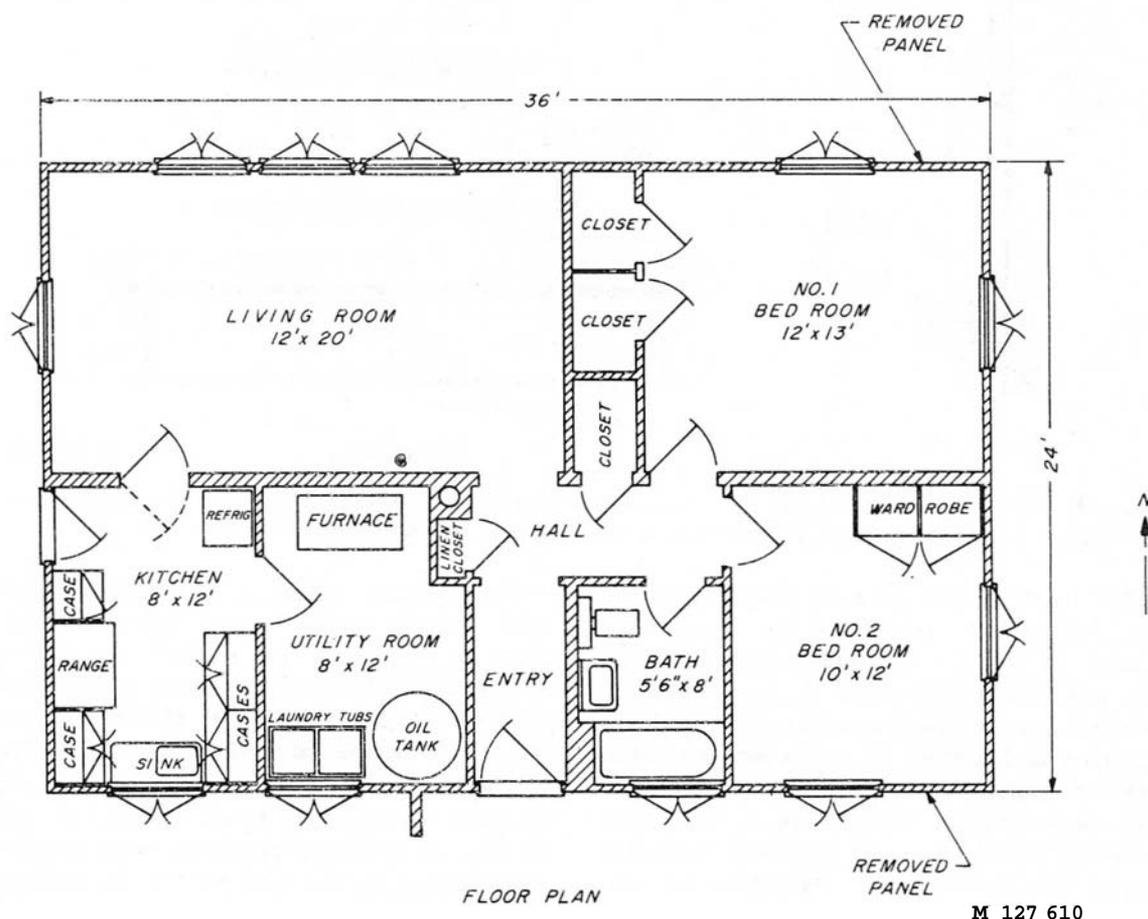
Figure 3.—Room layout of the one-story prefabricated house and location of the removed panels.

Two panels were taken from the one-story prefabricated house--one from the northeast corner of the north wall and the other from the

southeast corner of the south wall (fig. 3).

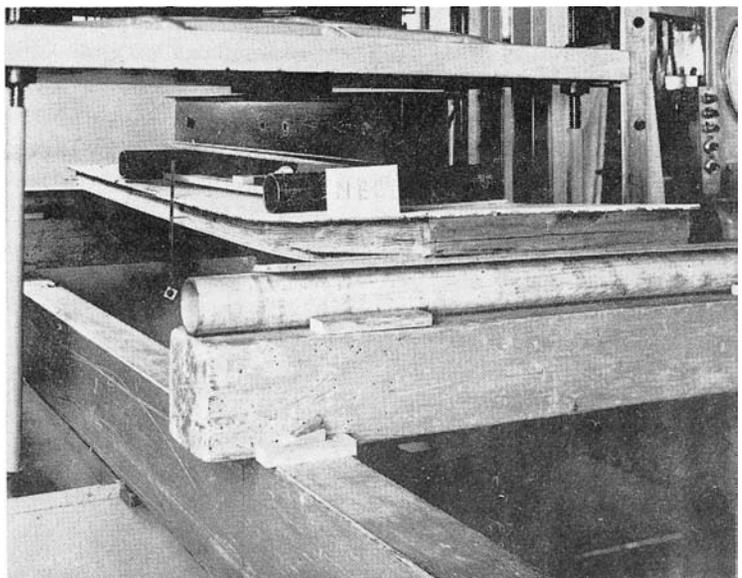
M 122 557

Bending strength tests were also made on one-half of the width of each of the 4-foot panels removed from the experimental house (panels 1 and 2, table 1). The half-width panels were 23 inches wide and approximately 8 feet in length and 3 inches thick. The other half width of the panel was used to evaluate the quality of the glue bonds in the plywood and between the plywood and the framing members.

Figure 9.--Final failure of half panel removed from northeast corner of the experimental prefabricated house. Failure consists of a tension failure of framing member and horizontal shear maximum load was 284 pounds per square foot. This is a standard method of testing wall panels with load applied at the quarter point of the span.

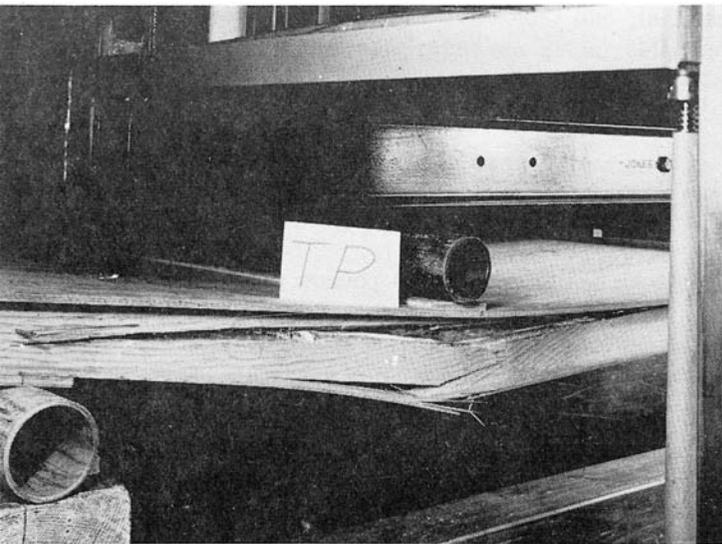
M 122 512

Figure 10.--Final failure of prototype panel, similar in construction to replacement panel, using plywood facings. Failure consists of a tension failure in framing member and horizontal shearing of the framing member. Maximum load was 239 pounds per square foot.

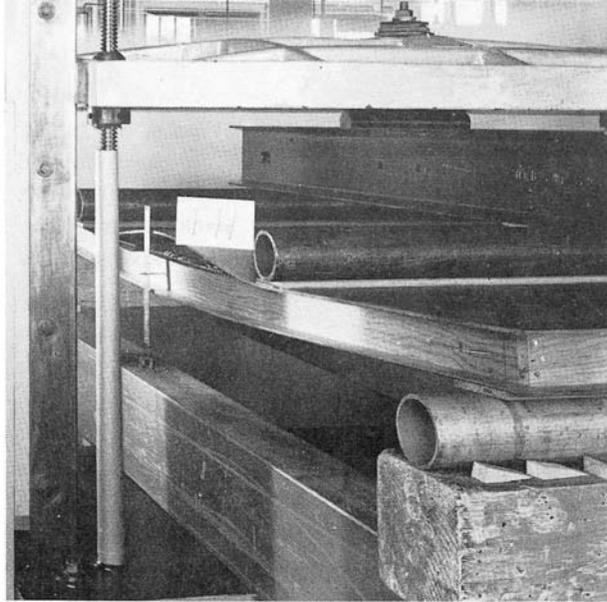
M 122 513

Figure 11.--Final failure of prototype panel, similar to replacement panel, using hardboard facing. Failure consisted of buckling of compression facing. Maximum load was 247 pounds per square foot.

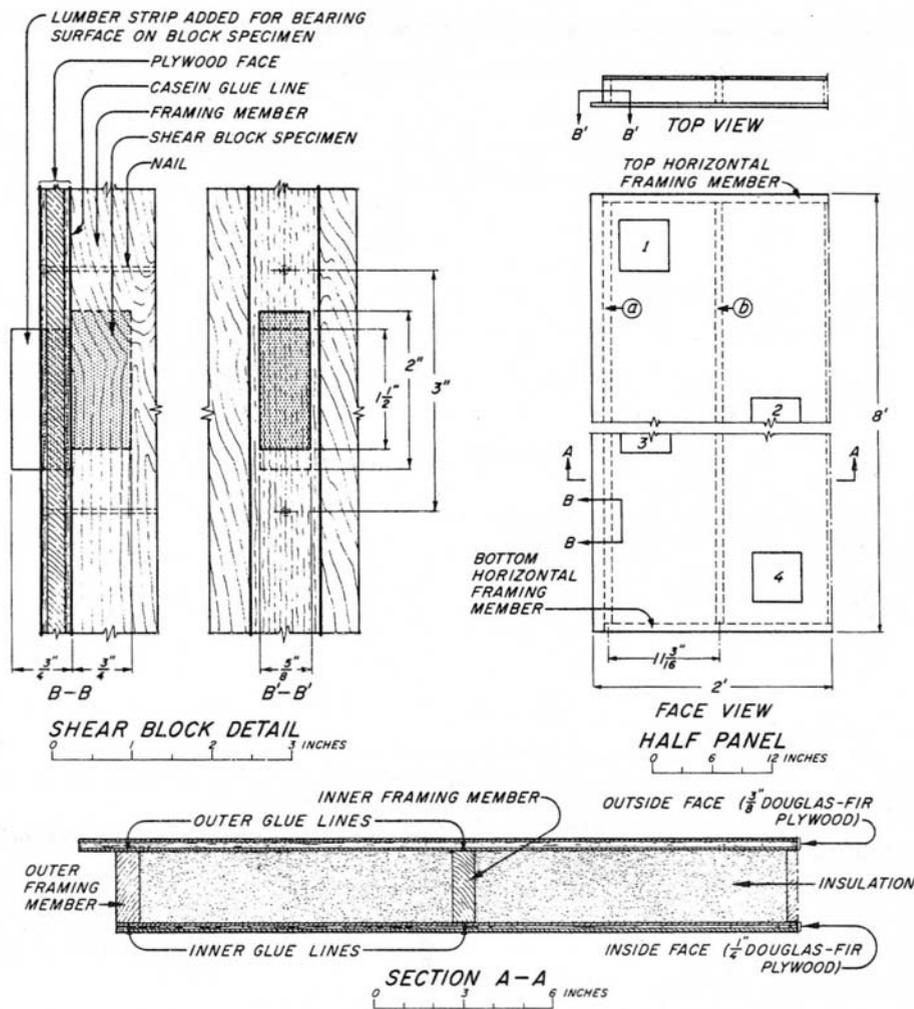
M 124 032

Figure 12.--Construction details and sampling of the wall panel portion that was removed from the experimental house for evaluating the quality of the glue bonds. Numbers 1 to 4 indicate approximate locations of plywood samplings, and letters a and b indicate the framing members from which structural bond specimens were taken.
