Research
Paper
FPL-RP-551

Field Performance of Timber Bridges

8. Lynches Woods Park Stress-Laminated Deck Bridge

July 1996

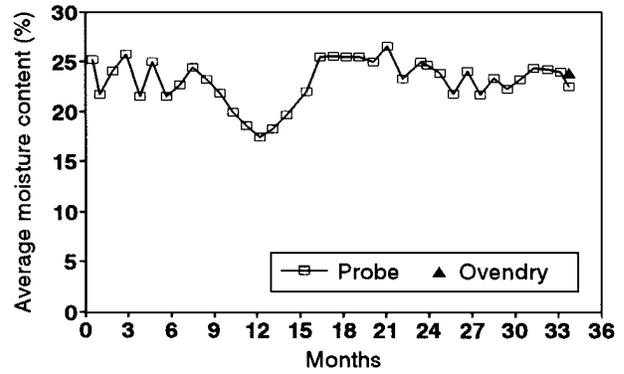
County personnel just prior to construction, the bridge was installed at an initial average moisture content of 26 percent. At the beginning of the monitoring period, approximately 10 months after installation, the initial electrical-resistance moisture content measurements indicated an average moisture content of 25 percent. Throughout the monitoring, climatic changes caused the average moisture content of the laminations to fluctuate from 20 to 25 percent. During an unusually dry period during the summer of 1992, the average

Figure 16—The average trend in moisture content readings taken at the lower 2–3 in. of the deck during monitoring, beginning 10 months after bridge installation.

moisture content briefly dropped below 20 percent. However, at the conclusion of monitoring, the average moisture content had rebounded to approximately 25 percent. In addition, ovendry moisture core samples obtained at the conclusion of monitoring indicated an average moisture content of 24 percent.

Although the moisture content of the Lynchs Woods Park bridge was more than the recommended maximum of 19 percent at installation, it did not affect overall performance of the structure. In addition, rapid wetting and drying cycles did not occur as noted in previous reports on exposed structures treated with waterborne preservatives.

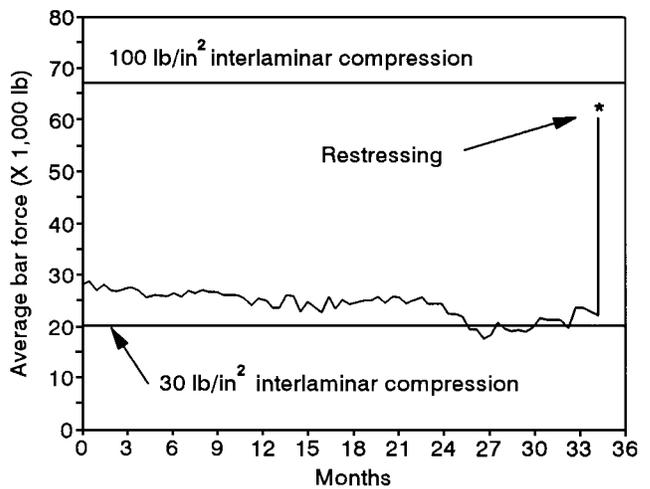
Figure 17—The average trend in bar force measurements since the initiation of monitoring, beginning 10 months after bridge installation.

The average trend in bar force measurements during the monitoring period is shown in Figure 17. At the initiation of monitoring, the average measured bar force was approximately 29,000 lb. Thus, during the 8 months since the final bar tensioning, the average bar force decreased ap-

the final bar tensioning, the average bar force decreased approximately 60 percent (43,000 lb) prior to the initiation of monitoring. Periodic measurements during the monitoring showed that the average bar force was relatively stable at approximately 25,000 lb, or 37 lb/in² interlaminar compression. At the conclusion of the monitoring, the average bar force was approximately 24,000 lb, or 35 lb/in² interlaminar compression. Although not required for performance reasons, the bars were retensioned at the end of the monitoring period because of equipment availability and to allow load testing of the bridge at different interlaminar compression levels.

Although the overall bar force was relatively low at the initiation of monitoring, the bar force retention for the Lynches Woods Park bridge was satisfactory. Factors affecting the bar force were moisture content changes and stress relaxation. The moisture content changes were small and occurred in the outer portion of the laminations; therefore, the effect on bar force was minimal. The majority of bar force loss, both before and during the monitoring period, was due primarily to stress relaxation of the lumber laminations.

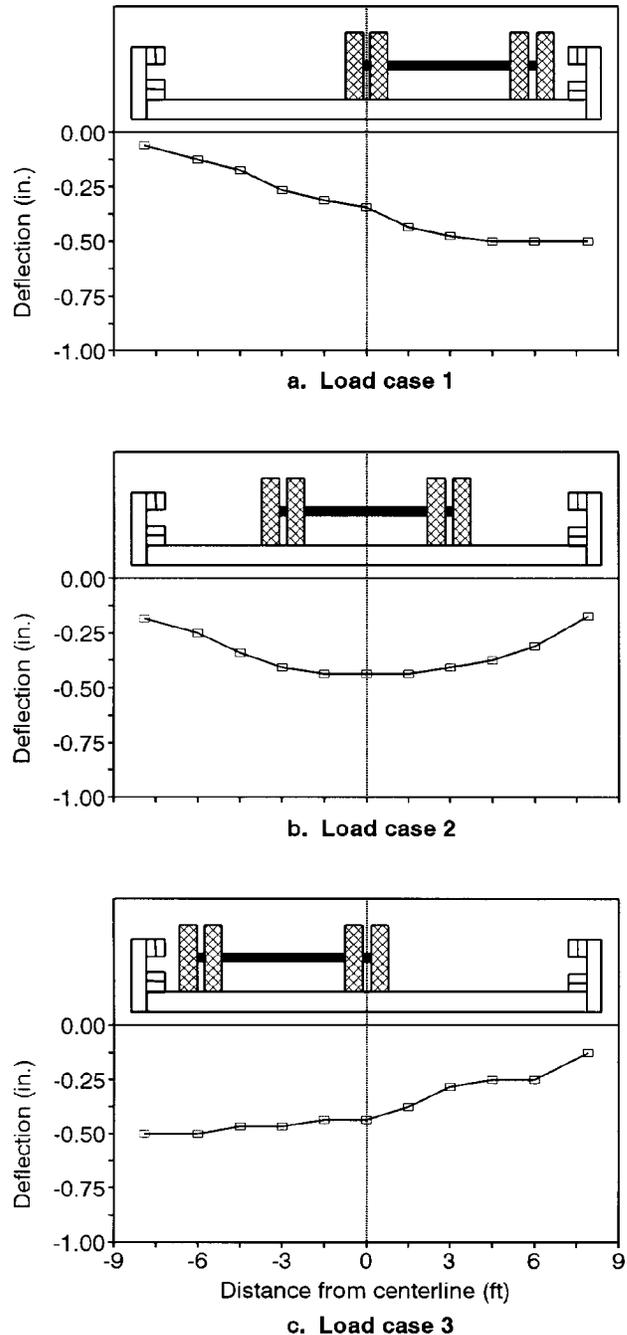
Transverse deflection for load test 1 is shown in Figure 18. For load case 1 (Fig. 18a) and load case 3 (Fig. 18c), the symmetry of the load cases resulted in the same maximum measured deflection of 0.50 in. under the wheel line nearest the bridge edge. For load case 2 (Fig. 18b), with the vehicle centered on the bridge cross-section, the maximum measured deflection of 0.44 in. occurred at the bridge centerline. In all cases, the deflection is typical of the linear elastic orthotropic plate behavior of stress-laminated bridges, and the locations of maximum measured deflection correspond to those observed in other similar bridges (Ritter and others 1991).

Figure 18—Transverse deflection for load test 1, measured at the bridge midspan (looking north). Bridge cross sections and vehicle positions are presented to aid interpretation only and are not to scale.

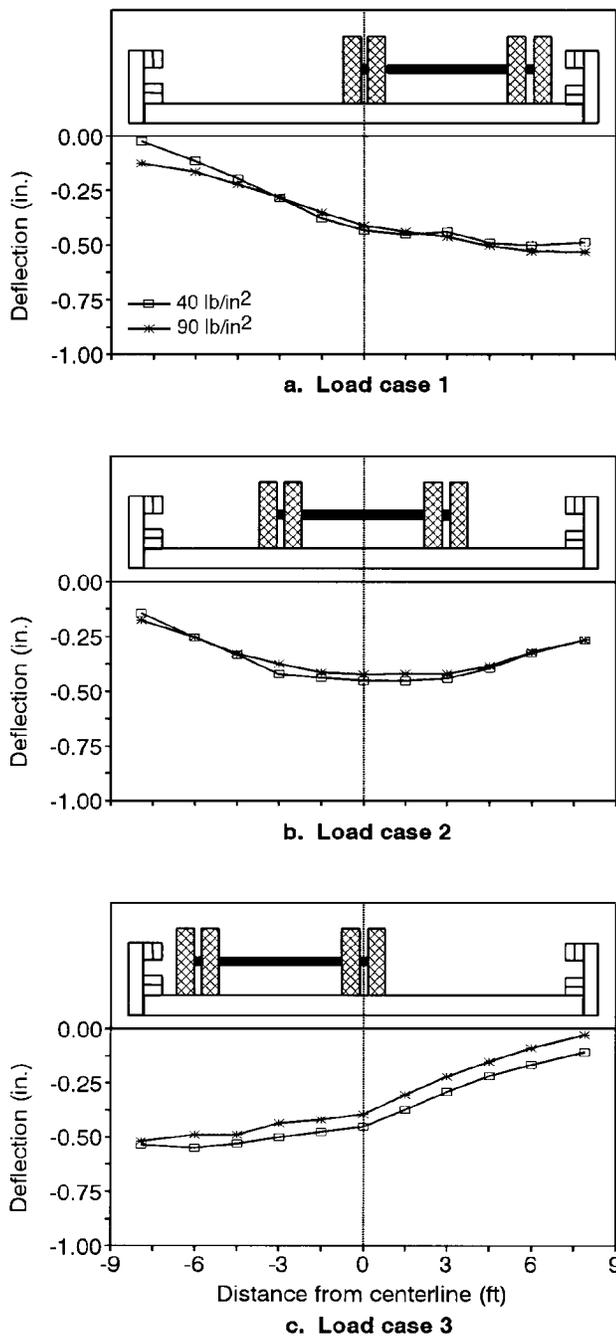
Transverse deflection for load test 2 at interlaminar compression levels of 40 lb/in² and 90 lb/in² is shown in Figure 19. At the 40 lb/in² level, the maximum deflection for load case 1 (Fig. 19a) and load case 3 (Fig. 19c) occurred under the wheel line nearest the bridge edge and measured 0.50 and 0.55 in., respectively. For load case 2 (Fig. 19b), the maximum measured deflection of 0.45 in. occurred at the bridge centerline. For all load cases, the maximum measured deflections are very similar to those of load test 1, with no difference in location and only minor differences in magnitude. Such a small difference in magnitude was not expected because of the increased loading for load test 2, which should have resulted in a substantially greater deflection magnitude.

Figure 19—Transverse deflection for load test 2, measured at the bridge midspan (looking north), at interlaminar compression levels of 40 and 90 lb/in². Bridge cross sections and vehicle positions are presented to aid interpretation only and are not to scale.

At 90 lb/in² interlaminar compression, the magnitude and location of the maximum measured deflections changed slightly from those measured at the 40 lb/in² level. For load case 1 (Fig. 19a) and load case 3 (Fig. 19c), the maximum measured deflection occurred at the bridge edge, rather than under the wheel line nearest the bridge edge, and measured 0.53 and 0.52 in., respectively. For load case 2 (Fig. 19b), the maximum measured deflection of 0.42 in. occurred at the bridge centerline, the same location measured for the 40 lb/in² level and for load test 1. Given the 50-lb/in² increase in interlaminar compression, we expected that the bridge stiffness would increase slightly (Oliva and others 1990). When comparing the two interlaminar compression levels, the relative deflection curves are very similar but an increase in stiffness, indicated by reduced deflection, is clearly evident only for load case 3. It is likely that a global increase in longitudinal bridge stiffness at the 90 lb/in² interlaminar compression existed for all load cases. However, it is not possible to draw definitive conclusions from these tests, given the accuracy of the deflection measurements.

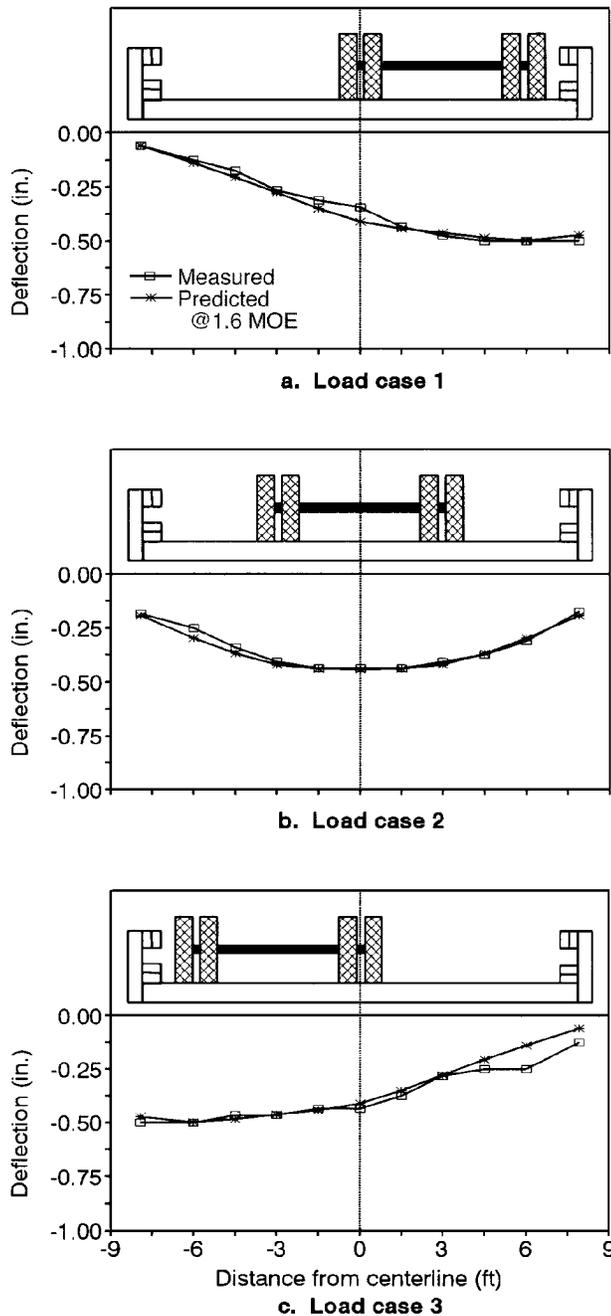
A comparison of load test 1 measured deflections to the theoretical bridge response based on orthotropic plate analysis is shown in Figure 20. For modeling purposes, we assumed a deck lamination MOE of 1,600,000 lb/in² for the Southern Pine material, based on tabulated design values (AFPA 1988). As shown in Figure 20, the theoretical bridge deflection is very close to that measured, although minor differences between the measured and theoretical deflection are evident in several locations.

Figure 20—Comparison of load test 1 measured and predicted deflections using orthotropic plate analysis.

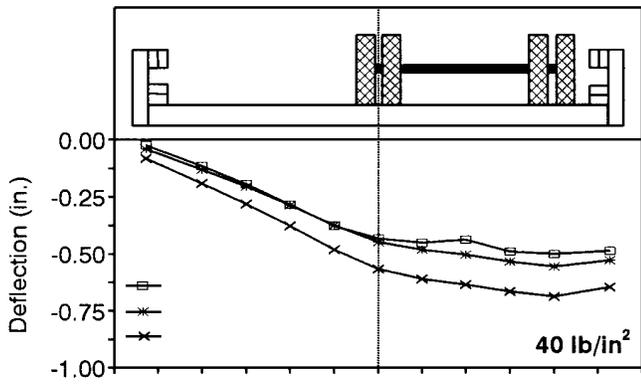
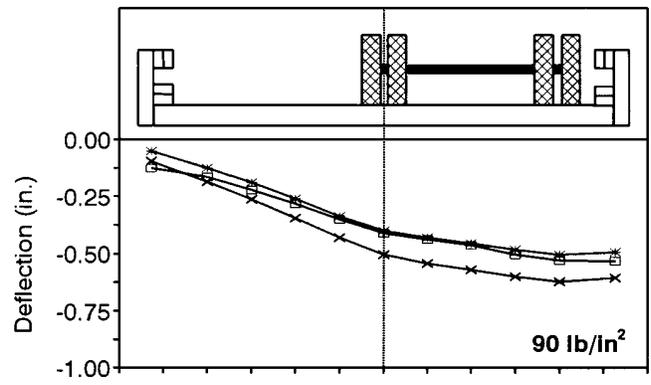
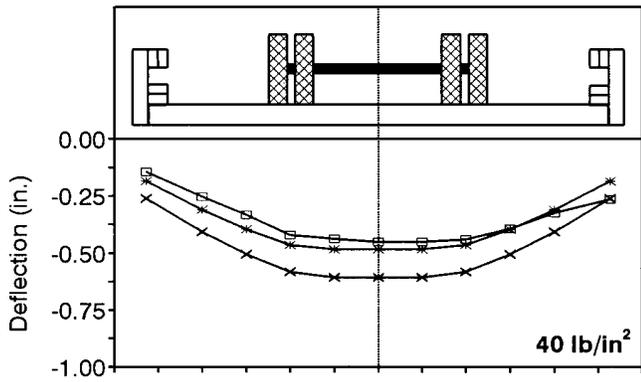
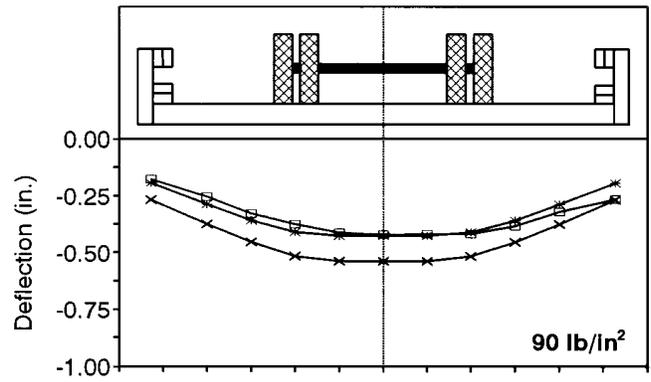
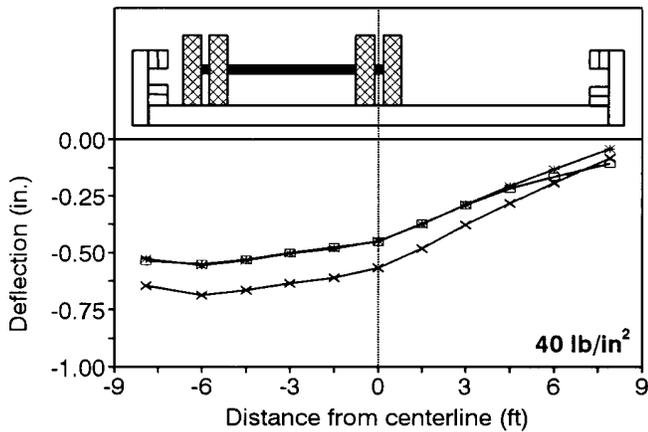
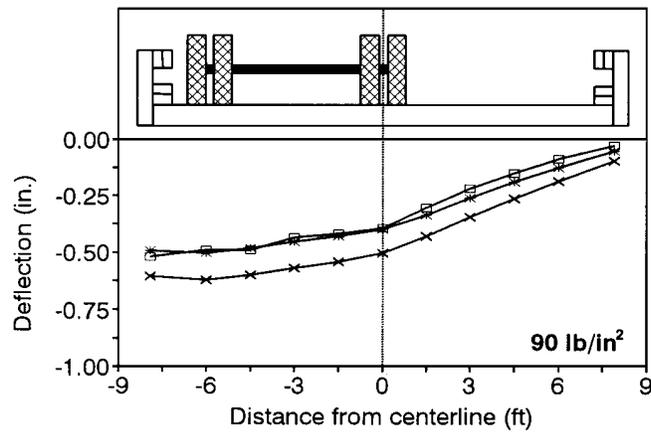
A comparison of the measured and theoretical deflections for load test 2 at interlaminar compression levels of 40 and 90 lb/in² are shown in Figure 21. In completing the analysis, we found that the assumed material MOE of 1,600,000 lb/in² used for load test 1 resulted in poor theoretical correlation with measured results and consistently overstated the deflections for load test 2. Based on these results, it was evident that a larger longitudinal stiffness was necessary for load test 2 to achieve a measured theoretical correlation similar to that obtained for load test 1. Given that both load tests 1 and 2 were conducted when the interlaminar compression was 40 lb/in², we eliminated bridge prestress effects on the transverse deck properties and butt joints as a possible cause of longitudinal stiffness change. In addition, the deck section and lamination moisture content were unchanged and did not significantly affect longitudinal stiffness. As shown in Figure 21, the correlation between the measured deflection and that computed using an MOE of 2,100,000 lb/in² is very good and similar to the load test 1 correlation with a material MOE of 1,600,000 lb/in². Although the exact cause of the apparent 30 percent increase in MOE is unknown at this time, it is suggested that a chemical interaction between the CCA treatment and the wood laminations could cause a modification to the wood structure that results in an

increase in MOE. An MOE change of this extent has not been observed in research studies of treated materials. However, the same type of phenomenon has been observed on other bridges built with CCA-treated lumber that are currently being monitored by FPL; conclusive findings will be forthcoming.

Figure 21—Comparison of load test 2 measured and predicted deflections using orthotropic plate analysis.

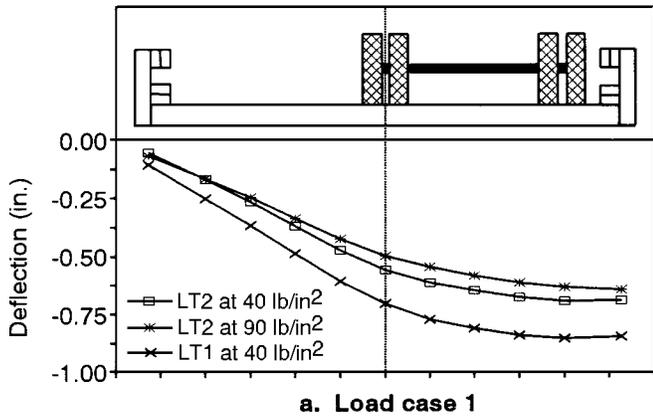
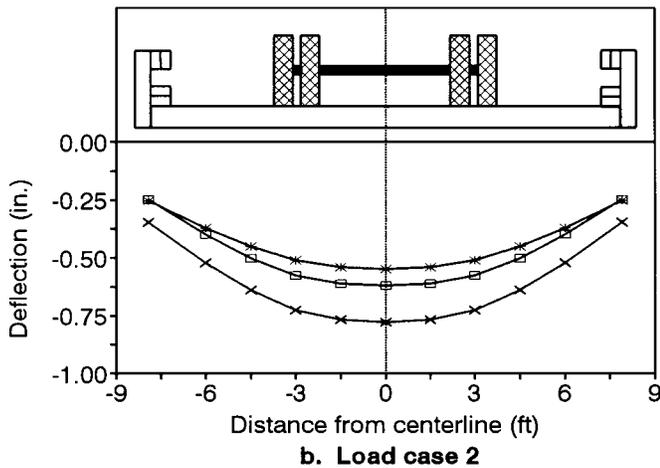
Theoretical deflection for AASHTO HS20-44 truck loading is shown in Figure 22 for load cases 1 and 2. (Load case 3 is a mirror image of load case 1.) Deflections correspond to the load test conditions previously discussed and are based on the same relative analytical input parameters for interlaminar compression and MOE. As shown for each set of load test conditions, the maximum HS20-44 theoretical deflection occurred for load case 1 rather than load case 2, and the location of maximum HS20-44 deflection for each load case corresponds to the location where maximum load test deflections were measured. As summarized in Table 2, the maximum theoretical HS20-44 deflection of 0.86 in., or $L/404$ as expressed as a fraction of the bridge span, occurred under load test 1 conditions. For load test 2, with an MOE of $2,100,000 \text{ lb/in}^2$, the maximum theoretical deflection of 0.69 in. or $L/503$ was obtained at an interlaminar compression of 40 lb/in^2 . After bar tensioning to 90 lb/in^2 , the load test 2 maximum theoretical HS20-44 deflection was 0.64-in. or $L/543$. Thus, the 50-lb/in^2 increase in interlaminar compression for load test 2 resulted in an approximate 7-percent decrease in the theoretical HS20-44 deflection.

Figure 22—Predicted midspan deflection for load cases 1 and 2 using HS20-44 loading and orthotropic plate analysis.

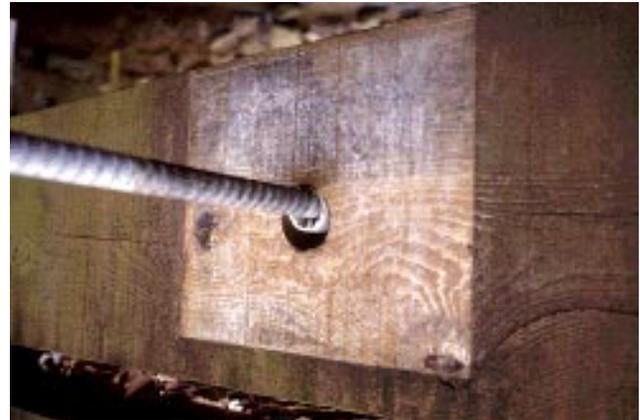
Figure 23—Visual inspection of outer lamination after removal of bearing plate showed no signs of bar corrosion.

Inspections of the stressing bar system indicated satisfactory performance. Galvanized steel hardware that was exposed to the environment was in good condition, with no visible sign of corrosion or deterioration. At the conclusion of monitoring, several bearing plates were removed to allow visual inspection of the stressing bars and bearing plate areas (Fig. 23). The condition of several bars was examined inside the PVC tubing and signs of corrosion were not evident. In addition, there was no visible crushing of the discrete plate anchorage into the outside laminations. However, slight deformations were present in the outside laminations along each bridge edge. These deformations produced a gentle depression in the vicinity of the plate anchorages that measured from 1/8 to 1/16 in. (Fig. 24). These depressions were the result of stress relaxation of the deck laminations and did not affect the performance of the structure.

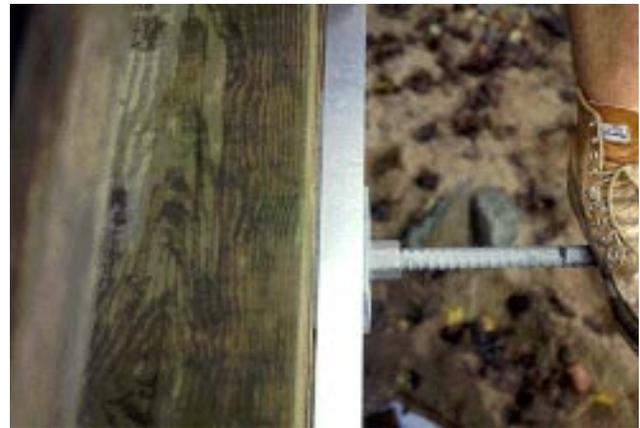
Figure 24—Gradual deformation of the laminations in the vicinity of the bar anchorages. Note the small gap between the aluminum straight edge and the deck edge.
