In: American Society of Civil Engineers, Proceedings of the 2005 Structures Congress, April 20-24, 2005, New York, NY. 2005.

Kings Covered Bridge Rehabilitation, Somerset County, PA

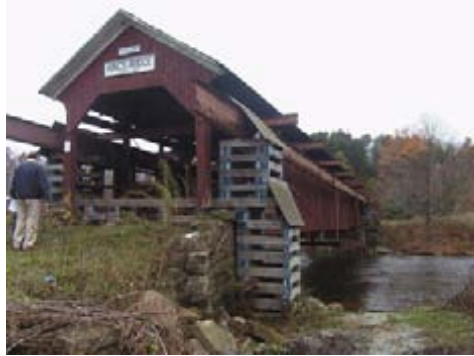
Figure 1 – Kings Bridge eastern portal w/ temporary truss system

Stabilization – A stabilization system of two queenpost trusses was designed by DCF to be placed to the exterior of the bridge. Each truss bears on timber cribbing towers that rest on the stream banks below. The system was designed and installed with the expectation to temporarily hold the bridge securely in place during the shoring, engineering, planning, and fundraising phase. The inserted steel queenpost shoring system is inherently stable. Steel wide flange “needle beams” were placed transversely through the bridge, and bear on the upper chords of the temporary queenpost trusses and are positioned to suspend the timber bridge from its upper chords. The downstream truss was critical at the time shoring was installed. Only the bolts where the lower chord was repaired were preventing the bridge from collapsing into the creek. The abutment walls provide critical support to the bridge and were not be disturbed.

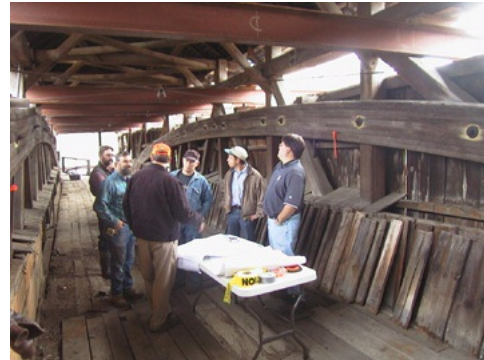
live load, however the subsequent failures of both lower truss chords changed the distribution of the loading through the truss-arches in a dramatically visible way. See Figure 3.

Figure 3 – View of interior trusses, arches, SJC Team

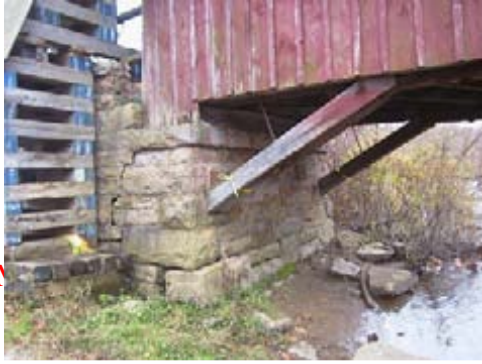
Substructure - The truss bears on stone abutments. “Seats” were carved in the face of the abutments to bear the timber struts to transfer loads from the arches through the lower chords to the substructures. See Figure 4.

Figure 4 – Northern face of eastern abutment. (Note the separation of the wingwall face resulting from the horizontal thrust of the truss/arches after lower chords failed.)

- Arch Struts – These members are installed below the line of the lower chords and are not sheathed by the bridge siding – probably to avoid obstruction of the creek during flood levels. These untreated heavy timbers have long since lost structural integrity where the hearts have decayed at the bearing seats on the stone abutments.

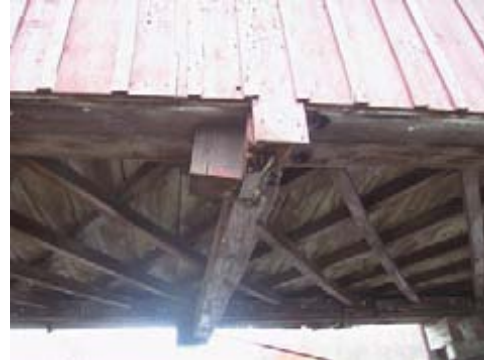
Figure 5 – View of floor joist system from below. (Note the retrofitted tie beam fastened with canted rods that imposed enough horizontal force to damage the lower post relish.)

- Truss Posts – Leaks in the areas of lower chord failures also resulted in damage to several truss posts and shouldered truss braces. The joints in a covered bridge timbers are often the weakest points in the structure. The head of two posts had failed in shear at the joints due to excessive new loading patterns after the lower chord failures and repairs were installed by the King Family. See Figure 5.

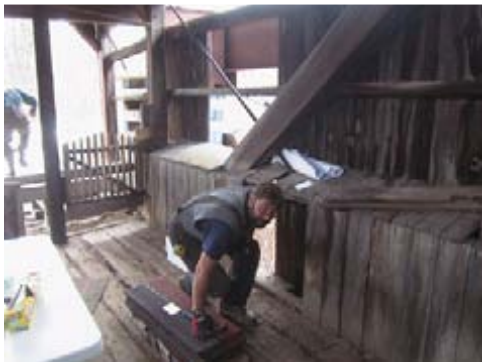
Figure 6 – Interior “wainscot”(Note retrofit rod and gates from previous “barn” use”)

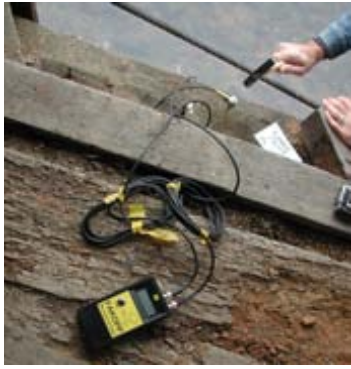
- **Stress Wave** – Measurements were performed with (Fakkop Microsecond Timer) stress wave timing equipment in accordance with established procedures (Ross and Others 1999). At each identified location, the width of the member was measured along with the wave transmission time. Calculated stress wave velocities (foot per micro-second) helped to identify potentially decayed locations in the bridge truss members. See Figure 8.

Figure 8 - Using a stress-wave timer to detect interior decay in a lower chord member”

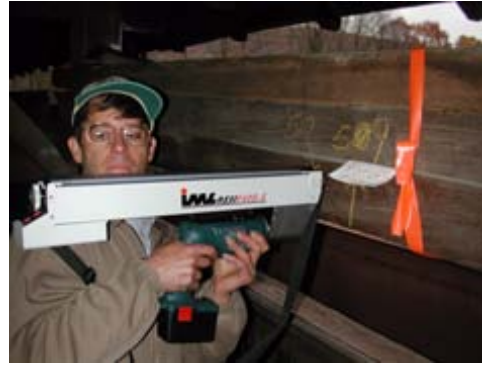
- **Resistance Drilling**. Measurements were performed with a micro-resistance drill (IML Resistograph model F400) that measures drill bit resistance that provides a good density profile of the wood member (Figure X) (Ross and Others 2004). True scale density profile plots were used to characterize the extent of internal deterioration in the bridge truss members. See Figure 9.

Figure 9. Using a resistance-drill to locate interior decay in an upper a chord member.

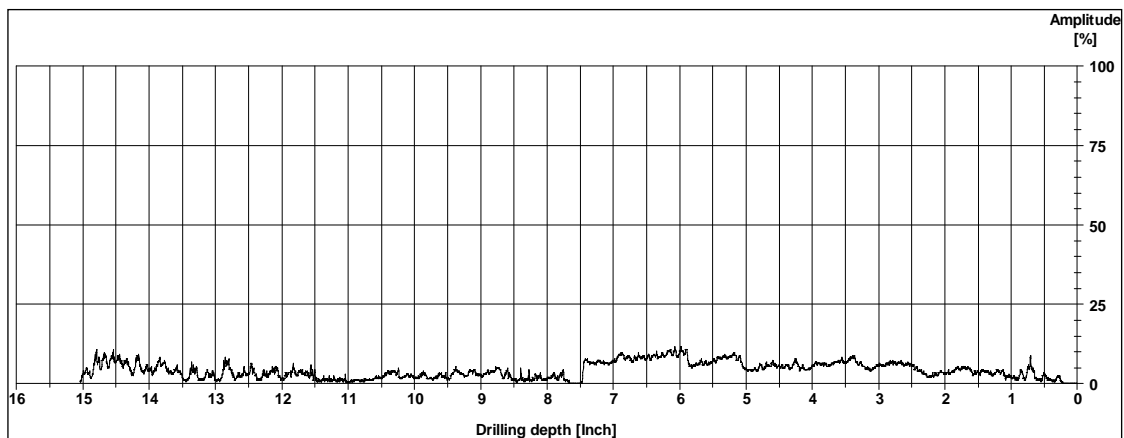
Several micro-drill resistance measurements reported consistently low wood density and confirmed the stress wave measurements. A representative resistance plot shows relative density profile of both (inner & outer) top chord truss members at location 10S-c. See Figure 11. Both truss members had a relative drilling resistance below 15 percent, with the interface between members visible at approximately 7.5 inches drilling depth.

Figure 11. Resistance drill plot 513 (corresponding to test location 10S-c) The resistograph plot shows a typical low resistance at a suspected deteriorated location.
