## Evaluation of a timber column bent substructure after more than 60 years in-service.

This paper describes both the field evaluation and laboratory testing of two timber-column-bent bridge substructures. These substructures served as intermediate pier supports for the East Deer Park Drive Bridge located in Gaithersburg, Maryland. A field evaluation of the bridge substructure was conducted in September 2008. Nondestructive testing was performed with a moisture meter, a stress-wave timer, and a resistance micro-drilling tool. In addition, several core samples were removed for further laboratory evaluation. Live load testing of the bridge superstructure, which consists of steel girders with a glulam timber deck, was conducted concurrently using a single test vehicle. Based on subsequent load rating analysis performed on the entire bridge structural system, it was determined that the timber substructures would be replaced and were salvaged for further testing. Nondestructive tests were conducted to detect internal decay in each of the timber columns using a stress wave scanning technique. The timber-column bridge bents were then reassembled for laboratory testing. Loadings were appl

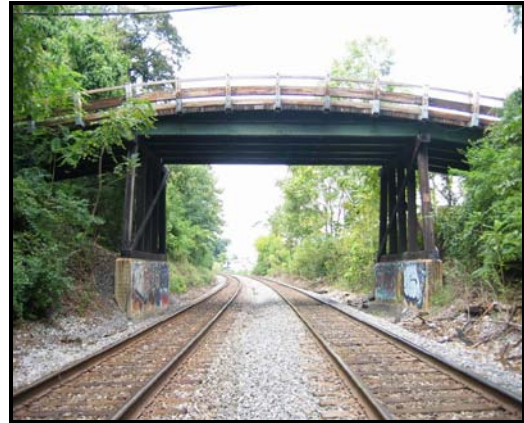
Figure 1 – View of East Deer Park Drive Bridge.

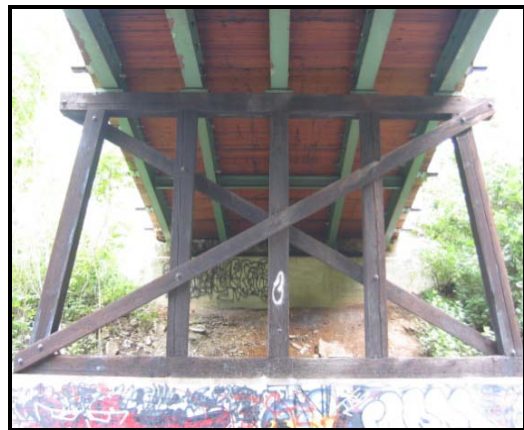
Figure 2 – Timber column-bent support pier.

Our comprehensive inspection data indicated that column 5 in the East Pier contained a thru-split approximately 610 mm (2 ft) above the (sill) base beam, column 4 of the west pier contained a 610 mm (2 in.) deep decay pocket near its center approximately 1.2 m (4 ft) above the (sill) base beam, and extensive internal deterioration present in both cap beam members. Replacement of both cap members in conjunction with reinforcement techniques for the split column was recommended to the bridge owner.

Based on the inspection recommendations and a finite element analysis of the overall bridge structure, the county decided to replace the timber column-bent piers entirely in 2009. During their rehabilitation they were able to salvage all of the heavy timber components and ship them to FPL for further laboratory evaluation. This paper will summarize the field evaluations of the timber-column bents and include preliminary laboratory test results for those tests completed to date.

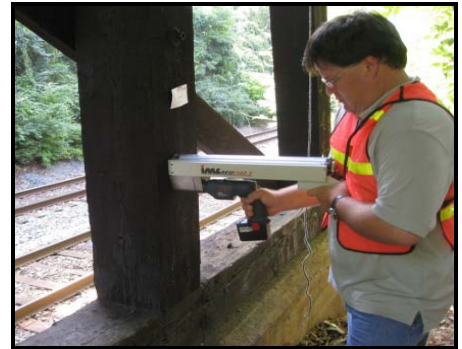
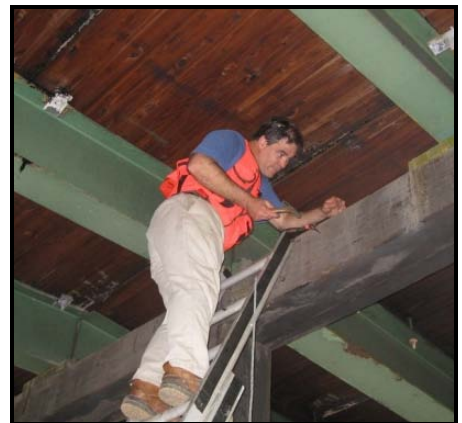
*Figure 3 – Nondestructive assessment included resistance micro-drilling (top) and stress-wave timing (bottom) in the columns and cap beams.*

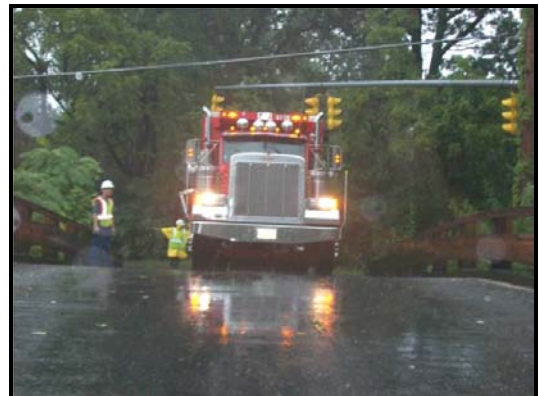
The live load strain response data from the September 2008 load test is shown in table 1. For this concentric load case, the test truck was aligned with the roadway centerline, as it crossed over the bridge at a crawl speed. Maximum tensile strains in the end span steel girders totaled 203 micro-strains ( $\mu\epsilon$ ), with the both rear axles positioned at the bridge midspan and the front axle off the bridge. The strain distribution percentage for each individual girder was calculated as the girder strain divided by the cumulative total strain. These individual girder strain percentages defined the lateral load distribution characteristics of the superstructure and were later utilized in laboratory testing. Additional details about the load testing are summarized in a field report (Zhou, 2008).

Figure 4 – Load testing completed in Sept. 2008.

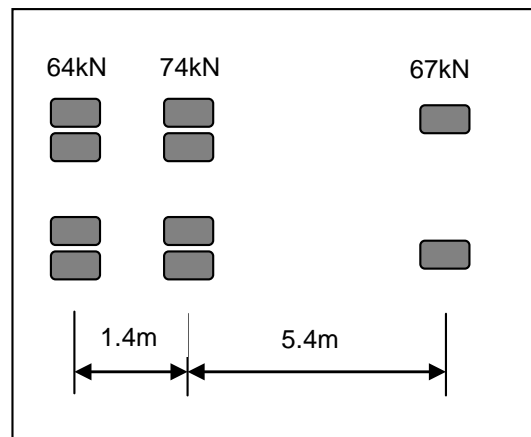
Figure 5 – Truck axle weights and spacings.

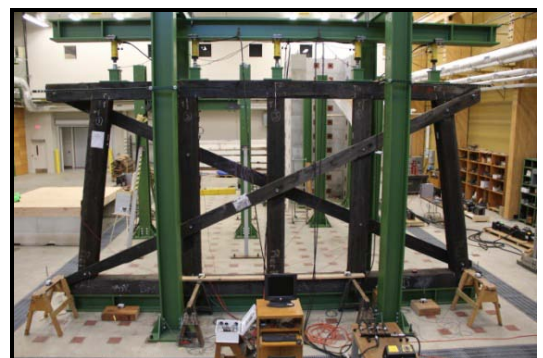
Figure 7 – Column-bent substructure re-assembled for laboratory evaluation.
