SERVICE LIFE ASSESSMENT OF TIMBER HIGHWAY BRIDGES IN USA CLIMATE ZONES

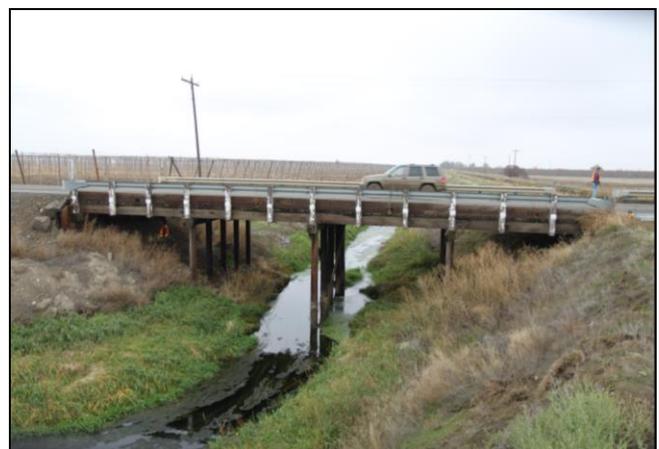
Several examples of outstanding sawn girder bridge durability were discovered; one from Yakima County, Washington is shown in Figure 4. This bridge has no record of repair or rehabilitation, with the exception of one sister beam added near the deck edge. It has been in-service for approximately 75 years and still maintains an average daily traffic of 1,600 vehicles and trucks. The bridge remains in satisfactory condition (NBI condition rating of 6) with no measurable section loss or deterioration at critical locations.

Figure 4: 75-year old sawn girder bridge located in Yakima County, Washington remains in satisfactory condition.
