Avast Ye Salty Dogs: Salt Damage in the Context of Coastal Residential Construction and Historical Maritime Timbers

Grant T. Kirker
Samuel L. Zelinka
Leandro Passarini

USDA Forest Service, Forest Products Laboratory
Madison, Wisconsin

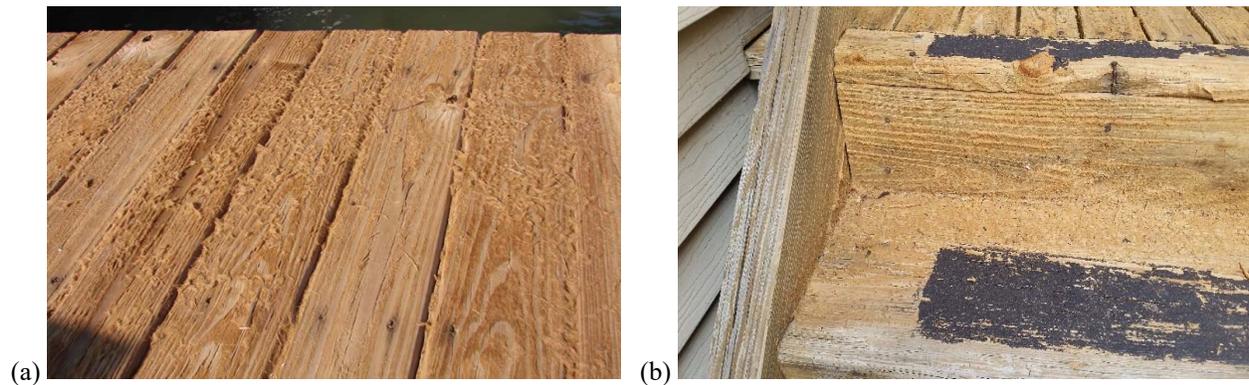
Figure 1: Characteristic damage to treated wood caused by salt. (a) Treated deck boards exposed to frequent wetting of saltwater develop a fuzzy appearance. (b) Excessive use of de-icing salts can also cause salt damage as evidenced on these stair treads.

The issue of salt damage is not new to the wood protection industry and has always been treated as a curiosity that can frequently be seen on wood in and around coastal areas, as well as non-coastal areas through contact of wood with deicing salts (Figure 1). Parameswaran [1] detailed observations of defibered wood in potash storage areas, which typically have a very high pH. Their study attributed much of the damage to alkaline pulping of the middle lamella. Johnson and Ibach [2] studied fiber tracheid separation and found that they could create the phenomenon in the lab after 100 repeated wetting cycles with a saturated salt solution. In their discussion, they attributed salt damage to physical damage to the middle lamella via microchecking. Blanchette and his colleagues have also studied salt damage in Antarctic expedition huts [3] and pueblo houses in the New Mexico desert [4] and attributed salt damage to corrosion of the middle lamella via action of the salt accumulation. The common theme that has been observed in all of these studies is that salt damages the middle lamella and results in tracheid separation.

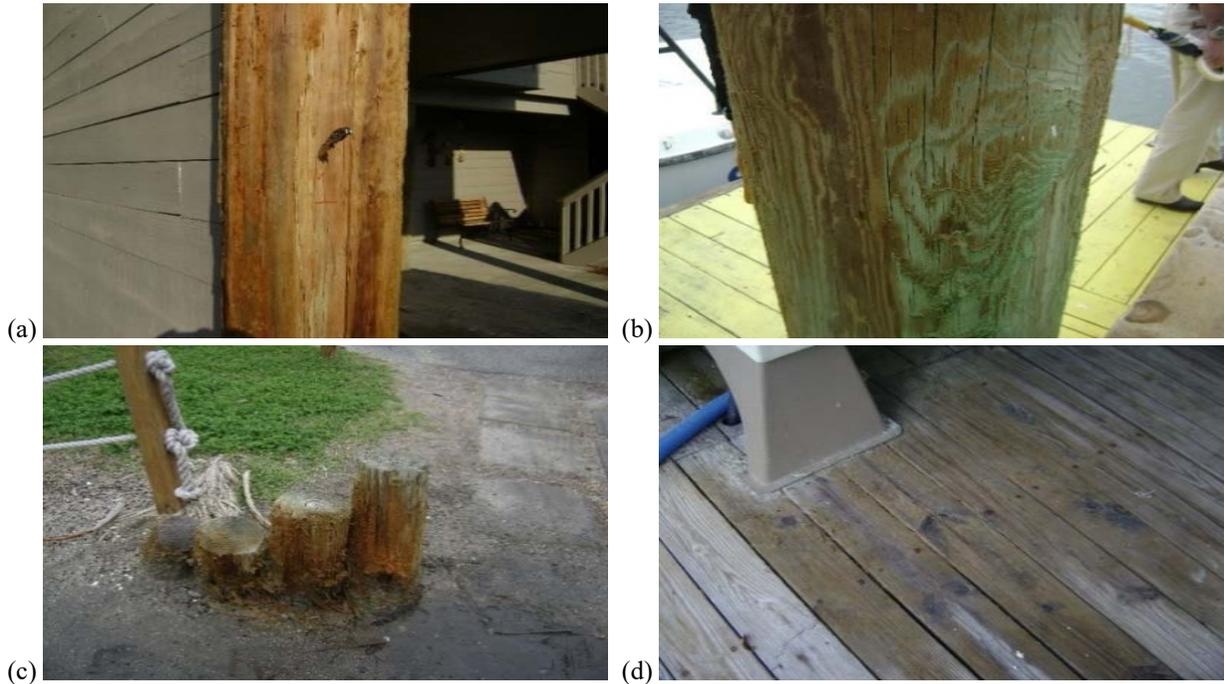
In 2012, samples from 26 piles in and around the port of Charleston were sent to FPL from Jim Healey at Cox Industries [5]. The samples in question had varying degrees of salt defibration (Fig. 2) and it was suggested by a third party that the condition of these pilings was due to the presence of a copper tolerant decay fungus.

Figure 2: Images from Charleston, SC depicting various instances where salt damage was found: (a) foundation pilings of a condominium installed into the salty water table, (b) marine pilings, (c) terrestrial piles with butt ends sitting in salty water table, and (d) treated deck boards exposed to constant wetting with seawater.

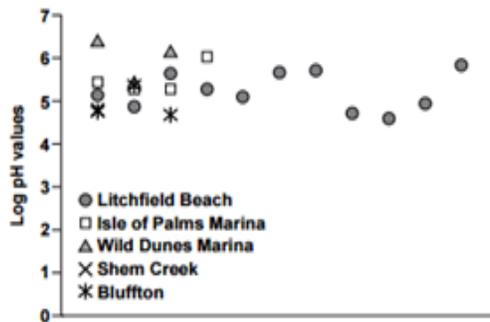
The samples were analyzed for pH (Fig. 3) and microscopically for fungal presence using scanning electron microscopy (SEM) and energy dispersive x-ray spectroscopy (EDS) for elemental analysis (Fig. 4). Results indicated that the pH ranged from 5-7 and there was no presence of fungal hyphae other than a few sap stain fungi that do not impact wood strength. The pH range was much too high for brown rotted wood, which is normally in the 2-3 range due to production of organic acids by the fungi [6]. In addition, none of the samples had any symptoms of brown rot decay, which is typically characterized by a rusty brown cross checked surface.

Figure 3: pH values for wood samples received from Charleston.

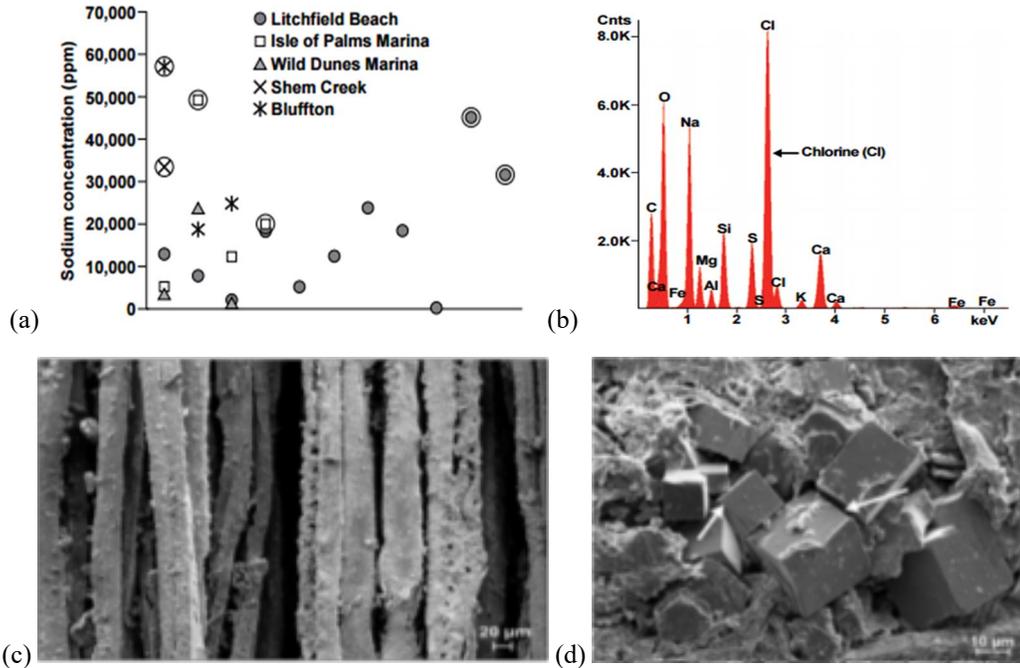
Figure 4: (a) Results of salt concentrations of samples in ppm determined by ICP-OES. (b) Example EDAX output showing high abundances of Na and Cl within the samples. (c) SEM images showing defibered wood; note removal of surrounding lignin matrix (middle lamella), leaving only residual tracheid cells. (d) Large cubical NaCl (halite) crystals found in and around wood surfaces of fuzzy wood samples.

Preservative retentions were also analyzed using inductively coupled plasma atomic emission spectroscopy (ICP-OES), and measured retentions were well within expected values for poles of their class and age. It was concluded that the damage observed on these pilings was indeed due to the actions of salt and not a decay fungus. In attention to the general technical report, an FPL TechLine differentiating salt damage from biological degradation was published [7] in order to provide end users better information on this matter. Additionally, a separate technical report was issued by Mississippi State University (MSU) with similar information [8]. As a result of the information provided by both FPL and MSU, the frequency of reports of salt damaged wood has increased.

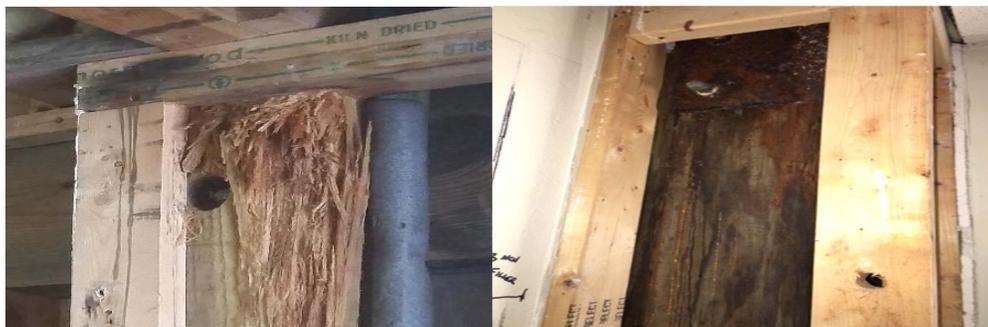
In the fall of 2014, FPL received several data calls from condo owners in and around ocean front properties in Florida that had extensive salt damage on the surface of foundation piles that were enclosed with stud walls and sheathing to create a garage. The salt water was wicking up through the piling from the water table and the customers indicated moisture problems as well as corrosion to fasteners in the vicinity of the salt damage. Photos that highlight the damage are shown in Figure 5.

Figure 5: Residential damage due to salt. These are foundation piles placed into a high salt water table. The saltwater has wicked through the wood causing fuzziness and corrosion. The image on the right also had extensive water damage as it was encased in drywall.

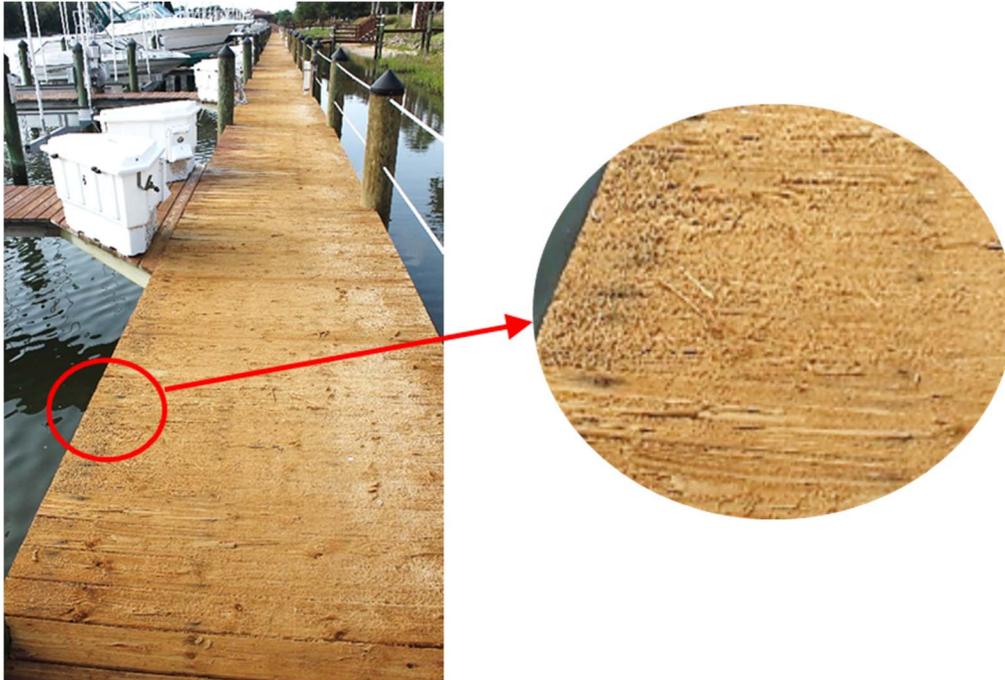
Additionally, marina owners in coastal Florida have submitted questions about salt damage occurring on wood being used as decking and a bulkhead in a marina. The salt damage was not as extensive as what is typically seen in a covered exposure, but the damage was severe enough to prompt its replacement, for which a wood plastic composite (WPC) was being considered. There are some limited literatures on the effects of salt damage on WPCs, but the damage is fundamentally different [9].

Figure 6: Treated deck boards, approximately 5 years old with severe salt damage. Marina owners were concerned that this was not safe for foot traffic. Additionally, a nearby marine treated bulkhead (not pictured) had extensive damage and was scheduled to be replaced with a composite product.

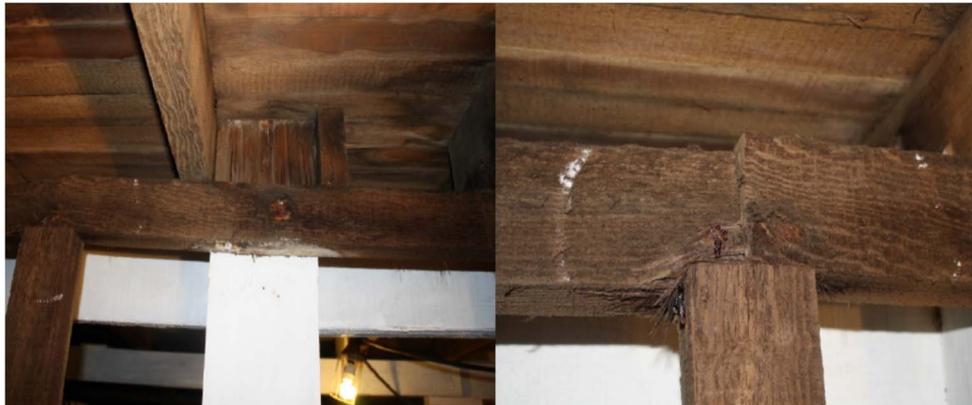
The National Park Service contacted FPL in the spring of 2015 to discuss on-going renovations to a wooden ferry, the *Eureka*, located at the Maritime National Historical Park in San Francisco, CA. On-site inspections were made by FPL staff, and it was determined that excess moisture was a key contributor to the problem. Salt damage was noted throughout the holds and corrosion was also apparent. Salt damage was severe enough to warrant failure of vertical beams within the rear hold (Figure 7).

Figure 7: Compressively failed Douglas-fir posts with severe salt damage. White posts were installed 5 years ago to help support the failing members. This is the first structural failure of salt damaged wood documented by FPL.

Following our initial observations of the *Eureka*, moisture monitors have been placed throughout the two holds that exhibited the highest concentration of salt damage. Temperature fluctuations, percent moisture content and relative humidity (RH) within the holds are being monitored to gather baseline data on the moisture dynamics. A key underlying condition in the *Eureka* is that of excessive moisture, which has been shown to be a key driver of salt migration in comparable materials [10]. By controlling moisture levels in the hold of the ship, it should be possible to slow the capillary migration of the salt. A secondary objective is to evaluate suitable coatings that can be used to remedially repair damaged surfaces. Typically, paints and sealants fail to adhere to the damaged surface and the salt will continue to disrupt wood from underneath the coating.

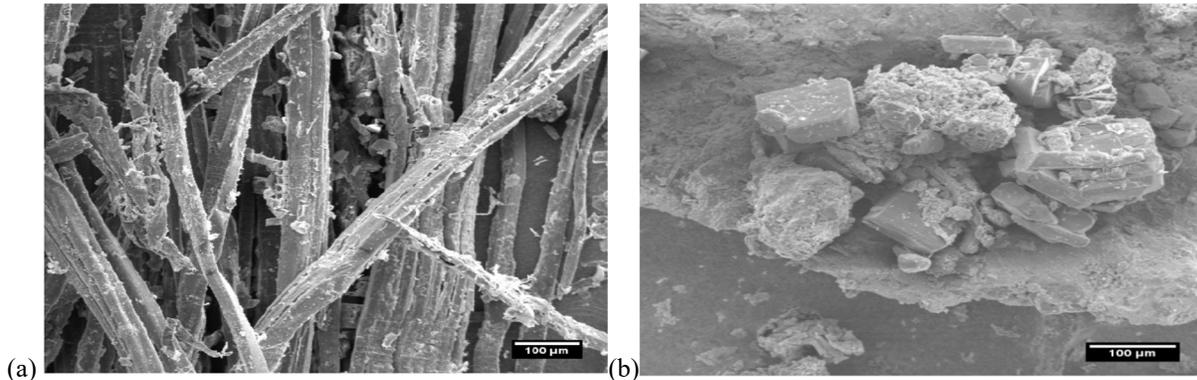
In addition to the excessive amount of visible salt defibration, corrosion was present on almost all of the iron fasteners embedded into the timbers. Samples were taken in the hold of the *Eureka* and subjected to elemental, microscopic and mechanical testing. Elemental characterization using energy-dispersive X-ray spectroscopy (EDS) indicated high levels of Na and Cl as noted in the Charleston study. Scanning electron microscopy (SEM) revealed fiber separation consistent with salt damage and presence of large cubical crystal deposits indicative of the rock salt crystal structure (Figure 8).

Figure 8: SEM micrographs of (a) defibered wood found throughout the hold of the *Eureka* and (b) corrosion products found on the surface of the wettest timbers in the hold. SEM micrographs created by Tom Kuster, USDA-FS, Retired.

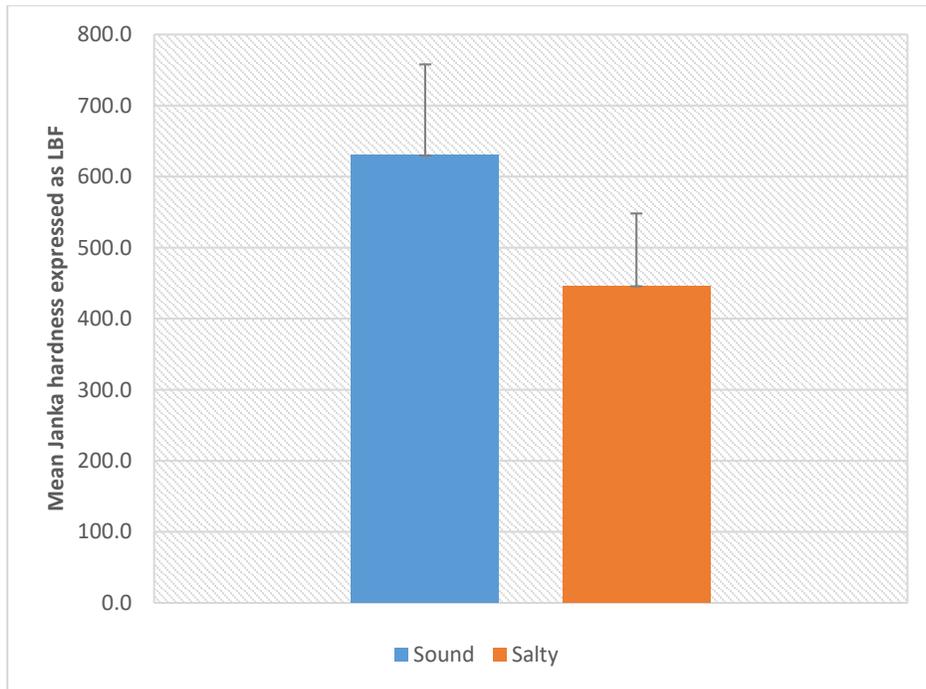
Several 2x2 Douglas-fir rails that were used to keep rock salt in place were found in the hold of the *Eureka*; these had varying levels of salt defibration, heavy corrosion, and were water soaked. These rails were tested at FPL using Janka hardness as an indicator of strength reduction. Bending strength was not evaluated as the Douglas-fir sections were not large enough to conduct ASTM E445 tests [13]. Results of the hardness test indicated that, compared to sound Douglas-fir sapwood, the Janka hardness was reduced by approximately 25-30%. Preliminary results of the hardness tests conducted at FPL are presented in Figure 10. Prior literature does not address any mechanical impacts to wood as a result of salt damage. However, Schneider et al. 1997 [12] studied long term storage of Douglas-fir poles in the Great Salt Lake and found minimal strength degrade as a result. This is not to say that salt damage does not impact wood, only that wood soaking in salt water for an extended time does not cause strength loss. The actual extent of salt damage occurs as wood wicks saturated salt water up through the piling and the salt crystals are re-deposited as the moisture exits the wood via evaporation. The concentration of salt crystals at the evaporative interface is where the defibration occurs, therefore, contact with salt water is not solely what causes the damage. Additional testing is necessary to determine the extent and exact location of strength degrade due to salt damage.

Figure 10: Preliminary results of Janka hardness testing of Douglas-fir rails from the hold of the *Eureka* (orange column) compared to control Douglas-fir in sound condition (blue column). Tests were conducted with a 2mm ball on all four faces of the rails. Janka units are reported in pounds-force (LBF). Published values for Janka hardness of sound Douglas-fir are 660 lbf.
