# GROUND-PENETRATING RADAR INVESTIGATION OF SALVAGED TIMBER GIRDERS FROM BRIDGES ALONG ROUTE 66 IN CALIFORNIA<sup>1</sup>

**Abstract.** This study describes assessment of the internal conditions of timber bridge structural members along Route 66 in California. These timber bridges were exposed to desert climate conditions for several decades, which can lead to a variety of deterioration. Overtime, the deterioration may cause loss of structural integrity within the bridges and lead to potentially hazardous conditions for the motoring public. Members from dismantled bridges were brought to the Forest Products laboratory in Madison, WI. Strength-reducing features including decay, splits and cracks, insect attack, and corrosion of metal components were initially identified using visual inspection. Further assessment was then performed using several nondestructive testing technologies including ground-penetrating radar (GPR). GPR was used, among other nondestructive techniques, to identify and locate internal features and defects within the timbers. The tomographic output of the GPR, known as radargrams, revealed deterioration. Based on the information contained within the radargrams,

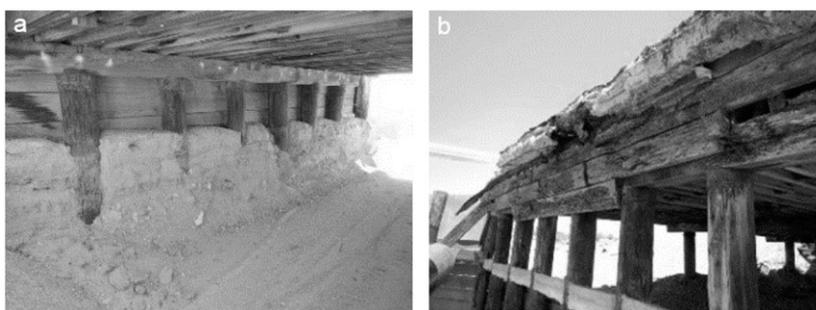
Figure 2. Bridge defects by visual inspection that include flood scouring: (a) annual floods deposited silt and (b) erosion around bridge abutments.

Overtime, exposure to the environment has caused damage to the bridge and led to potential safety risks. Annual floods deposited silt (Fig 2[a]) under bridges and, in some cases, eroded bridge abutments (Fig 2[b]). The erosion also caused decay on the abutment back walls. Common methods of protecting and reinforcing the abutment include seasonal removal of silt, abutment wing wall repairs (Fig 3[a]), and adding temporary midspan shoring (Fig 3[b]). Damaged stringers were reinforced by attaching metal bars under the stringers. For the nail-laminated decks, repairs and regular evaluations of intermediate pier supports are also important (Fig 4[a] and [b]).

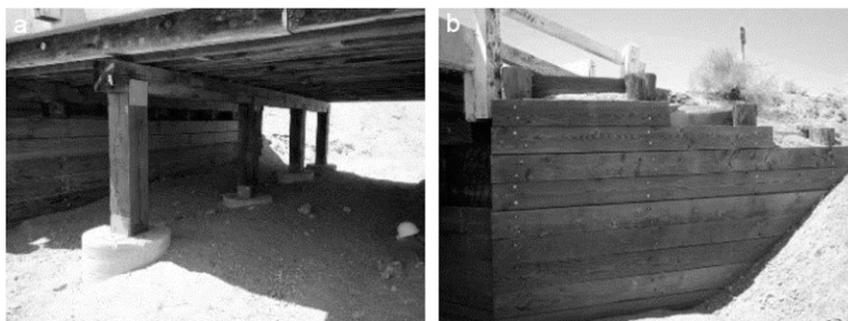
Figure 3. Protecting and reinforcing the bridge abutment: (a) midspan shoring and (b) wing wall repair.

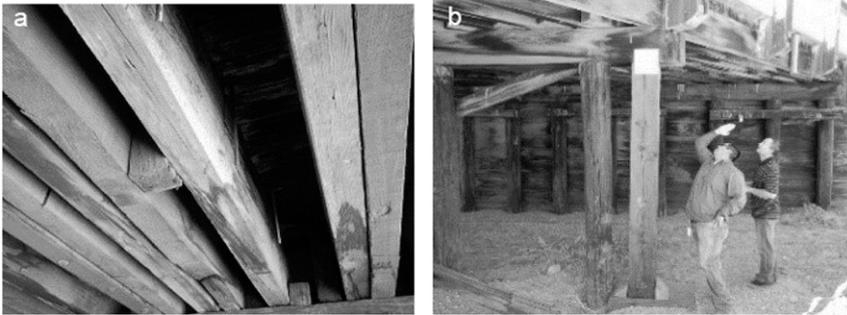
Figure 4. Bridge evaluation: (a) reinforcement of damage stringers and (b) evaluation of intermediate pier pillars.

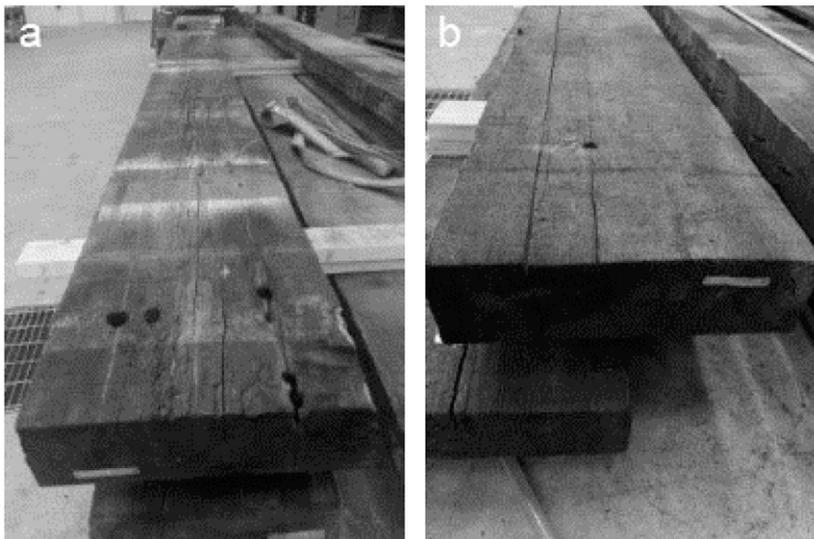
identified external damage as shown in Figs 5 and 6. One common feature of the bridge timbers was holes for steel bars near the ends of the timber (Fig 5[a]). Along the length of the timbers were holes for steel connectors between the timber and the bridge structure; some of these holes contained nails broken during the disassembly process. Large splits and knots that extended to the surface were visible, but small or interior splits and interior knots cannot be located visually (Fig 6).

Figure 5. Common defects of timbers: (a) holes of metal bars and (b) cracks and splits on the timber surface.

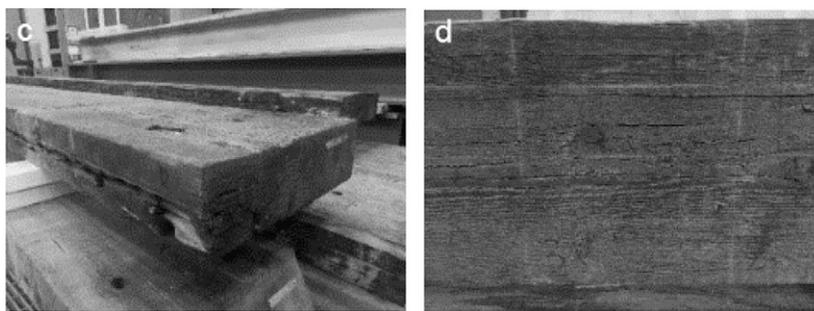
Figure 6. Common defects of timbers: (a) drilled holes and bar holes with some cracks and (b) visible surface knots.

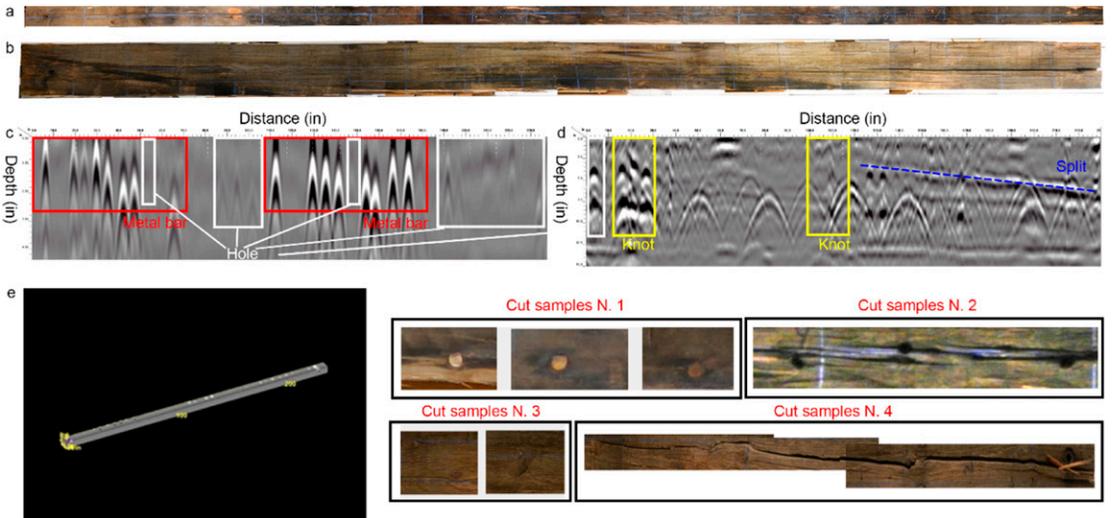
connections. The relatively dark and fuzzy areas on the radargrams (Fig 13[c] and [d]) shown within the white squares were verified as holes by comparing the defect mapping with the photographs. These findings correspond with the cut

sample No. 2 in Fig 13. The yellow boxes indicate knots detected by the GPR. The presence of knots is verified in cut sample No. 3 in Fig 13.

GPR scan in Fig 11(a). The higher microsecond travel times also reflected the split as shown in Fig 13(b). The higher travel times may be caused by the presence of the metal connectors or damage

Figure 13. Comparison of No. 5 timber with radargram and camera pictures.

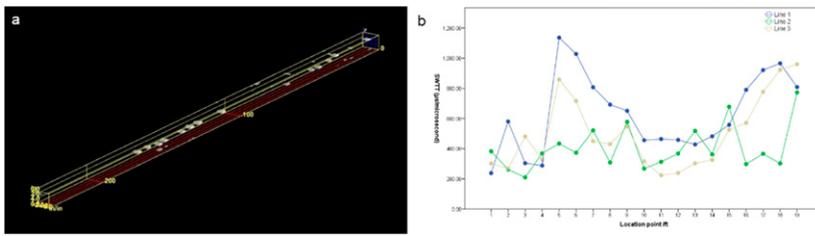
RADAN software allows abutting 2D images to be assembled into a 3D image. The 3D image gives additional information regarding the size and location of defects. The compiled 3D image is shown in Fig 14(a); the yellow lines show the outline of the timber, and the bright areas are the interior metal. As mentioned in the description of Fig 8, the sides of the timbers were scanned along three lines using both GPR and acoustic stress wave inspection. The

results of the acoustic inspection are shown in Fig 14(b). Higher microsecond travel times from 1.23 m to 2.13 m and 4.57 m to 5.80 m are seen in areas of metal connectors as identified by the 3D

Figure 14. 3D and acoustic results of No. 5: (a) 3D image of No. 5 and (b) the results of acoustic tests.

to the wood surrounding the connectors caused by the disassembly process. The combination of the photographs and the acoustic stress wave inspections provides verification of the GPR results.

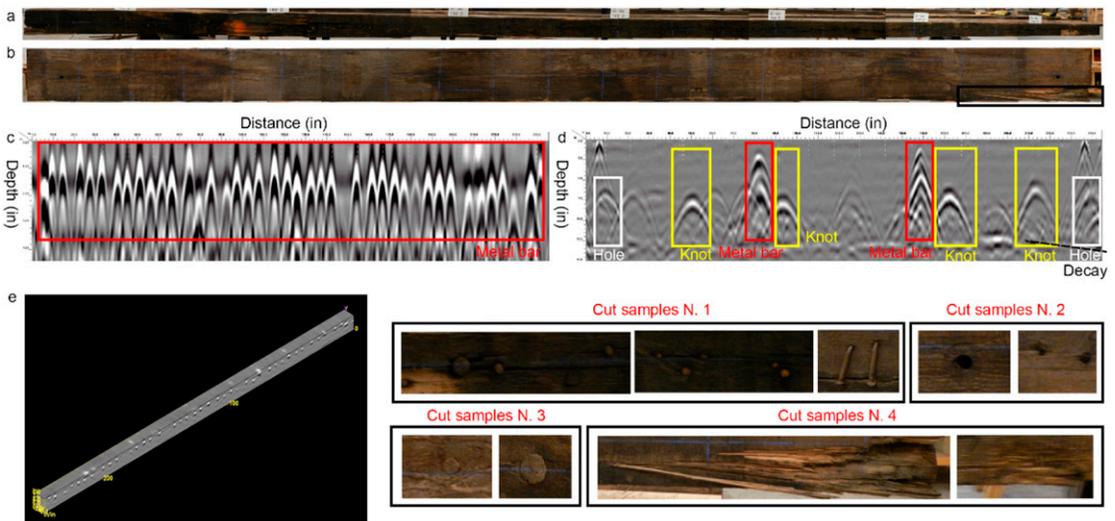
Timber 18 had many defects: four cracks, 23 knots, 7 holes, and 105 metal nails and bars. Figure 15(a) and (b) show Faces D and E. Surface defects were identified from the images. Metal connectors were used along the length Face D of the timber. The connectors were driven perpendicular to Face D and parallel to Face E. Scans of Face E show high numbers of metal connectors; the connectors are identified by red boxes in Fig 15(c). The white dots in the 3D image shown in Fig 15(e) correspond to the locations of the metal connectors. The nails are shown in cut sample No. 1. Several bars were used to assemble the bridge. The Face D scan revealed two large bars

indicated by red boxes in Fig 15(d). During disassembly, many of these bars were removed leaving holes; these holes are shown in Fig 15(d) within the white boxes. Large knots are also visible and are identified with yellow boxes. A close-up view of the knots is shown in cut sample No. 3. The black box in Fig 15(b) and the black line in Fig 15(d) indicate a region of decayed and broken wood. A larger view of the decayed region is shown in cut sample No. 4. Reflections caused by metal are noticeably brighter than reflections caused by other features. Smaller diameter nails produce less noticeable reflections than larger diameter nails. In some cases, closely spaced metal connectors appear as a single feature in the radargram.

Figure 15. Comparison of No. 18 timber with radargram and camera pictures.

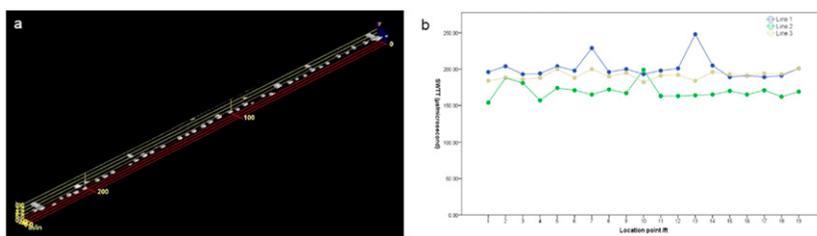
Figure 16. 3D and acoustic results of No. 18: (a) 3D image of No. 18 and (b) results of acoustic tests.

assessment of the timber. The white regions indicate metal connectors. The results of the acoustic stress wave tests are shown in Fig 16(b). Two notable regions of higher TOF are between 1.83 m to 2.44 m and 3.66 m to 14 ft 4.27 m. These regions correspond to the metal bars shown in the red boxes of Fig 16(d).
