James D. Katsaros<sup>1</sup> and Charles G. Carl<sup>2</sup>

## Extreme Exposure Fenestration Installations—The Florida Challenge

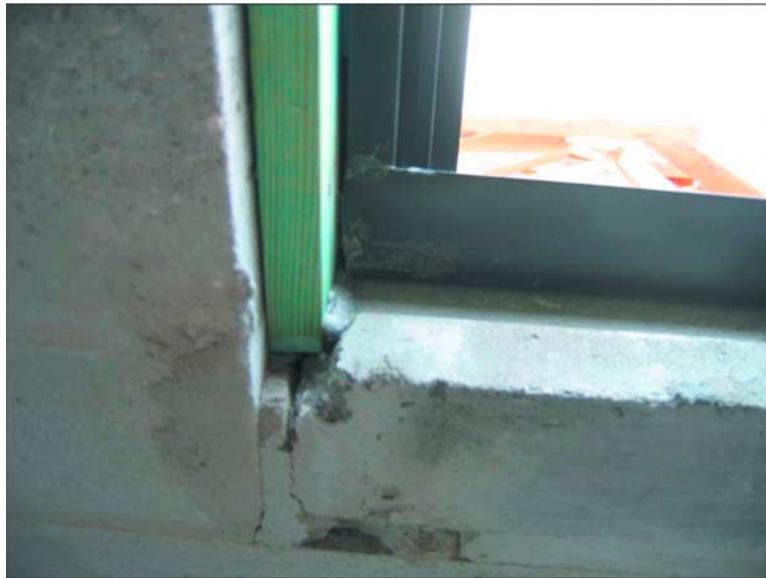
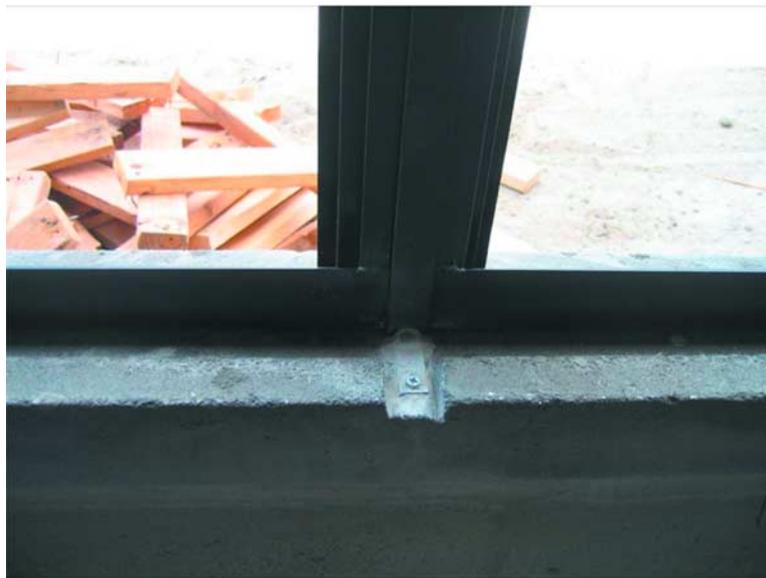
FIG. 3—Common installation flaws. Cracks in joint between sill and rough opening, forced fitting of wood buck (a), and raised leg in sill back dam is cut out to fit anchoring hardware (b).

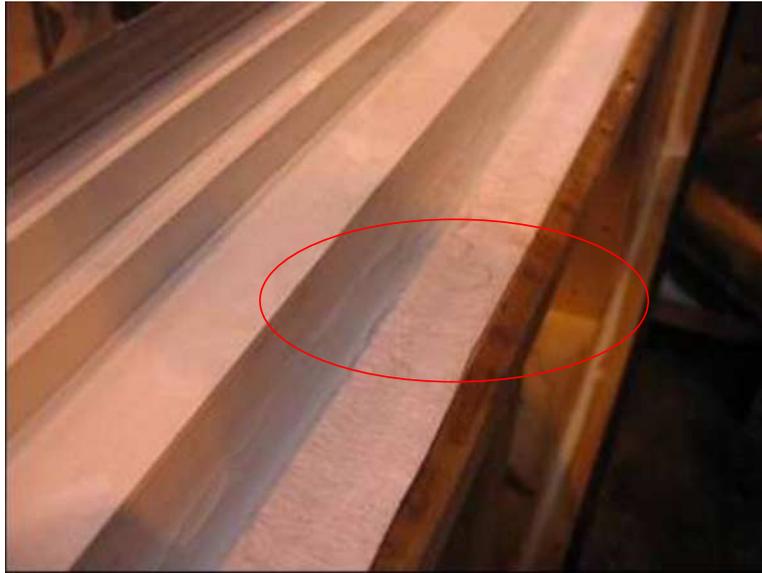
*Results of FMA AAMA 100 Wall #1 Test*—In the first round of testing of this wall assembly, water leakage was not observed until air pressure differential, reached 540 Pascal (11.29 psf), as shown in Fig. 8. At that 540 Pascal, leakage was observed between the sill pan and the sealant that served (along with backer rod) as the air seal (and the pan back dam) below the window unit's sill. It was noticed that the

1. There was poor interfacial adhesion between the polyurethane hybrid sealant and the flashing topsheet—the sealant could be easily pulled away from the topsheet. This resulted in an insufficient bond to hold water back against the pressure differential (the back dam would leak at the higher differential pressures).
2. Since the leak occurred at the same location as the first test, it was also concluded that the repair “patch” was ineffective.

FIG. 8—Water leak formed at 11.29 psf on FMA/AAMA 100 Wall #1 at interface between sealant and flashing, after 24 hour cure time.

Given the conclusions drawn above, the polyurethane hybrid sealant was removed at the sill area of the installation and a short distance up the jambs and replaced with pure polyurethane sealant. It was known from previous experience that the topsheet of this flashing adhered effectively to pure polyurethane sealants.

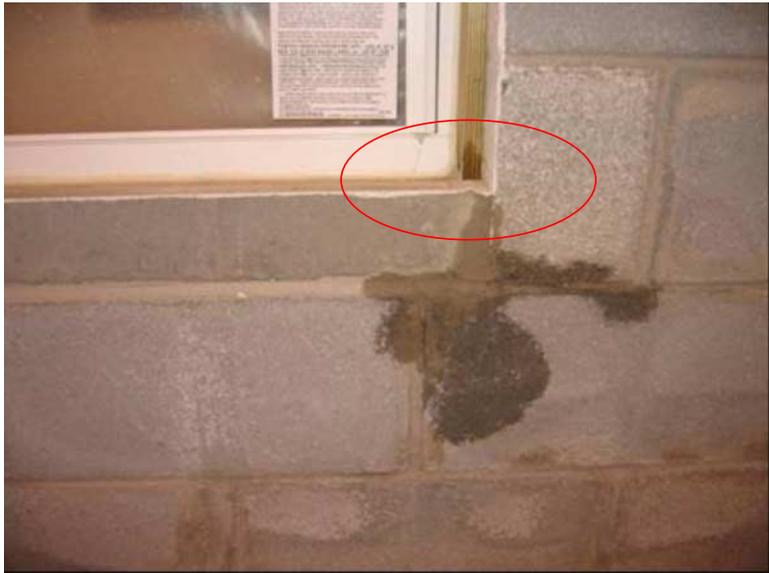
In the first tests performed in early 2007, the window was masked with film. The masking covered the window flanges, including the sill flange. The only interface actually exposed to water spray was the joint between the wood buck and the concrete block wall. Pressure differentials of 145 Pascal (3.13 psf), 290 Pascal (6.2 psf), 440 Pascal (9.2 psf), and 540 Pascal (11.29 psf) were applied. At roughly 290 Pa differential, water seepage was noted at the interior lower corner of the concrete block, as shown in Fig. 10. Water leakage at the lower extremity of the wood buck was also noted (circled in Fig. 10). The test was continued to 1437 Pascal (30 psf) pressure before stopping. Additional leakage locations were not noted at

FIG. 10—Water seepage through concrete block in first FMA/AAMA 200 wall test near lower corner at interior, as well as the lower buck area, as highlighted by the circle.

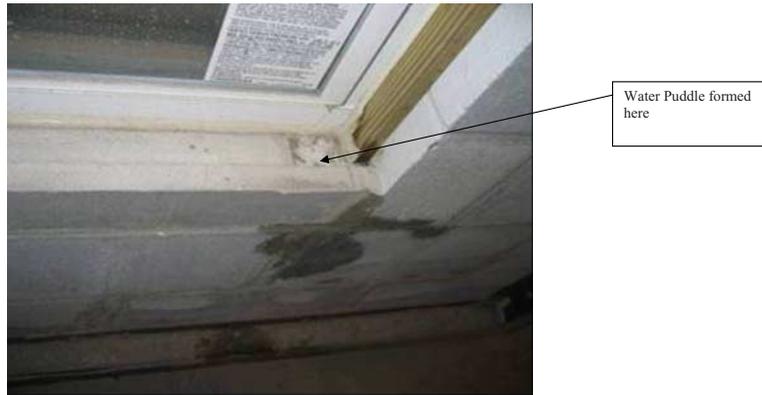
FIG. 11—*FMA/AAMA 200 water test—water puddle formed in lower corner with lower flange open.*

The masking film was removed from the sill flange; this exposed the sill flange and the joint between the sill flange and the concrete sill. The wall was then retested. At 440 Pascal (9.2 psf), a pool of water was noted at the lower corner of the interior on the same side as the leak observed in earlier testing (Fig. 11). Spray testing was suspended and dye tracer was applied to the exterior surface of the assembly around the window perimeter. Dye application was by the same method, described previously, for assemblies conforming with FMA/AAMA 100.

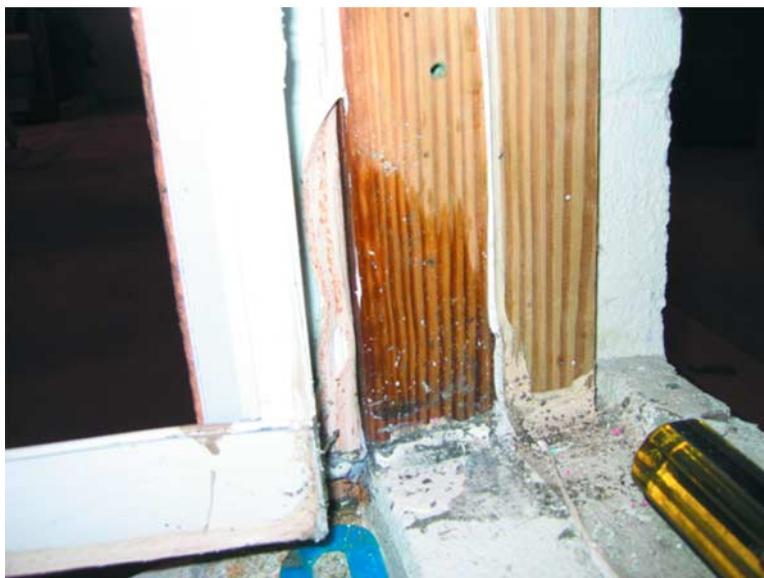
The window was subsequently removed from the assembly. After window removal, it was noted that the lower portion of the wood buck on the left side facing the wall was very wet. It was evident that leakage had occurred at a mortar joint in the vicinity of the wood buck; the water that entered at this location traveled between the buck and the sealed concrete blocks and then penetrated the fillet sealant joint between the wood buck and the block wall. Figure 12 shows the area where the buck was soaked. Figure 13 shows the water path between the buck and the concrete wall, made evident by the blue dye tracer. The sill area of the window was dry, indicating that no water penetrated the open sill region under the flange.

FIG. 12—*FMA/AAMA 200 wall after first test showing leakage at lower wood buck.*

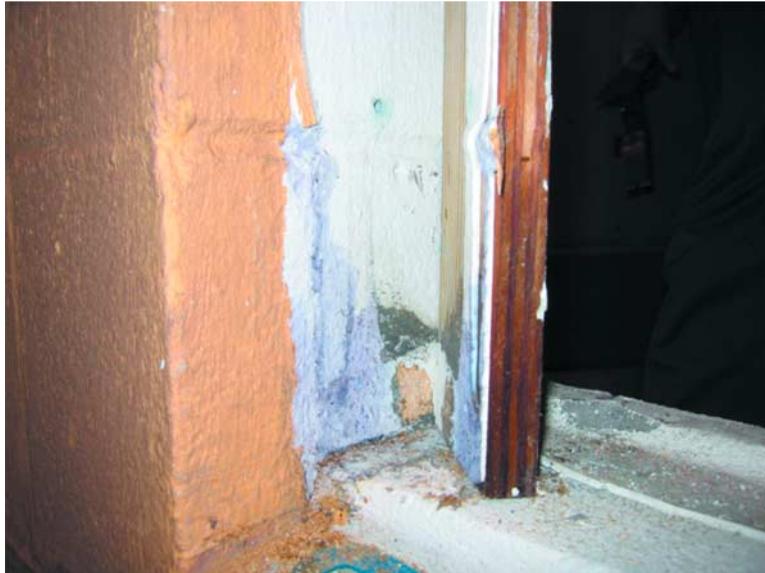
The interface between the wood buck and the sealed concrete block wall had (as described previously) been subjected to a 1437 Pascal (30 psf) pressure differential. Leakage, as described previously, had been observed at pressure differentials below and substantially above the criterion level. The dye tracer had only been applied, however, after the assembly had been exposed to a test pressure well beyond the criterion

FIG. 13—FMA/AAMA 200 wall test indicating path of leakage with blue die entering at mortar joint between sealed concrete block and wood buck, penetrating the sealant.

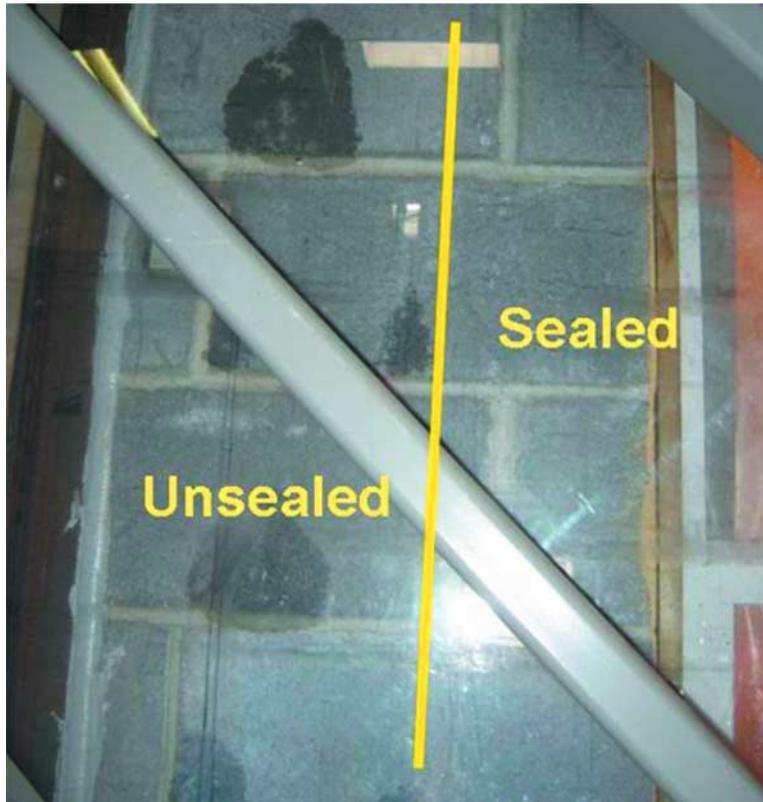
When the masking was removed and the entire CMU wall was exposed to water spray, water seepage to the interior occurred at the lowest pressure differential included in the test protocol (Table 4). Figure 17 shows the water penetration through the interior side of the unsealed area, but not the sealed area of the block. Unsealed portions of the CMU wall system were thus notably incapable of meeting the FMA/AAMA 200 criterion. Additional testing has shown that water seepage through block walls occurs readily in the absence of any air pressure differential. A “whole wall” approach to water management is thus justified. This, incidentally, was recognized in the report (dated January 2005) by Lstiburek [4]. It will be a key challenge for the FMA Installation Committee going forward.

FIG. 17—FMA/AAMA 200 second phase wall test results—water seepage through the internal portion of the block at unsealed area, but not at in the sealed area.
