General
Technical
Report
FPL-GTR-191

Remote Monitoring of Historic Covered Timber Bridges for the Prevention of Arson and Vandalism

February 2010

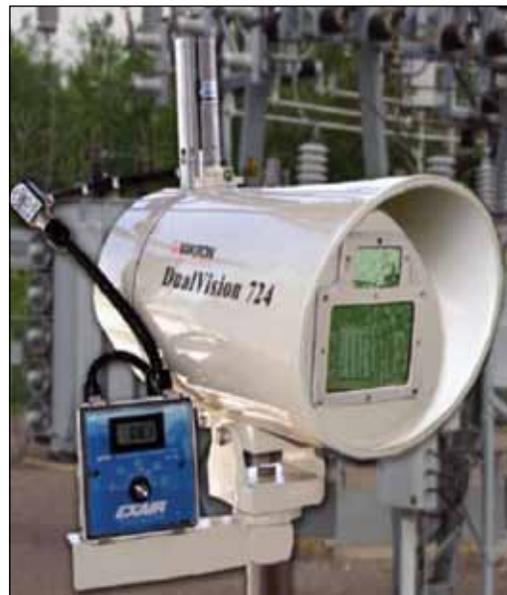
Figure 3. Infrared camera.

demonstrated their camera (Fig. 3) using an online Web link and Company B brought their camera (Fig. 4) to the BEC and provided indoor and outdoor demonstrations of the camera, including a summary of the software available with the camera.

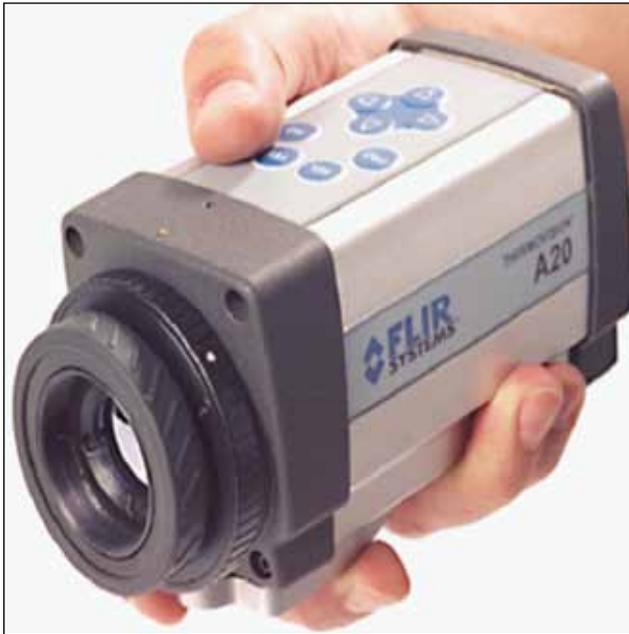
Figure 4. Infrared camera.

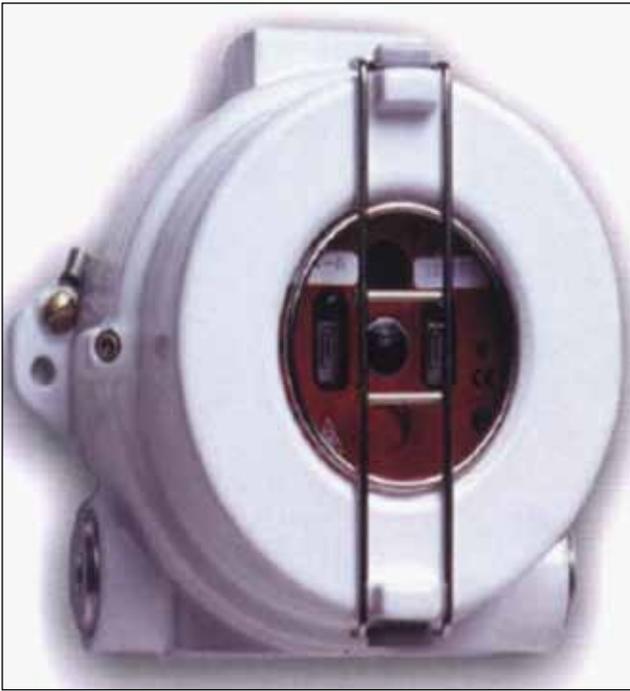
Figure 5. Flame detector.

The flame detector outputs a fault circuit and a fire circuit. Each of these circuits operates in a binary mode and the voltage output by each circuit can be read using a multimeter or by other means. The fault circuit is tripped after the flame detector performs a self-check and finds a problem with its internal operation. The fire circuit is tripped when the unit detects the presence of a fire. To reduce the number of false detections, the unit was programmed to trip the fire circuit only when two of the three wavelength spectra independently identified a positive condition. The output combined with internal redundancy made integration of this sensing system relatively easy while also being very reliable.

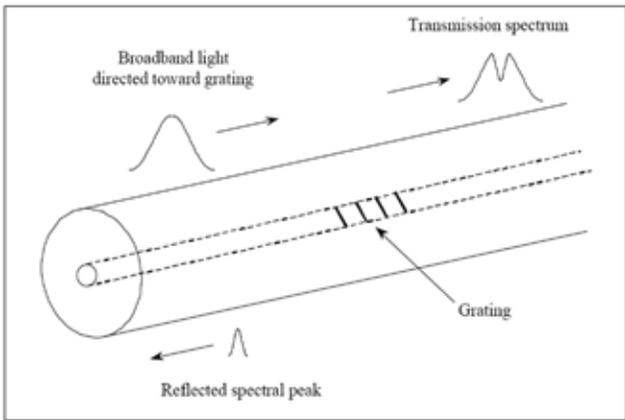
Figure 6. Fiber Bragg grating operation.

A FBG sensor, a specific type of FOS, consists of a series of etched perturbations in the index of refraction along a short length of glass fiber (Figs. 6 and 7). This grating reflects a spectral peak and permits the remainder of the light to be transmitted along the fiber. The reflected spectral peak is based on the grating spacing and, therefore, changes in the length of the fiber (strain) will change the grating spacing and thus the wavelength of light that is reflected back to the source.

The center wavelength of each sensor in a series is spaced such that no signal overlaps between adjacent sensors. The leading end of the chain is connected to a device known as an interrogator, which transmits a pulse of very pure light

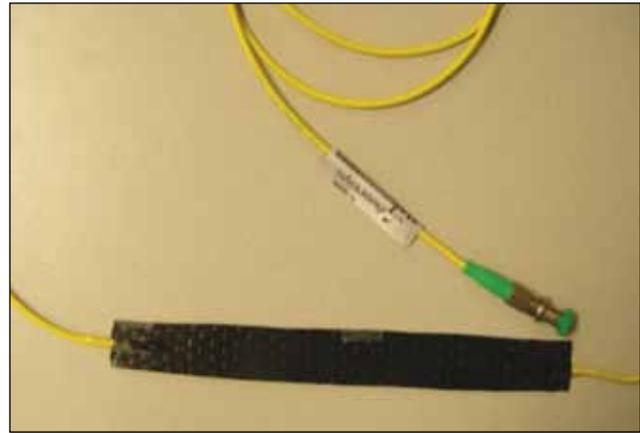
Figure 7. Fiber optic fiber Bragg grating sensor.

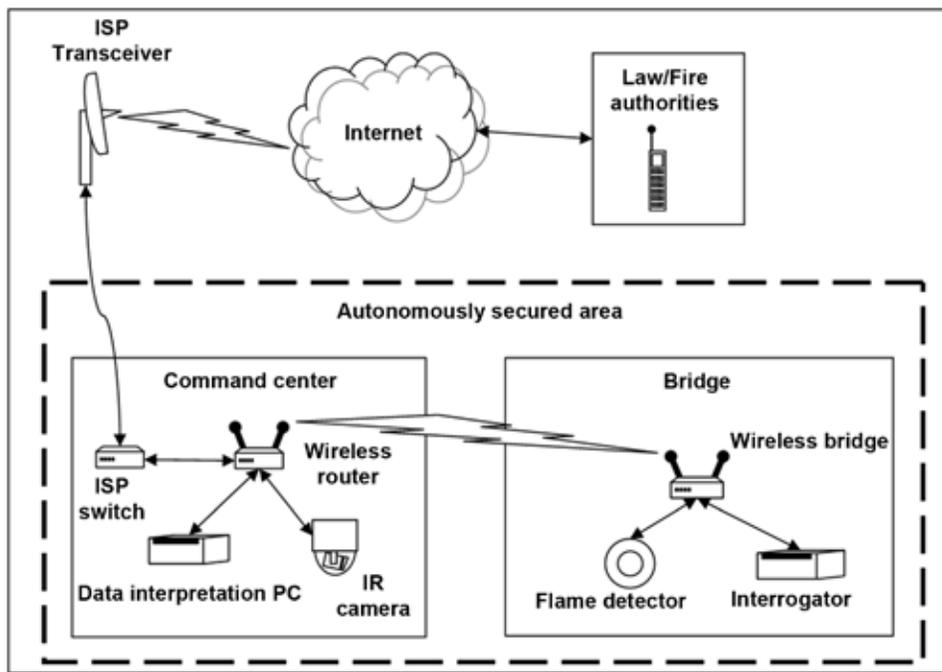
Figure 8. Schematic view of security system layout.

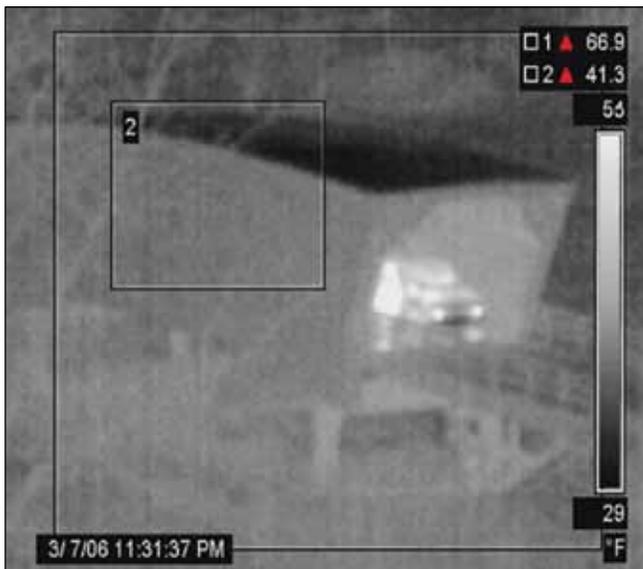
Figure 9. Sample image taken from onsite infrared camera following a person event.

- Main module—manages the inputs and outputs from the other modules. The main module only takes action when a fire, fault, or person event status is reported by one or more of the sensing systems.
- Flame detector module—sends two types of status reports to the main module: fire or no fire, and fault or no fault.
- Interrogator module—sends only one type of event status report to the main module: fire or no fire.
- Infrared module—sends two types of event status reports to the main module: fire or no fire, and person or no person.

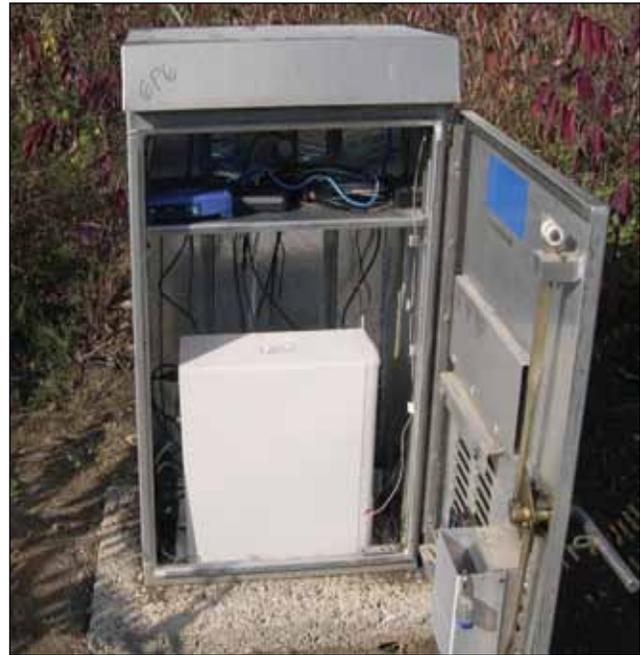
Figure 10. Cabinet installed near utility pole.

- Located beneath the south approach span of the bridge—containing the FOS interrogator, wireless bridge, and the 5-volt power supply and signal conditioners for the flame detector.
- Located near the base of the utility pole—containing the onsite computer and wireless router (Fig. 10).

The cabinets were supported on small, cast-in-place concrete pads and supplied with electrical power through an agreement between Madison County and the Winterset Municipal Utility. The Madison County engineer supplied equipment and labor to excavate a small trench to permit shared electrical power between the cabinets. Unfortunately, the distance between the cabinets prevented the direct connection of computer equipment and components using the same trench. Both enclosures were equipped with a heater and a fan to help control the temperatures within the cabinets. The two enclosures were purchased for approximately \$800 each and were installed in summer 2005.

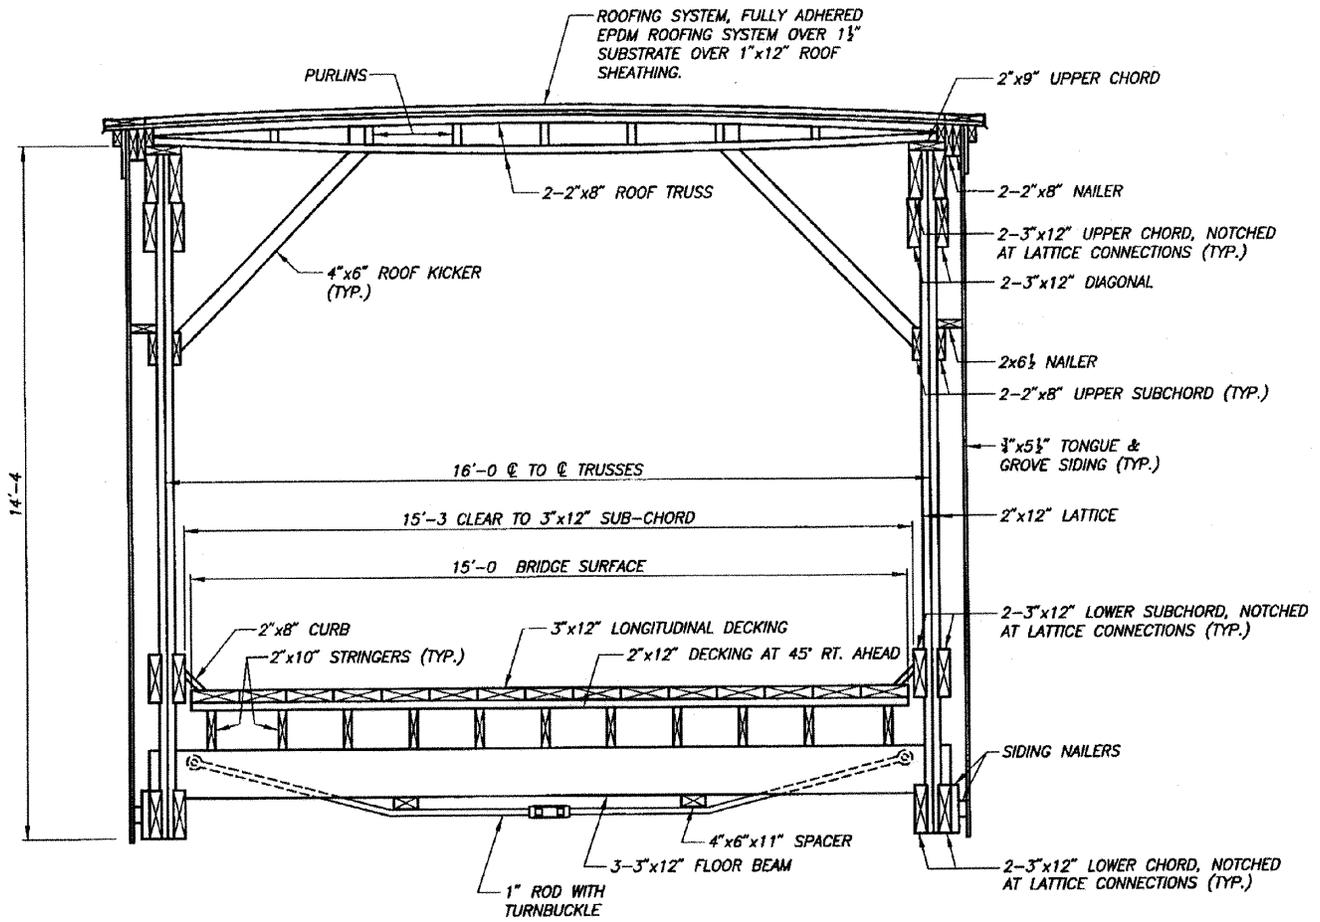
Figure 11. Section view of bridge showing original and revised location of flame detector.

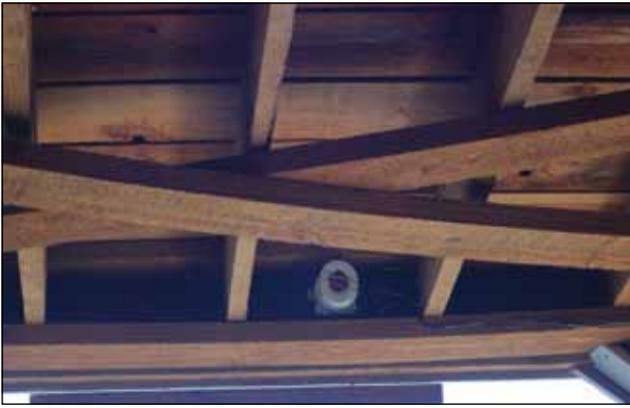
Figure 12. Original location for flame detector above south portal.

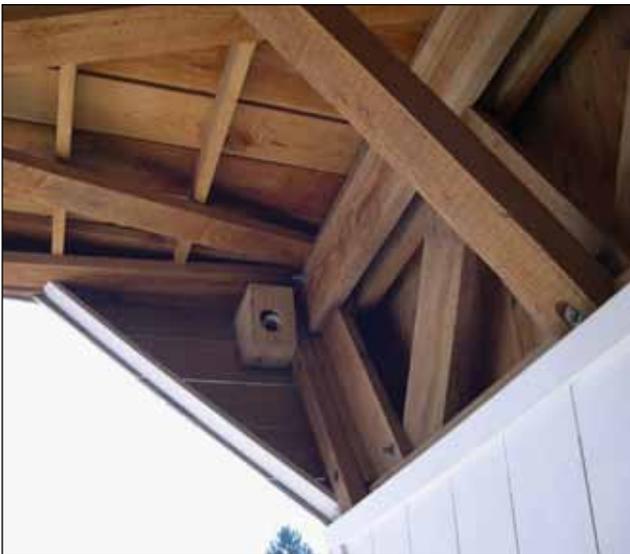
Figure 13. Flame detector installed near southwest portal of bridge.

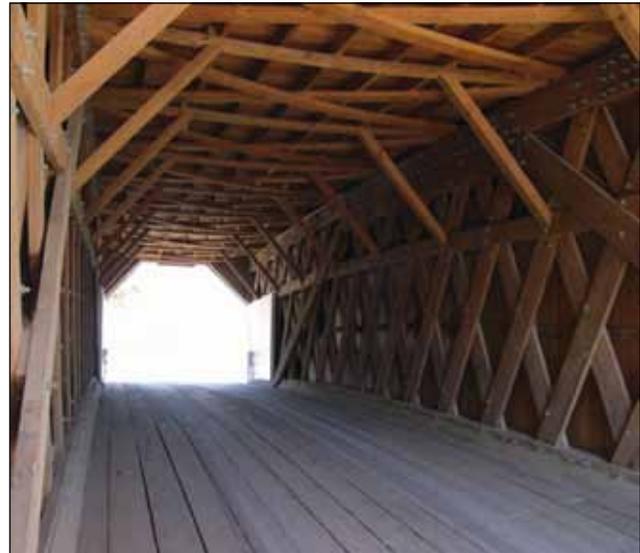
Figure 14. View of flame detector slightly obscured by roof kicker members.

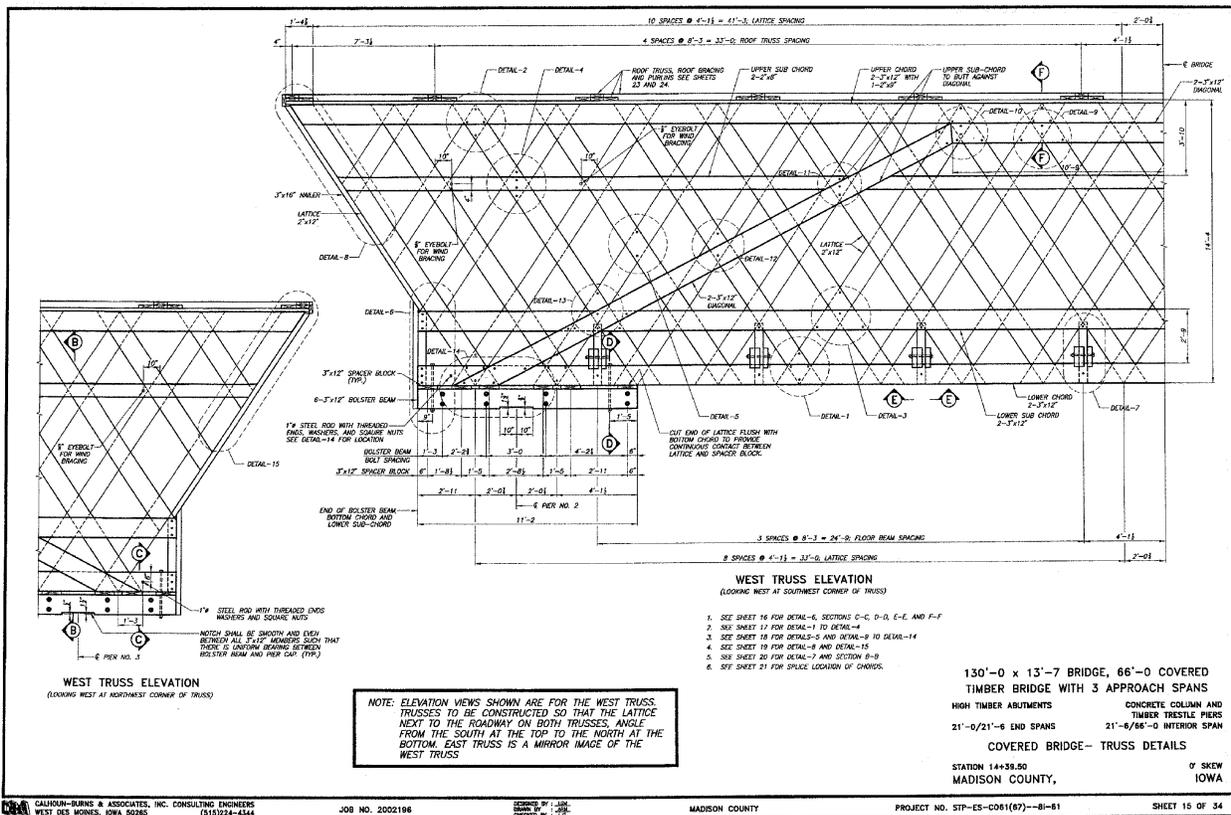
Figure 15. Truss elevation showing fiber optic sensor locations.

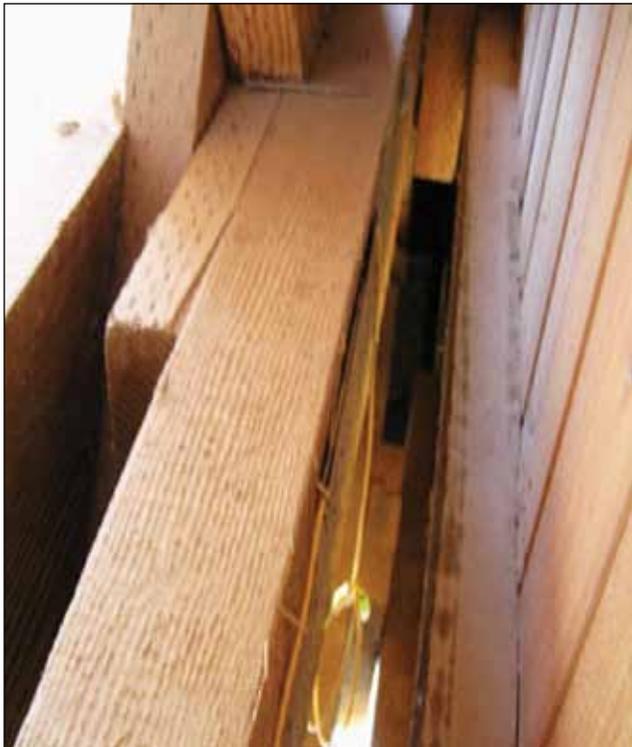
Figure 16. Installation of fiber optic sensors behind truss members.

Although precautions were taken to conceal the wires during installation, one series of six sensors (along the east truss) were disabled by an unknown person during the early months of 2006 (Figs. 16 and 17). The glass fiber within each patch cord is protected by a thin layer of Kevlar within the outer jacket, so it takes considerable effort to cut one of these fibers, which makes it unlikely that this damage was caused by any accidental event. Loss of the fiber was reported as an “event.”

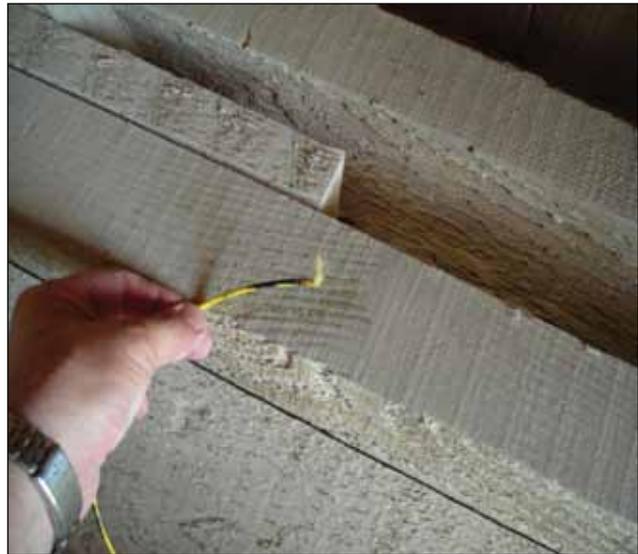
Figure 17. Fiber optic sensor series damaged by possible vandalism.

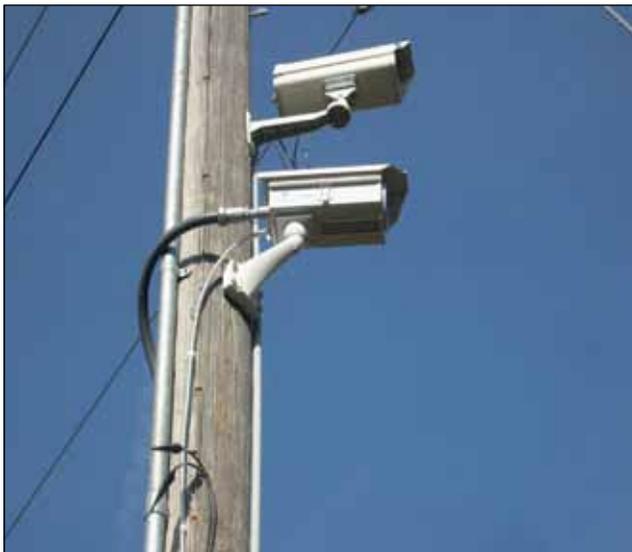
Figure 18. Infrared camera (bottom camera) and web-based video camera (top camera) attached to utility pole.

The camera enclosure was installed approximately 25 ft above the ground on the previously mentioned utility pole (Fig. 18). The infrared camera was aligned to view the entire bridge site including the approach roadway on both ends of the bridge. Unfortunately from this vantage point, a single mature tree created a significant viewing obstruction during

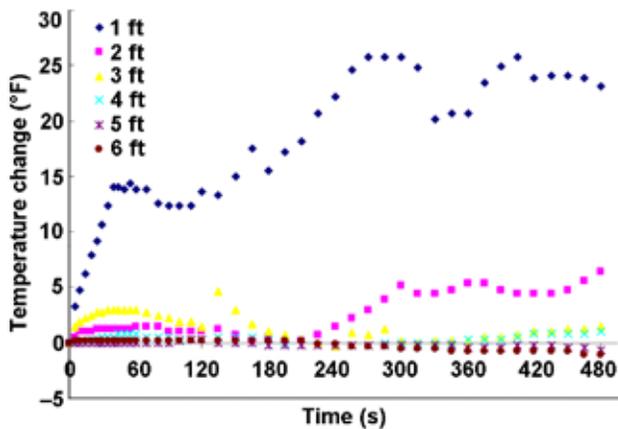
Figure 19. Fiber optic sensor sensitivity to pan fire.

From these test results, it is evident that the fiber optic sensor was not able to record any significant temperature changes from the pan fire beyond approximately 2 ft. However, since the installation location on the actual bridge will

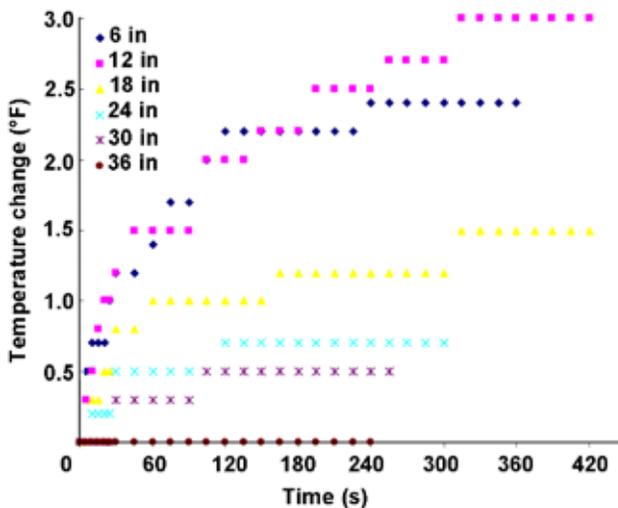
Figure 20. Fiber optic sensor sensitivity to propane torch.

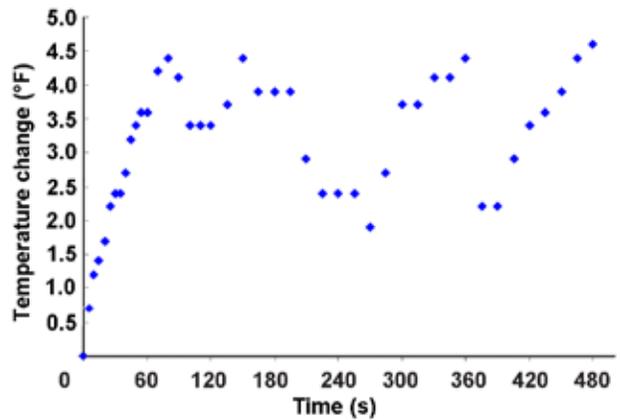
Figure 21. Fiber optic sensor sensitivity to pan fire with wood shielding.

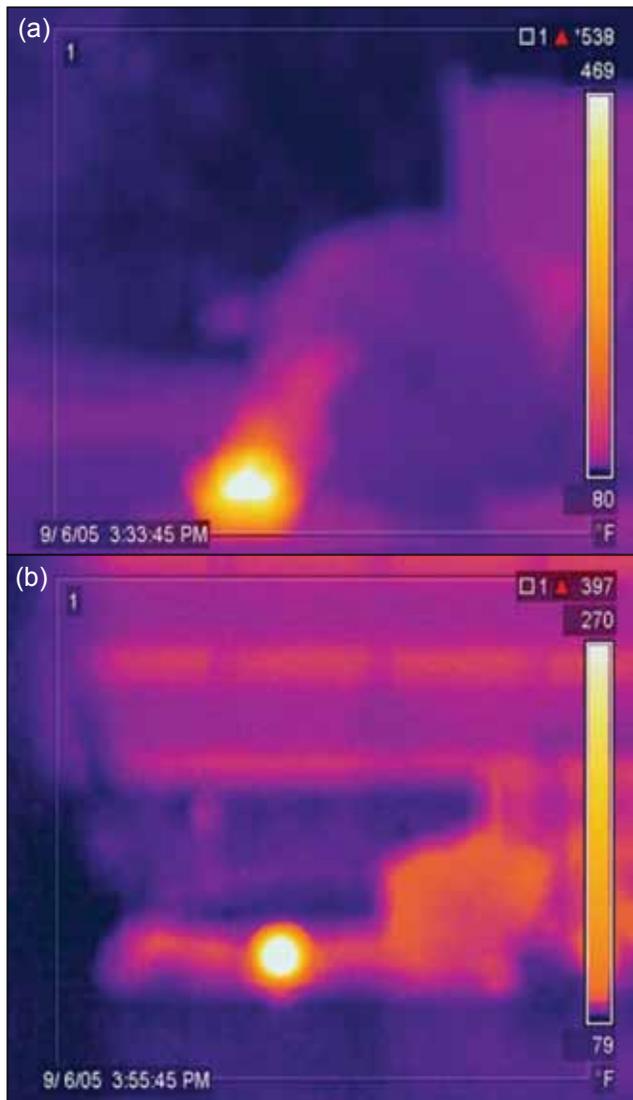
Figure 22. Infrared photo—pan fire with a) fire located 30 ft from camera and b) fire located 100 ft from camera.

Subsequent analysis of the infrared images from both the lighter tests and the pan fire tests indicate that the IR camera is able to detect temperatures very close to the actual fire temperatures almost immediately. A sample of the IR camera images recorded is presented in Figures 22 and 23.

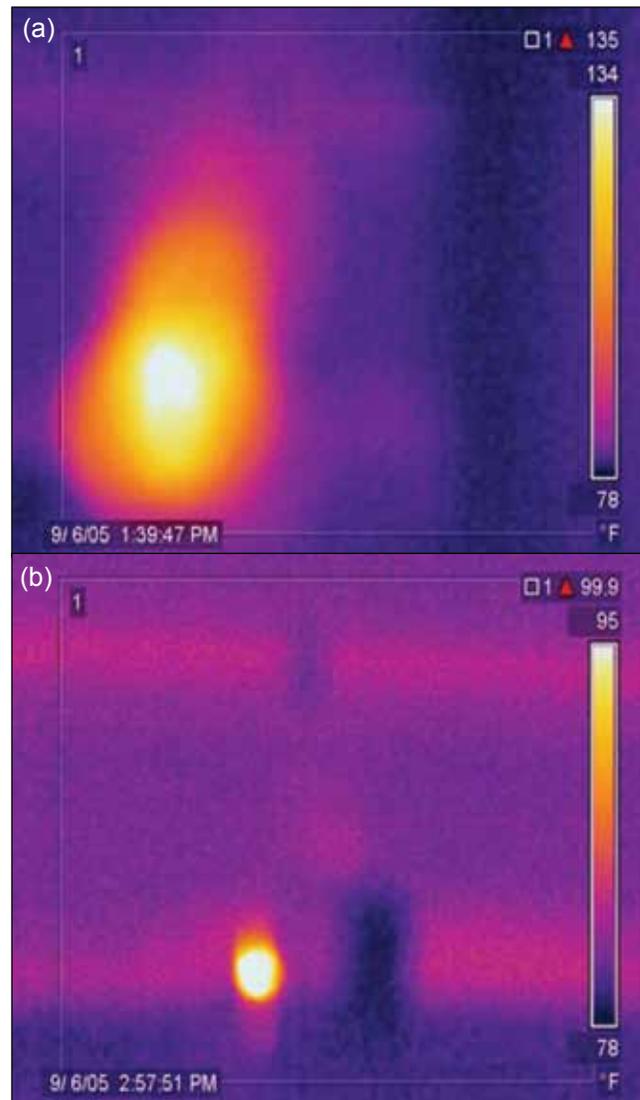
Figure 23. Infrared photo—butane lighter with a) fire located 2 ft from camera and b) fire located 20 ft from camera.

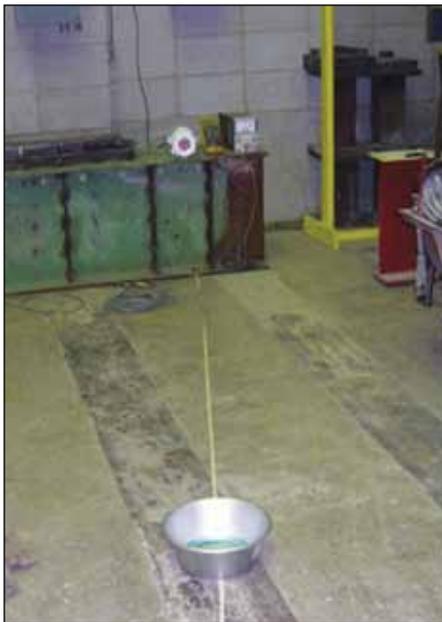
Figure 24.
Laboratory
setup for flame
detector tests.

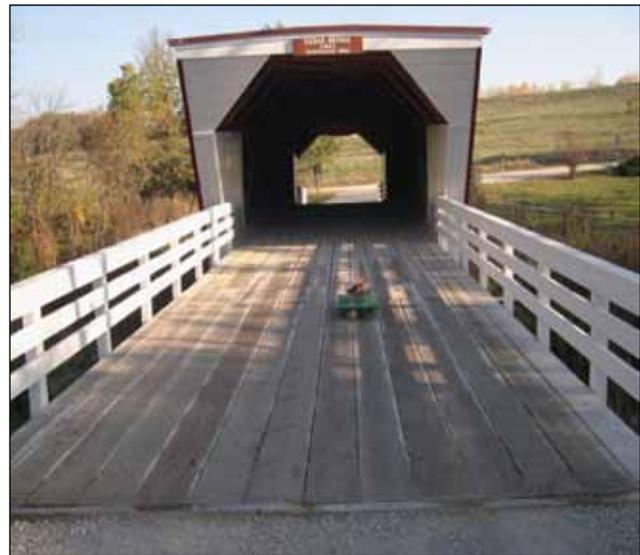
Figure 27. Pan fire test on south bridge approach span.

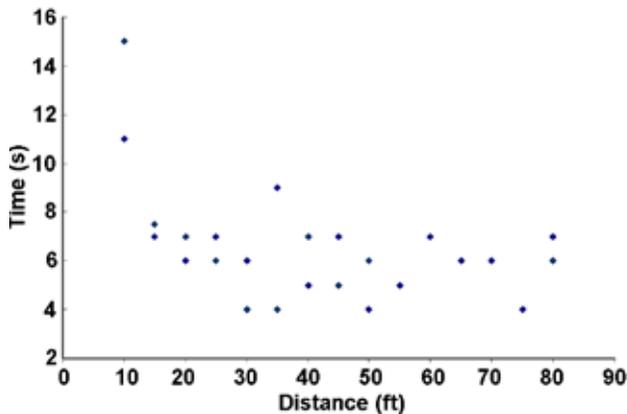
Figure 25. Flame detector sensitivity to pan fire.

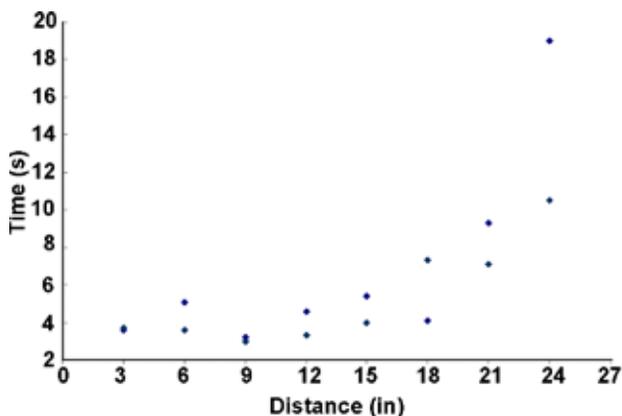
Figure 26. Flame detector sensitivity to butane lighter.

was located at distances from 3–24 in. from the source. Beyond this distance, the sensor could no longer detect the flame within 5 min. The results of these tests are shown in Figure 26.

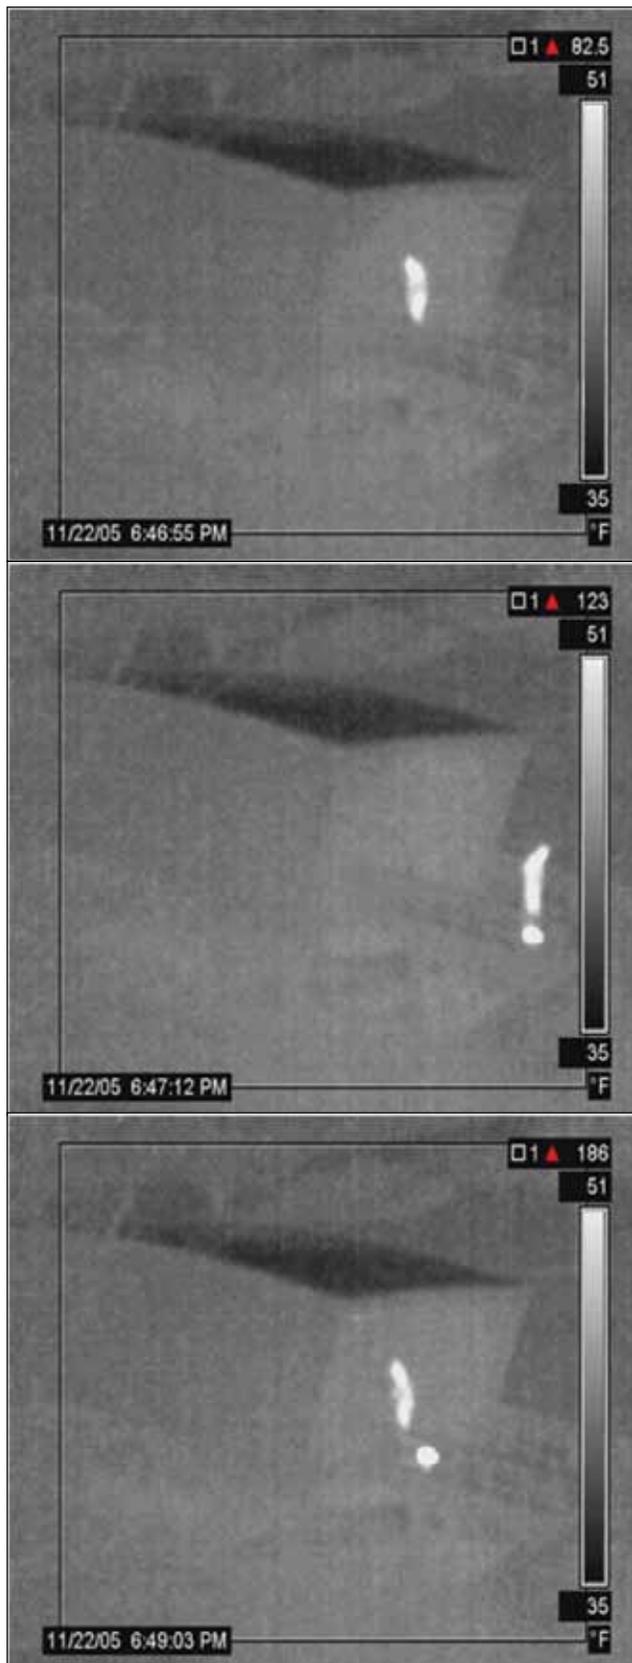
Figure 28. Infrared photos—onsite system evaluation of a) person only, b) person and initial fire, c) person and fire after 2 min.

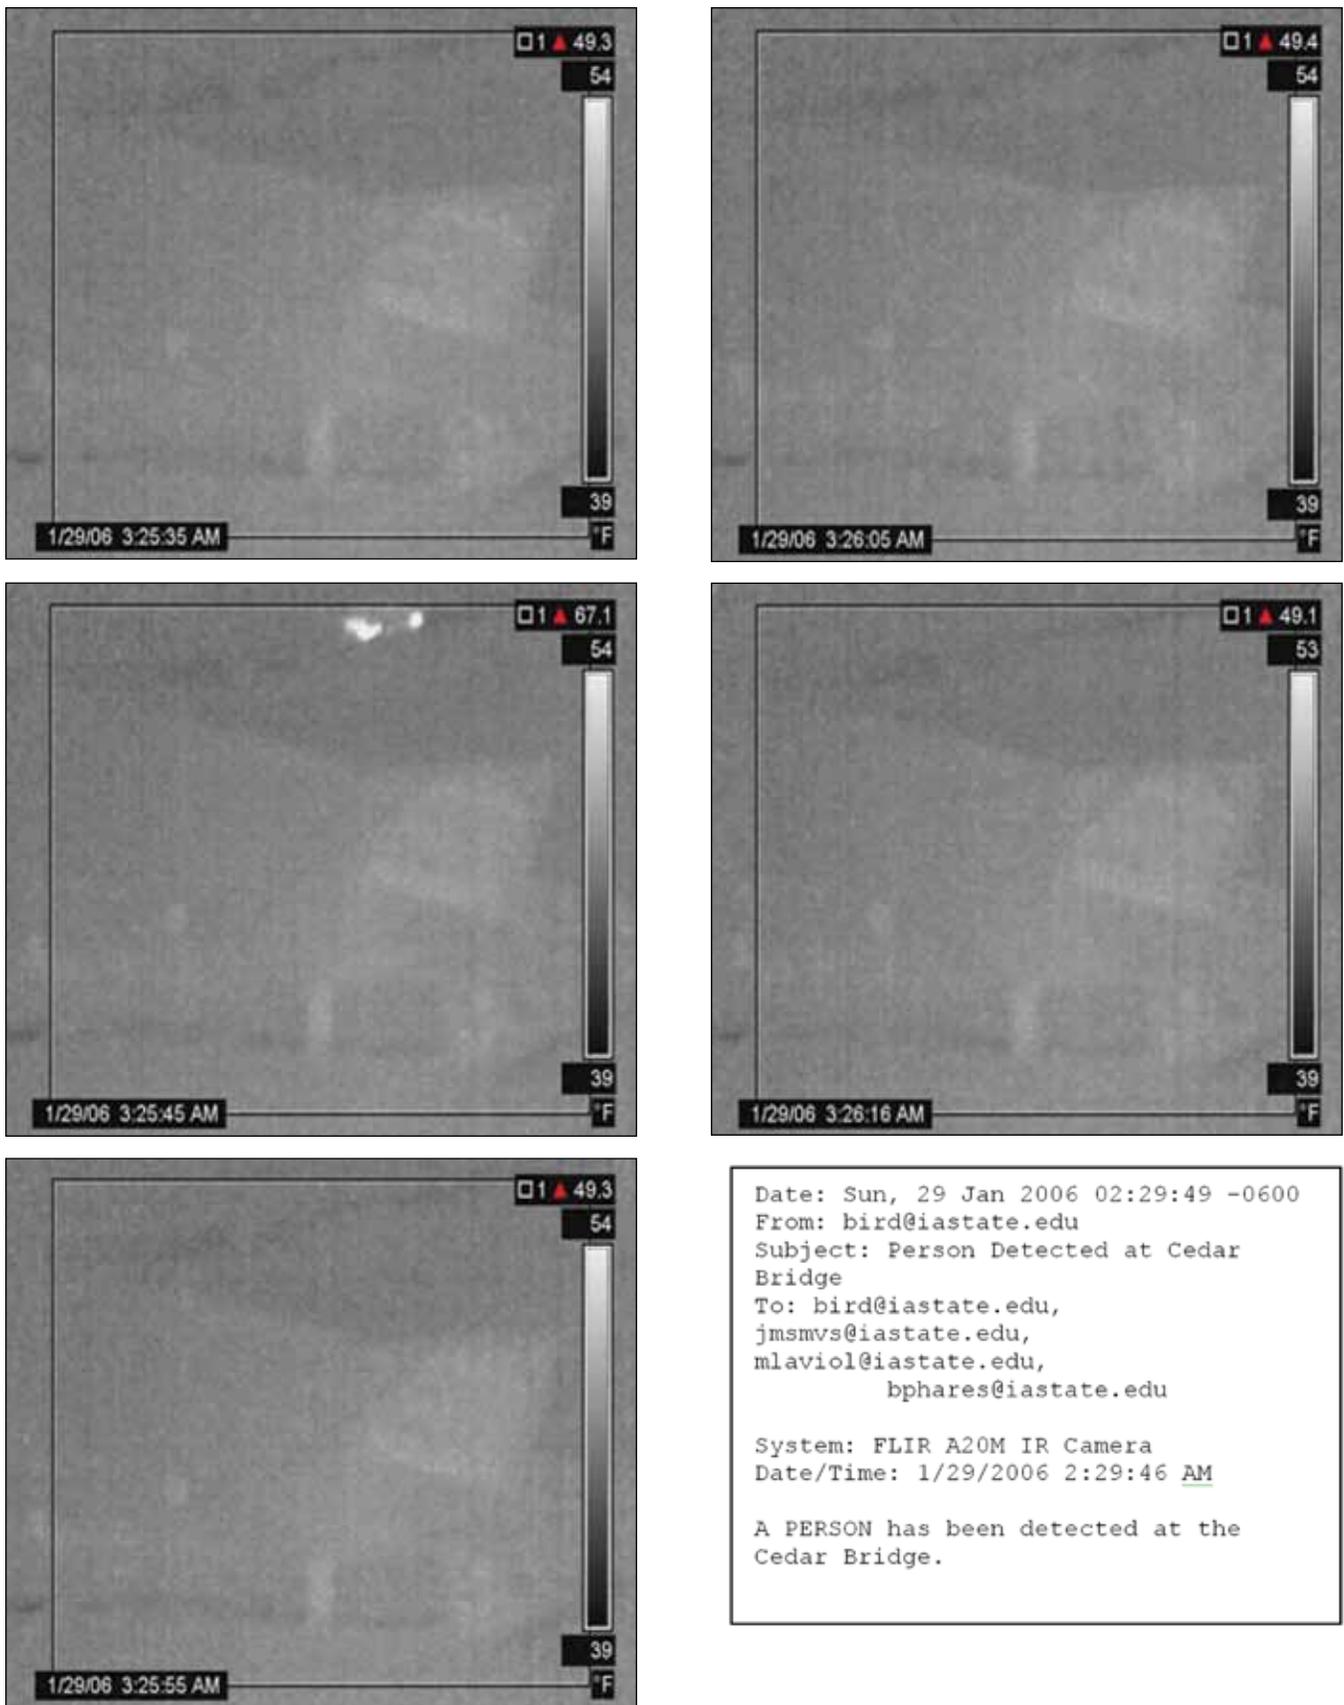
Figure A-1. Event 1—Person detected at Cedar Bridge (1/29/06, 2:29 a.m.) a. Image 1, b. Image 2, c. Image 3, d. Image 4, e. Image 5, f. E-mail notification.

Event number	Date	Time	Type	True/False
1	01/29/2006	2:29:46 a.m.	Intruder	True
2	03/03/2006	10:07:33 p.m.	Intruder	True
3	03/07/2006	10:40:13 p.m.	Intruder	True
4	03/11/2006	9:04:21 p.m.	Intruder	True
5	04/19/2006	2:57:57 p.m.	Fire	False
6	04/27/2006	9:10:14 a.m.	Fire	False
7	05/04/2006	10:27:45 a.m.	Fire	False
8	05/24/2006	7:41:38 a.m.	Fire	False
9	06/16/2006	4:10:32 a.m.	Intruder	False

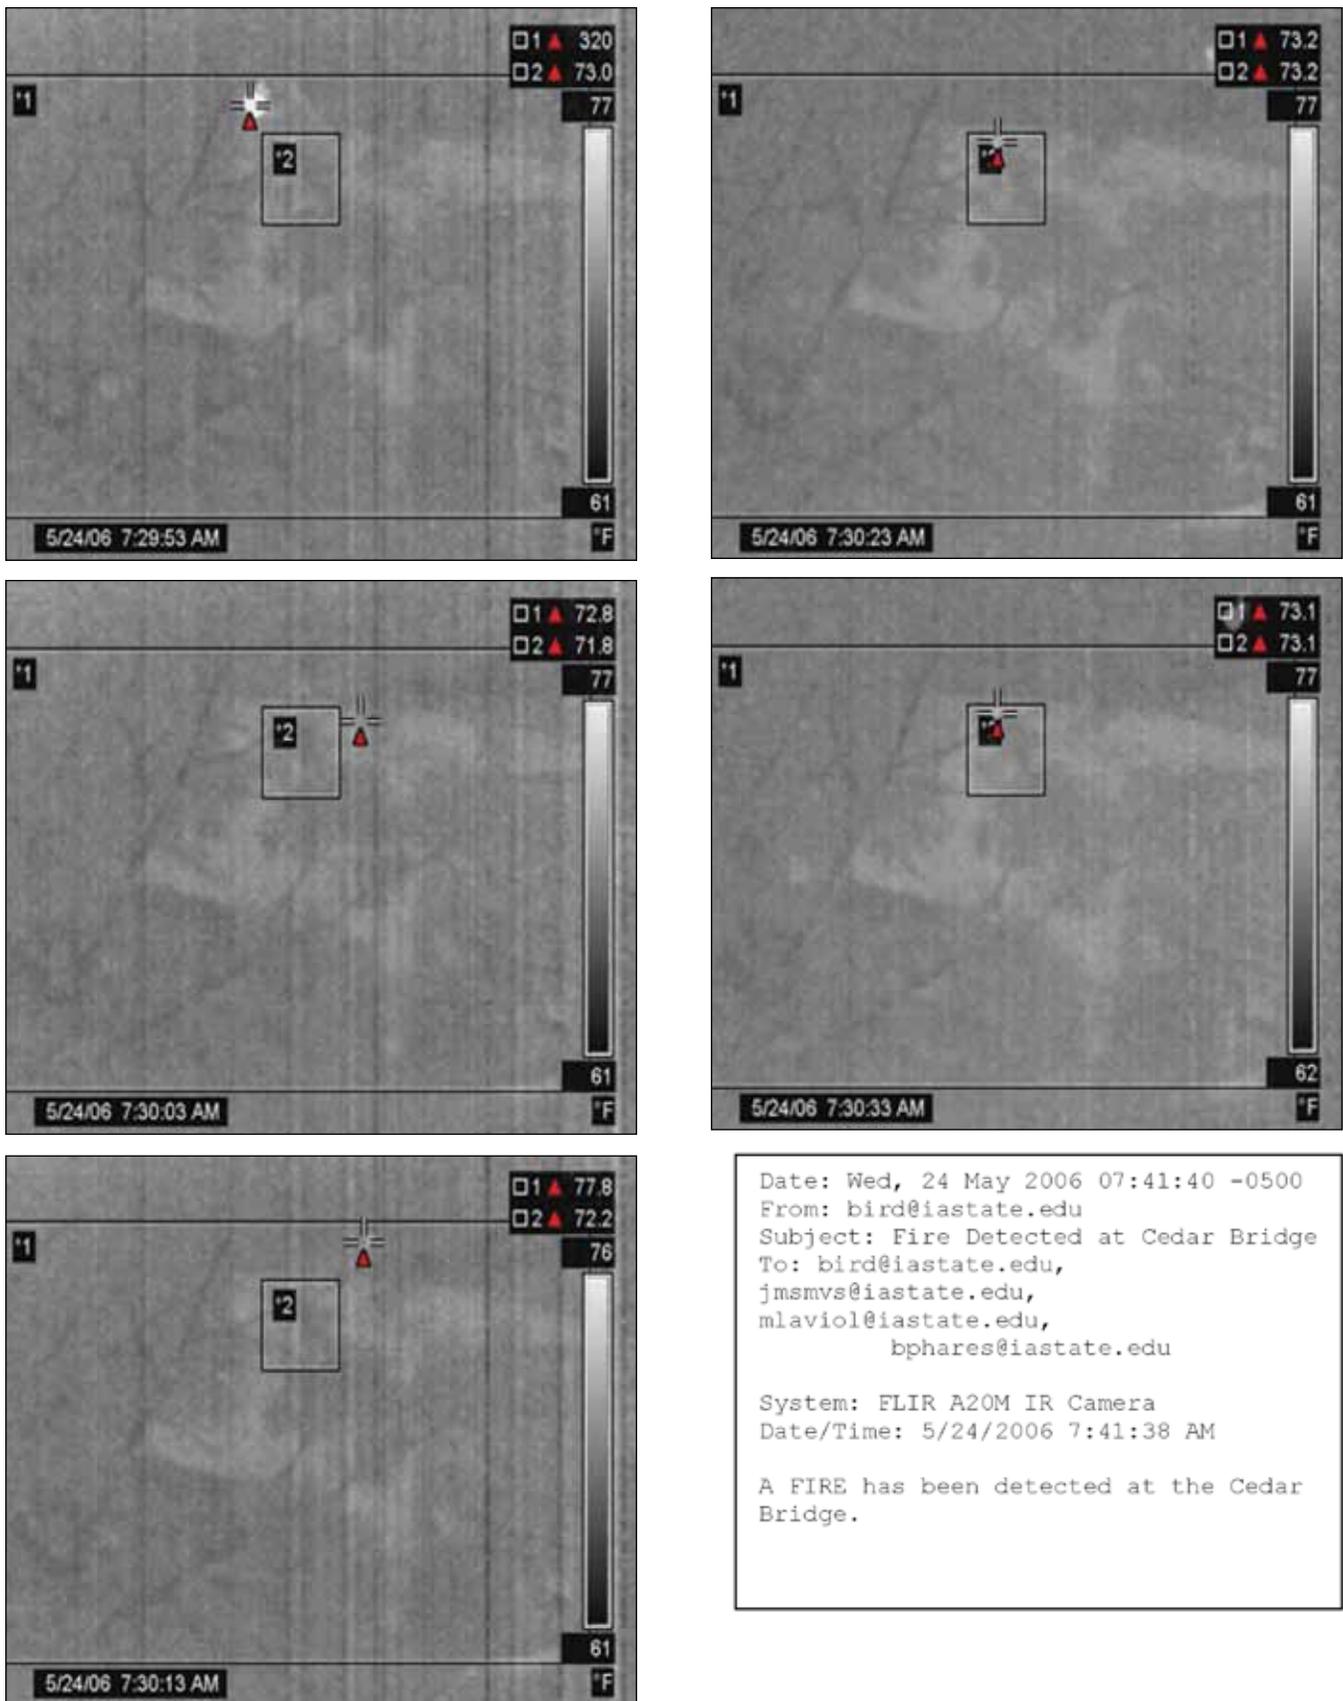
Figure A-8. Event 8—Fire detected at Cedar Bridge (5/24/06, 7:41 a.m.) a. Image 1, b. Image 2, c. Image 3, d. Image 4, e. Image 5, f. E-mail notification.
