# Attic and Crawlspace Ventilation: Implications for Homes Located in the Urban-Wildland Interface

*Stephen L. Quarles and Anton TenWolde*

# **Woodframe Housing Durability and Disaster Issues**

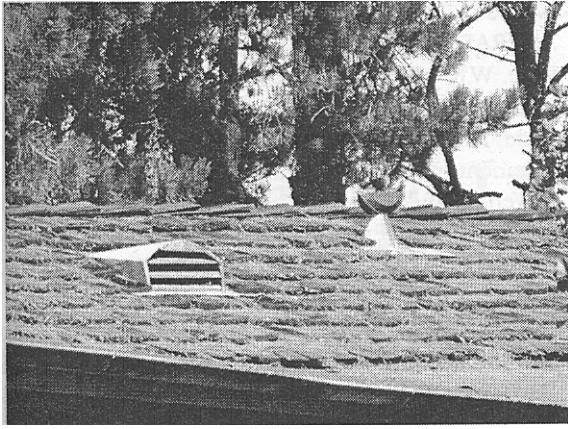
**Figure 7.** ~ An example of a dormer-type through roof vent that would be vulnerable to both wind-driven rain and flames and embers from a wildfire. Debris from nearby pine trees and the untreated shake roof also pose significant problems for this structure.

In some high wildfire hazard areas, soffit and eave vents are being eliminated, sometimes without consideration to the potential negative impact on the moisture management function of the vent. Where applicable, vents are selectively eliminated, for example only on the side where the wildfire would most likely approach. In some cases, soffit and eave vents are being converted to through roof vents, on the lower slope of the roof (**Fig. 6**). Some existing through roof vents can be vulnerable to both rain (particularly wind-driven rain) and flame and ember entry (**Fig. 7**).

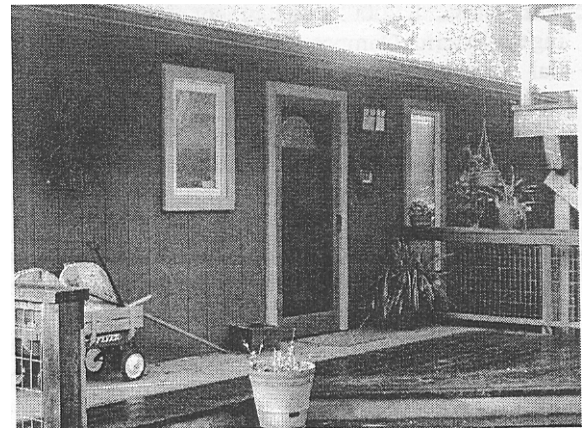
**Figure 8.** ~ Wide overhangs on this structure protect the cladding and penetrations (windows and door) from rainfall. Note the dry deck boards near the house, and the wet deck boards away from the house.
