## FIELD INVESTIGATIONS OF HISTORIC COVERED TIMBER BRIDGES IN THE USA

**ABSTRACT:** The Federal Highway Administration is sponsoring a comprehensive research program on Historic Covered Timber Bridges in the USA. This national program's main purpose is to develop improved methods to preserve, rehabilitate, and restore the timber bridge trusses that were developed during the early 1800s, and in many cases are still in service today. The overall goal of the National Historic Covered Bridge Preservation Program is to preserve these iconic bridge structures for future generations. One of the many ongoing studies is aimed at establishing a procedure for safely and reliably load-rating historic covered bridges through physical testing. This paper will provide an overview of the field testing methods, results, and finite element modeling procedures and briefly discuss the load rating procedures to be developed based on the testing results.

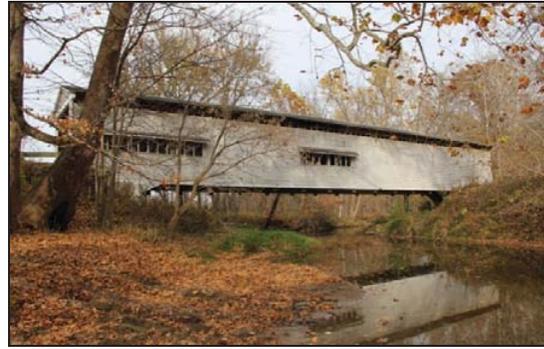
**Figure 1:** Profile view of the Portland Mills Bridge

The Portland Mills Bridge (County Bridge No. 155) is located on an unpaved road, County Road 650, and allows for vehicular traffic to cross the Little Raccoon Creek as illustrated in Figures 1, 2, and 3. The original structure was built by Henry Wolfe in 1856 and crossed the Big Raccoon Creek in Portland Mills, but was moved to its current location in 1961. In 1991, new transverse glued-laminated timber floor beams and a new roof were installed along with further rehabilitation efforts to bring it back to original condition by 1996.

The bridge is a single-lane, single-span, simply supported double Burr-arch truss. The truss consists of two rectangular parallel bottom chord members with six stop-splayed splice joints per truss, double concentric arches enclosing the truss, one-member upper chords with four stop-splayed splice joints per truss, one-member diagonals and one-member verticals (see Figure 4). The total length of the structure is 36.7 m (120.5 ft.) and is currently posted for a 14.3-t (13-ton) load limit.

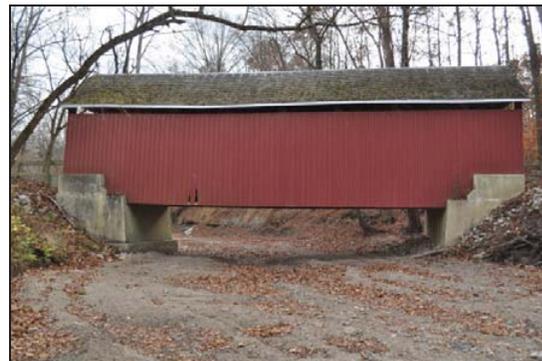
**Figure 9:** Profile view of the Zacke Cox Bridge

The Zacke Cox Bridge is located on Tickbridge Road in Parke County, Indiana, and allows vehicular traffic to cross Rock Run Creek. Elevation and end view photographs of the bridge are shown in Figures 9, 10, and 11.

The Zacke Cox Bridge was originally built by Joseph A. Britton in 1908 and rehabilitated in 1989, 1991, and 2002. The structure is a one-lane, single-span, simply supported double Burr-arch truss with a total length of 15.4 m (50.4 ft.). The truss consists of rectangular parallel chords, concentric arches enclosing the truss, two member lower chords with single headed hook fishplate and iron shoe splice joints, one-member upper chords, one-member diagonals and one-member verticals and is currently rated and posted for a 14.3-t (13-ton) load limit. The truss configuration for the Zacke Cox Bridge is illustrated in Figure 12.

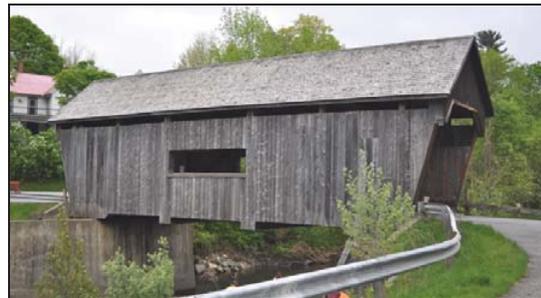
**Figure 13:** Profile view of the Warren Bridge

The Warren Bridge is located in the Town of Warren and allows town traffic to cross Mad River to access Hwy 100 and is shown in Figures 13 and 14.

simply supported Queen Post truss with a total length of 17.7 m (58 ft.). The truss consists of rectangular parallel chords, one-member lower chords, one-member upper chords, one-member diagonals and one-member verticals with no diagonal bracing, struts or counter braces. The structure is currently rated and posted for an 8.8-t (8-ton) load limit. The total height from the bottom of the bottom chord to the top of the top chord was measured to be 4.5 m (14.6 ft.) with an average truss panel spacing of 4.3 m (14 ft.). The truss configuration for the Warren Bridge is illustrated in Figure 16.

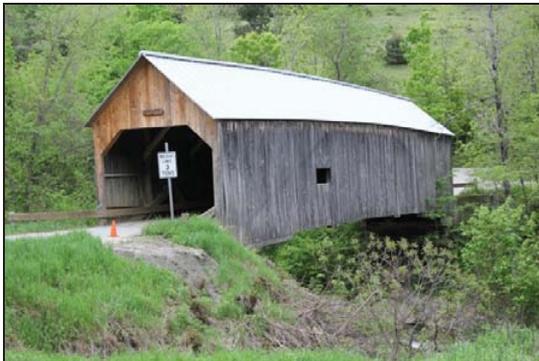
**Figure 17:** Profile view of the Flint Bridge

The Flint Bridge, shown in Figures 17, 18, and 19, is located north of the Town of Tunbridge, Vermont, and allows vehicular traffic to cross the White River.

The Flint Bridge was originally built in 1845. The structure is a one-lane, single-span, simply supported Queen Post truss with a total length of 27.1 m (89 ft.). The truss consists of rectangular parallel chords, one-member lower chords, one-member upper chords, one-member diagonals, and one-member verticals and is currently rated and posted for a 3.3-t (3-ton) load limit. Aside from the two Queen Posts; all verticals for the Flint Bridge were iron rods, all other members were solid sawn timber. The truss configuration for the Flint Bridge is illustrated in Figure 20. The total height from the bottom of the bottom chord to the top of the top chord was measured to be 4 m (13.3 ft.).

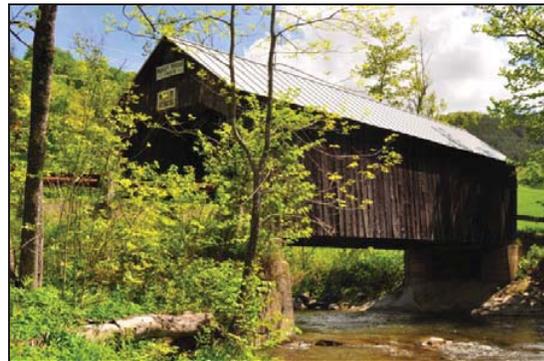
**Figure 21:** Profile view of the Moxley Bridge

The Moxley Bridge is located approximately 0.5 mile north of the Flint Bridge near Chelsea, Vermont, and also allows vehicular traffic to cross the White River as shown in Figures 21, 22, and 23.

The Moxley Bridge was originally built in 1883. The structure is a one-lane, single-span, simply supported Queen Post truss with a total length of 18.6 m (61 ft.). The truss consists of rectangular parallel chords, one-member lower chords, one-member upper chords, one-member diagonals, and one-member verticals and is currently rated and posted for a 4.4-t (4-ton) load limit. The truss configuration for the Moxley Bridge is illustrated in Figure 24. The total height from the bottom of the bottom chord to the top of the top chord was measured to be 4 m (13.3 ft.) with an average truss panel spacing of 4.6 m (15.25 ft.).

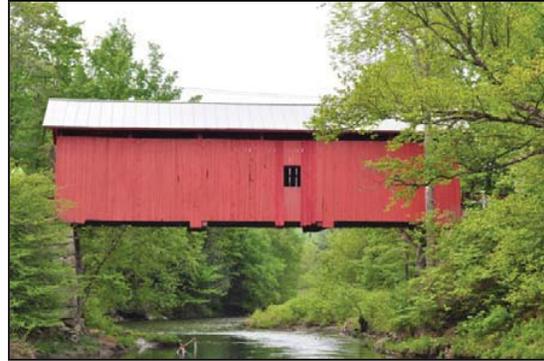
**Figure 25:** Profile view of the Slaughterhouse Bridge

The Slaughterhouse Bridge allows vehicular traffic to cross Dog River near the town of Northfield, Vermont, and is as shown in Figures 25, 26, and 27.

The Slaughterhouse Bridge was originally built in 1872. The structure is a one-lane, single-span, simply supported Queen Post truss with a total length of 20.1 m (66 ft.). The truss consists of rectangular parallel chords, one-member lower chords, one-member upper chords, one-member diagonals, and one-member verticals and is currently rated and posted for an 8.8-t (8-ton) load limit. The truss configuration for the Slaughterhouse Bridge is illustrated in Figure 28. The total height from the bottom of the bottom chord to the top of the top chord was measured to be 3.7 m (12.25 ft.) with an average truss panel spacing of 3.7 m (12.25 ft.).

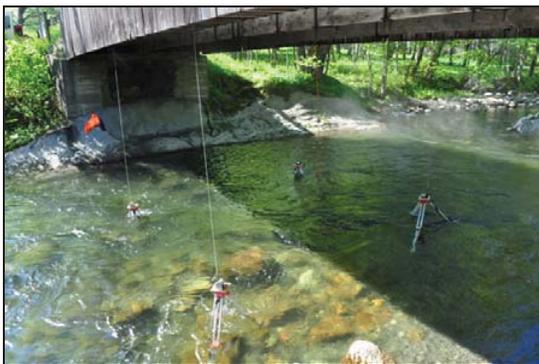
Global displacements of the structure, specifically the trusses, were measured at three locations on each truss: midspan, and at the location of both bottom chord splices. These displacements were recorded with ratiometric displacement transducers mounted on tripods connected to the bridge via aircraft grade steel cable extensions and recorded with an Optim Megadac data acquisition system (DAS) along with a Dell laptop computer running software. Figure 29 illustrates a typical setup for the measurement of global deflection.

**Figure 29:** Typical instrumentation setup for covered timber bridge global deflection measurement

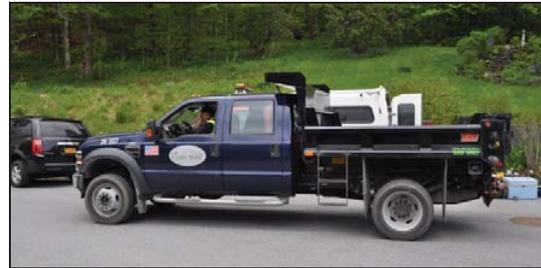
Loading for the Flint Bridge was a Ford F-450 flatbed pickup, shown in Figure 30. The total vehicle weight of the F-450 was 4,726 kg (10,420 lb.), rear axle weight was 2,595 kg (5,720 lb.), and the front axle weight was 2,132 kg (4,700 lb.), as illustrated in Figure 31. The axle spacing for the truck was 4.5 m (14.6 ft.), and the wheel base was 1.9 m (6.25 ft.). Because of the limited roadway width, only one load case was investigated, and involved the load truck straddling the center line along the bridge length. For all runs the load truck travels across the bridge at a crawl speed, or approximately 4.8–8 km/h (3–5 mph) and travels from East to West.

**Figure 30:** Ford F-450 flatbed truck used for load testing the Flint Bridge
