General
Technical
Report
FPL-GTR-222

Evaluation of the High-Heel Roof-to-Wall Connection with Extended OSB Wall Sheathing

Andrew DeRenzis
Vladimir Kochkin
Xiping Wang

A recently completed testing project conducted to evaluate optimized structural roof-to-wall attachment solutions demonstrated the effectiveness of wood structural panels in restraining high-heel trusses against rotation. This study was designed to further evaluate the performance of OSB wall sheathing panels extended over the high-heel truss in resisting combined uplift and shear forces. Five full-size roof-wall assemblies were constructed with extended OSB wall sheathing and each was tested under a different loading combination. Our test results indicate that using extended wood structural panel wall sheathing as the primary connection element at the roof-to-wall interface of energy trusses can provide a continuous load path in both the shear and uplift directions and can be considered a viable option for residential construction in most areas of the country.

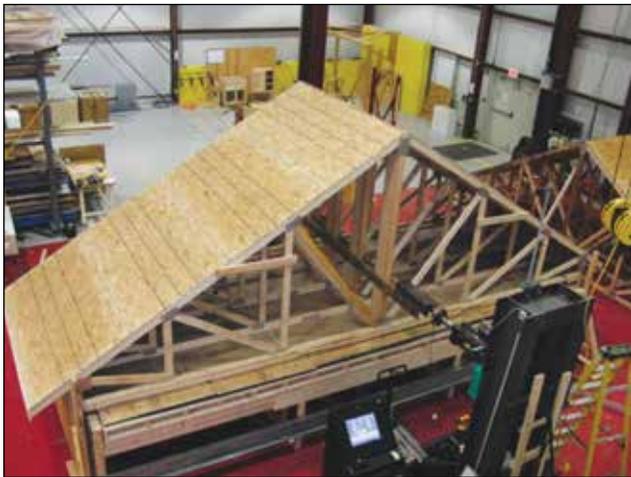
**Figure 1. Test specimen and set-up.**

capture the energy truss heel. Figure 1 shows a photo of a specimen and set-up.

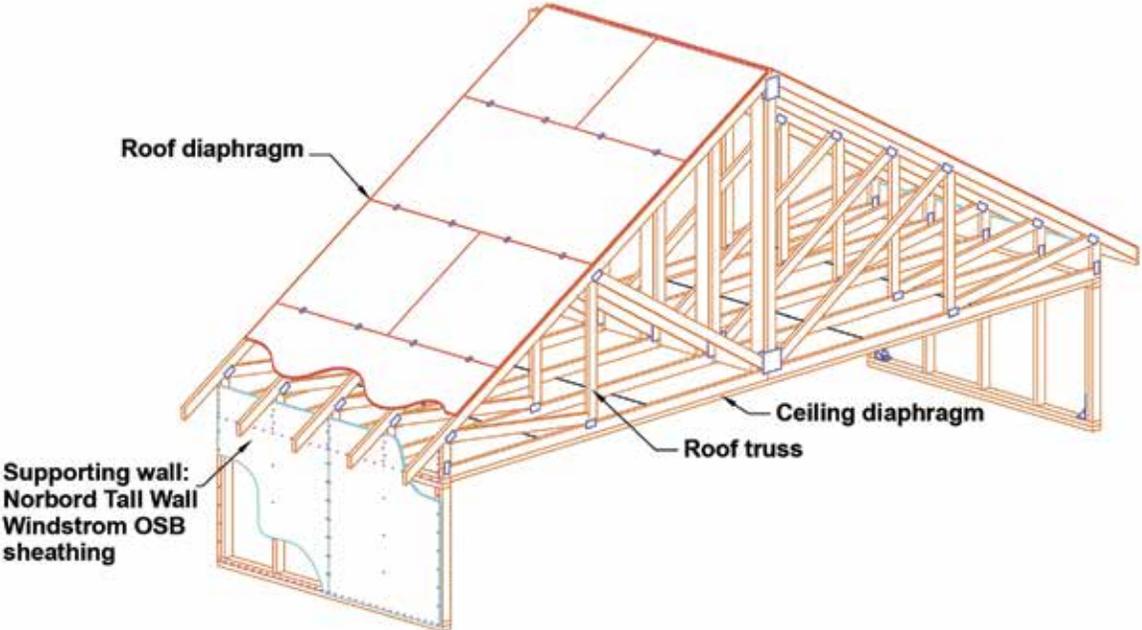
Tables 2 and 3 provide summaries of materials and methods used in construction of the specimens and the fastening schedule for the wall sheathing, respectively. Figures 2 and 3 show the typical test specimen and fastening detail, respectively.

Figure 2. Specimen construction.

Each specimen was constructed with five 24-ft span wood trusses with a 1 $\frac{1}{4}$ -in. heel height, spaced at 24 in. on center. The overall size of the full roof system was 8 ft deep by 24 ft wide with additional 16-in. long overhangs on each side. Trusses were supported at the heel by 4-ft high by 8-ft long light-frame wood walls. The supporting walls were constructed with 24-in. on-center framing and sheathed on the exterior with 4-ft wide Norbord Tall Wall/Windstorm OSB panels extending up past the top plate of the wall to

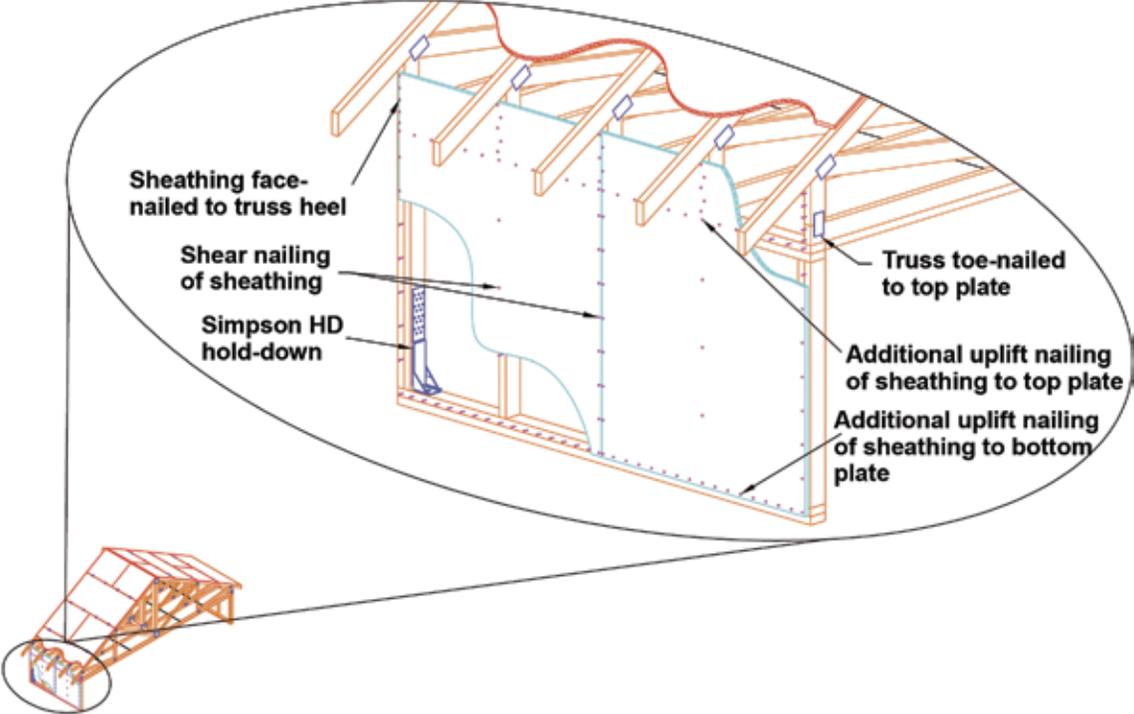
The Tall Wall OSB sheathing was fastened to the truss heel with five 8d common nails (2½ in. by 0.131 in.) (Fig. 3 and Table 3). This nailing schedule is based on the observed performance of OSB sheathing under lateral load only in Phase I testing where a total of three nails were used. For the current study, two additional nails were specified for added uplift resistance, for a total of five nails per truss heel (with a maximum of one of the five nails installed into the end grain of the bottom chord of the truss). Trusses were connected to the top plate with two toe-nails. No other connection hardware was installed.

Figure 3. Tall Wall OSB sheathing connection detail.

Sheathing was attached to the wall framing (Fig. 3 and Table 3) in general accordance with the provisions approved by American Wood Council for the use of wood structural panels to resist combined uplift and shear (Coats and Douglas 2011). These provisions specify additional nails along

the top and bottom plates of a shear wall to resist the uplift component in a combined loading scenario. One exception in the tested specimen attachment details was the 4-in. on-center nail spacing at the top plate (increased from the 3-in. spacing specified in the AWC provisions) on account of the additional roof-to-wall load path through the sheathing-to-truss heel fasteners.

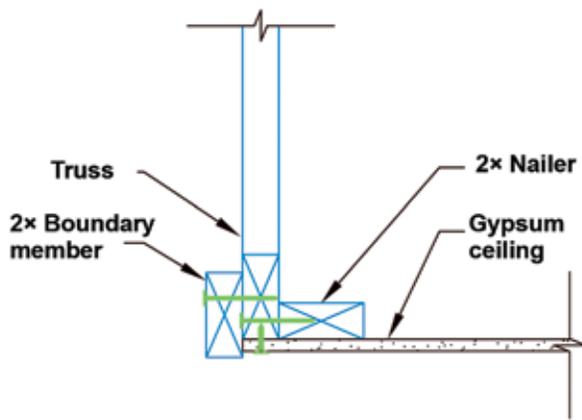
The ceiling gypsum panels were installed perpendicular to the truss bottom chord members and the first rows of fasteners was located approximately 8 in. from the supporting walls (i.e., floating edges) in accordance with the Gypsum Association's Application and Finishing of Gypsum Panel Products (GA-216-2010, Gypsum Association 2010). A single 2x boundary member and 2x nailing member were installed at the front and back trusses to simulate the presence of supporting gable-end walls by providing the bearing surface for the exterior edges of the gypsum as the gypsum panels rotate under the shear loading. Figure 4 shows a schematic of this boundary detail.

Figure 4. Ceiling diaphragm boundary detail at front and back trusses.

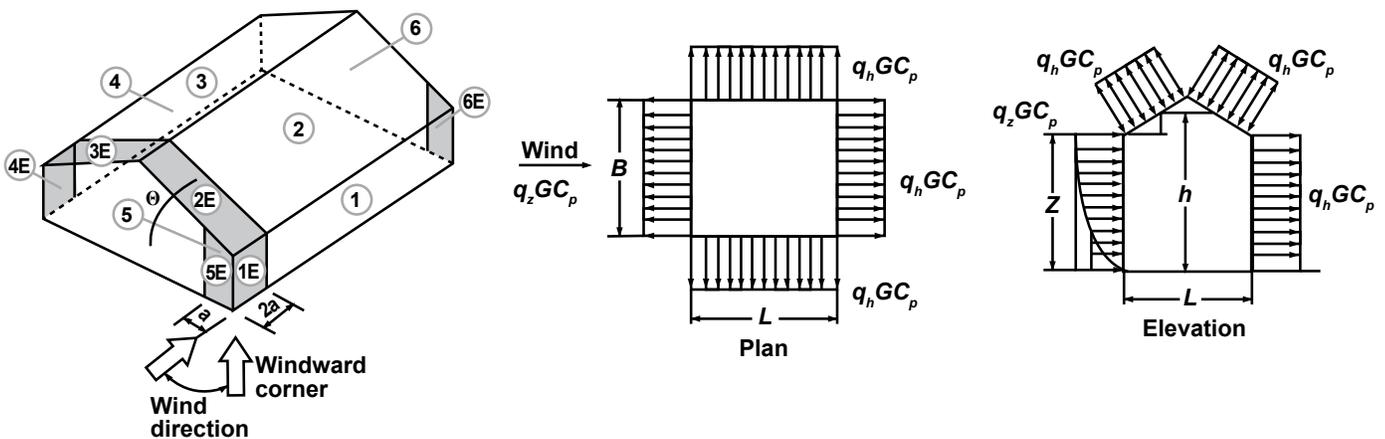
Figure 5 provides the American Society of Civil Engineers (ASCE) 7 lateral wind load profile in the direction parallel to the ridge. Wind pressures are transferred to the roof and ceiling diaphragms through the framing of the gable-end wall and wall below the roof. Figure 6 illustrates the tributary area associated with each of the diaphragms, including the additional load into the ceiling diaphragm from the wall framing below. The location of the lateral loading brace was chosen to most closely replicate this ratio of forces in the roof and ceiling diaphragms by a wind load. Refer to DeRenzis and others (2012) for a more in-depth explanation of the distribution of forces and derivation of the loading methodology.

Figure 5. ASCE 7 wind-loading profile.

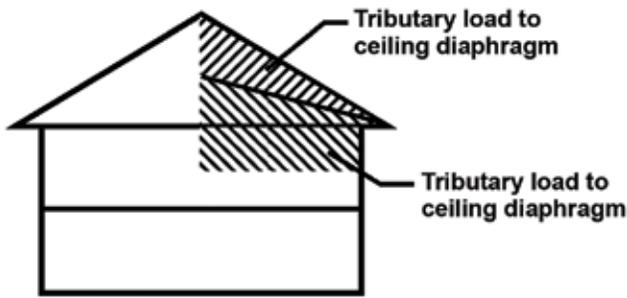
Figure 6. Tributary area of wind loads.

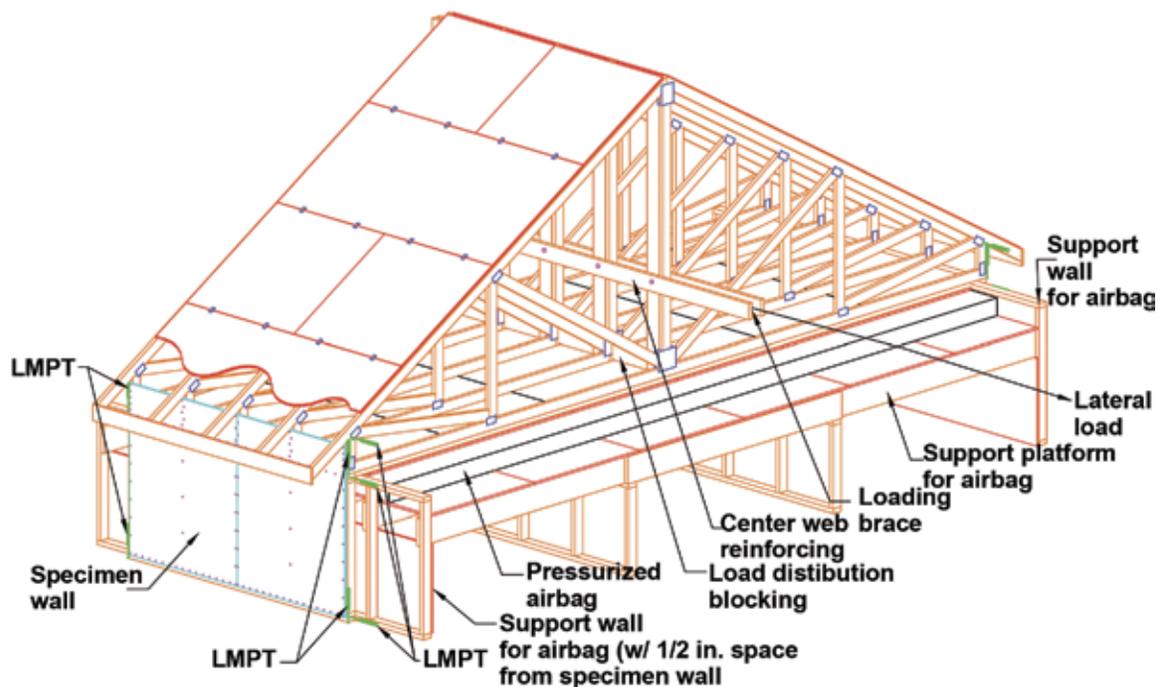
Figure 7 shows a schematic of the test set-up including the specimen, loading apparatus, and instrumentation and Figure 8 provides photos of the uplift–shear loading apparatus.

Figure 7. Test set-up and instrumentation.

Several displacements were measured using electronic linear motion position transducers (LMPTs), including the following:

- Lateral displacement of the top of the heel (TOH) on the first/front truss (T1) at both ends
- Lateral displacement at the top of the supporting walls (TOW)
- Lateral displacement of the roof ridge
- Lateral displacement of the ceiling diaphragm
- Lateral slip at the bottom of the supporting walls
- Uplift at the end stud of the supporting walls, and

- Compression at the end stud of the supporting walls
- Relative uplift between the supporting wall and the heel of the first/front truss at both ends
- Relative uplift between the supporting wall and the heel of the last/back truss at both ends

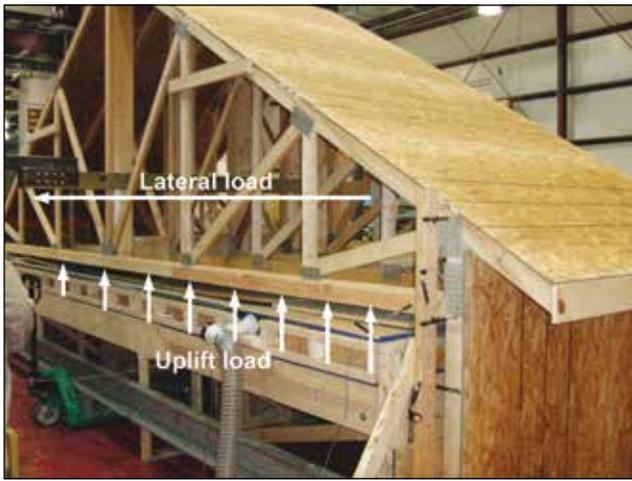
Figure 8. Specimen uplift and lateral load apparatus.

Uplift loading was applied uniformly to the ceiling diaphragm through a pressurized rectangular air bag. The air bag was constructed of flexible ethylene propylene diene monomer (EPDM) rubber and placed on a support structure underneath the test specimen (Figs. 8 and 9). The support structure also isolated the air bag from the test specimen walls to prevent any restraint of the walls caused by friction with the bag. The top of the air bag was isolated from the gypsum ceiling diaphragm by a translatable bearing surface constructed of a series of bearing plate rollers sandwiched

The lateral load was applied in tension using a computer-controlled hydraulic cylinder mounted to a steel reaction frame. The reaction frame was attached to the laboratory structural floor. Uplift loading via inflation of the air bag was achieved using a computer-controlled pressure load actuator (PLA).

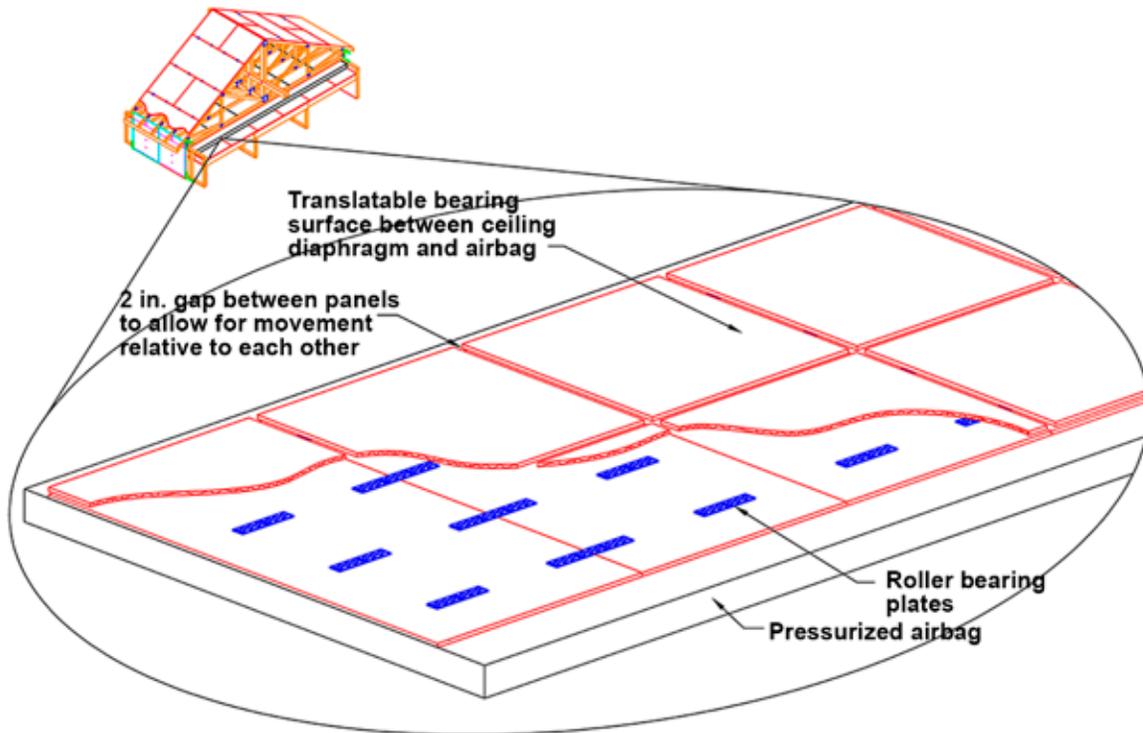
between two layers of OSB; the rollers allowed the specimen to move independently of the air bag in the lateral direction under combined loading. Figure 9 provides a detail of the translatable bearing surface.

Figure 9. Translatable bearing surface.

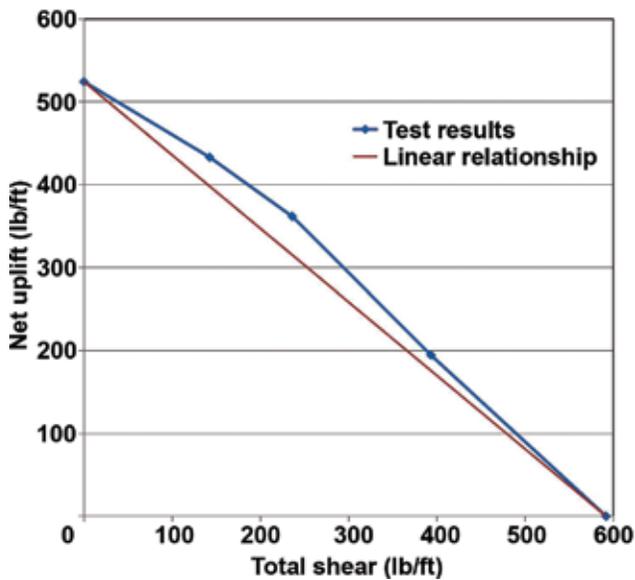
capacity for each specimen. Figure 10 shows the uplift versus shear capacity interaction curve based on the test results. For comparison, Figure 10 also includes a simplified linear interaction. The Appendix provides a summary of the shear load versus horizontal displacement curves for Tests B through E, measured at various locations on the specimen, including the midpoint of the bottom chord of the first truss, the TOH of the first truss and the TOW at both ends of the specimen.

Figure 10. Uplift versus shear interaction curve from testing.

Evaluation of the combined uplift and shear capacity interaction curve indicates a slightly nonlinear relationship with all of the tested capacities greater than those predicted by a linear relationship. Therefore, a linear relationship may be a simplified and conservative representation of the response under combined loading for design of energy truss heel connections using extended wood structural panel sheathing.

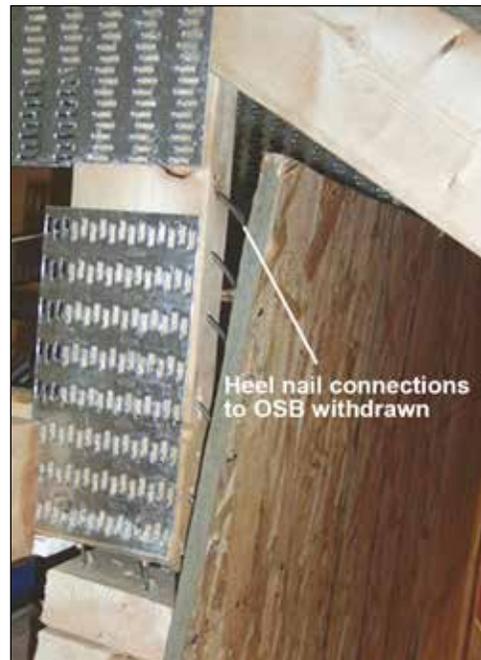
Tests B, C, and D evaluated the shear load capacity of the connection system at various levels of uplift loading. The primary failure modes of Tests B (85% uplift) and C (70% uplift) were similar to those seen in Test A. The majority of the OSB to heel nail connections exhibited the Mode III_m Yield failure (Fig. 12), with the back trusses (trusses under tension caused by global overturning) reaching capacity first. A few of the nail connections at the center truss, where the two OSB sheets are joined, failed by nails pulling through the OSB edges (Fig. 13). This change in failure mode most likely is due to the effect of the smaller panel edge distances at that location in conjunction with the shear load component acting perpendicular to the OSB edge.

Figure 12. Fastener yield failure mode of Test C.

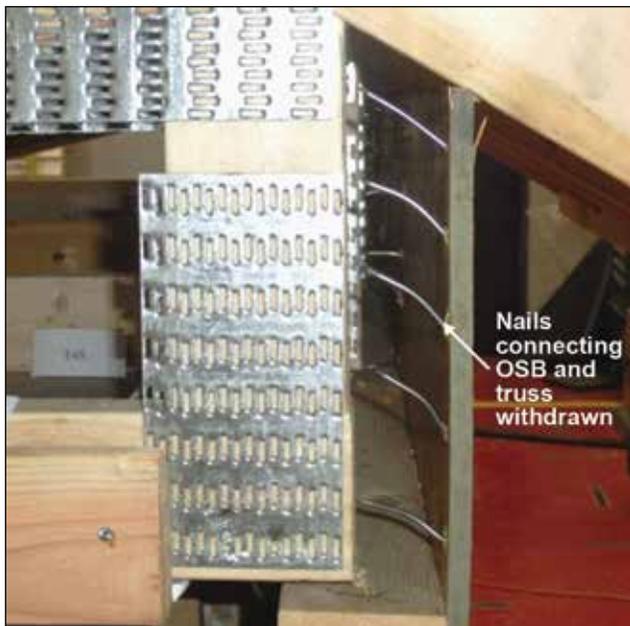
a unit uplift capacity of 525 lb/ft. The primary failure mode in Test A was a Mode III_m yielding followed by withdrawal of the nails connecting the OSB wall sheathing and the truss heel and a withdrawal of the toe-nails from the top plate (Fig. 11).

Figure 11. Primary failure mode of Test A.

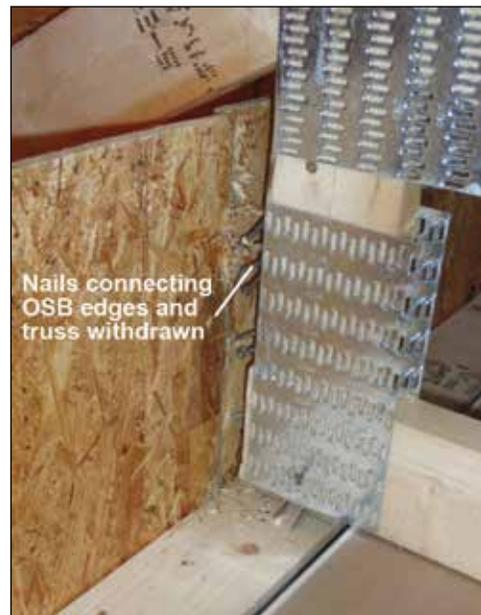
Figure 13. Nail pull-through failure of Test C.

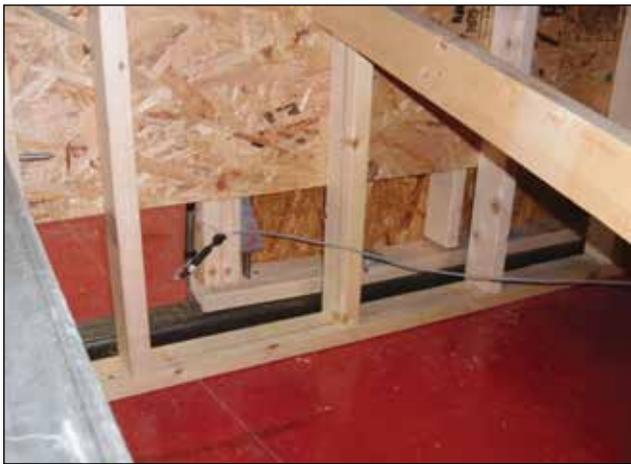
The primary failure mode of Test D (40% uplift) was a cross-grain bending failure of the wall bottom plates at the uplift ends of the supporting walls, initiated by a failure of the test set-up reaction anchors that secured the tension stud hold-downs (Fig. 14). However, significant deformations were observed at the heel connection (Fig. 15), suggesting that the roof-to-wall connection had reached or was near its capacity.

Figure 14. Set-up anchor failure of hold-down during Test D.

significant deformations observed at the heel connection; however, the overall capacity of the specimen was limited by the failure of the uplift hold-downs and subsequent cross-grain bending failure of the bottom plates at the uplift ends of the supporting walls. Further inspection indicated that the hold-down anchors had not been fully engaged within the reaction frame of the testing set-up before the start of the test.

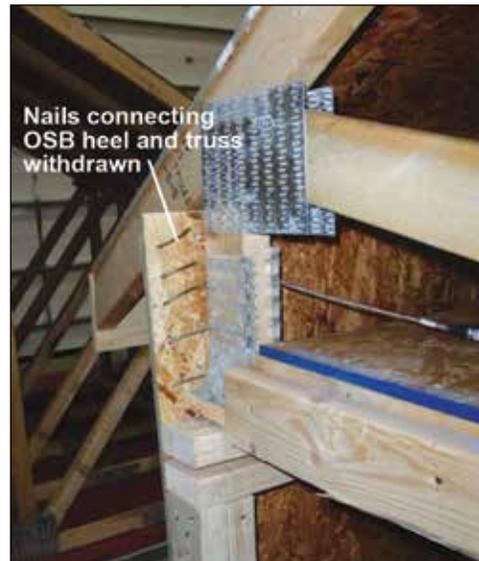
Figure 16. Fastener yield failure mode of Test E.

Test E (0% uplift load) benchmarked the shear capacity of the energy truss heel connection system. The ceiling diaphragm of the Test E specimen was reinforced with additional sheathing on the top face of the truss bottom chords to achieve failure at the energy truss heel connection. Test E reached a unit shear capacity of 592 lb/ft, and also exhibited a Mode III_m Yield failure at the OSB-to-heel connection as its primary failure mode, with the nail bending/yielding occurring in the horizontal direction (Fig. 16).

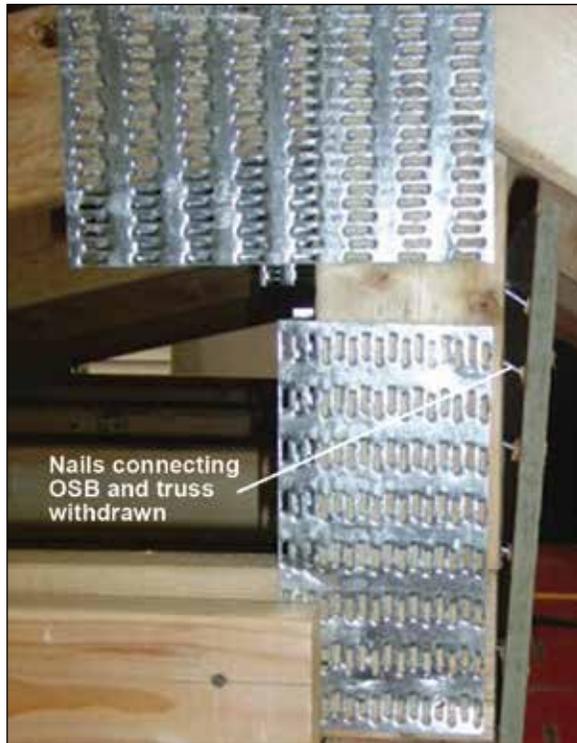
During Test D (40% uplift), the roof-to-wall connection had reached or was near its capacity as evidenced by the

Figure 15. Deformation of OSB-to-heel connection at failure of Test D.

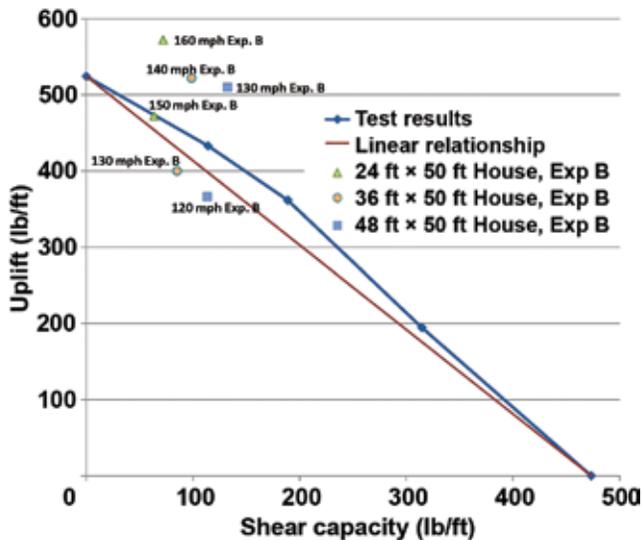
Figures 17 and 18 compare the combined uplift and shear interaction curve based on testing to design wind load scenarios for several typical house roof sizes. The roof sizes (24 ft by 50 ft, 36 ft by 50 ft, and 48 ft by 50 ft) were selected to bracket the majority of the building dimensions and roof length to width aspect ratios present in residential construction. The wind loads were determined using tables 2.2A and 2.5B from *Wood Frame Construction Manual (WFCM) for One- and Two-Family Dwellings—2012 Edition* (AWC 2012) assuming a mean roof height of 30 ft, a 7:12 roof pitch, and the truss span in the short direction. Note that the 2012 edition of the WFCM is based upon *ASCE/SEI 7-10 Minimum Design Loads for Buildings and Other Structures* (ASCE 2010) basic wind speeds for a 3-s gust and 700-year return period. Design wind loads were adjusted up by assuming a factor of safety of 2.0 to provide a direct comparison to the uplift and shear capacities of the system measured from testing.

Figure 17. Comparison of tested capacity to typical wind-loading scenarios (Exposure B regions).

Analysis presented in Figures 17 and 18 shows that the capacity of the energy truss heel connection exceeds the adjusted design values in Exposure B wind regions for all analyzed building configurations at basic wind speeds up to 120 miles per hour (mph), and in the case of the shorter roof spans at basic wind speeds up to 150 mph. Accordingly, the analysis indicates that the tested energy truss heel connection can provide a factor of safety of 2.0 in Exposure B wind regions

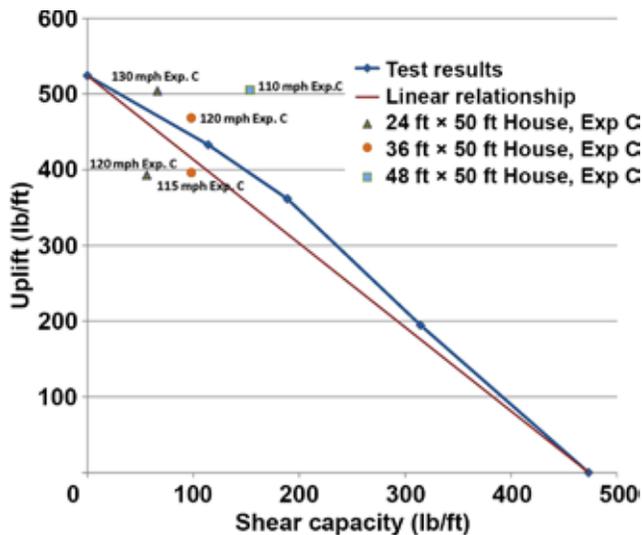
Figure 18. Comparison of tested capacity to typical wind-loading scenarios (Exposure C regions).

for nearly all typical building layouts across the majority of the country. The applicability of the tested system is less extensive when comparing peak capacities to design values in Exposure C wind regions (Fig. 18); the system capacity yields a factor of safety of 2.0 or greater at basic wind speeds of up to 115 mph in only two of the three layouts analyzed. A basic wind speed of 115 mph, however, encompasses the greater majority of the continental United States, excluding only the coastal regions in the eastern half of the country.
