# Development of a Smart Timber Bridge (Phase III)

## Moisture and Strain Sensor Investigation for Historic Covered Bridges

Forest Service  
Forest Products Laboratory  
General Technical Report  
FPL-GTR-268  
July 2019

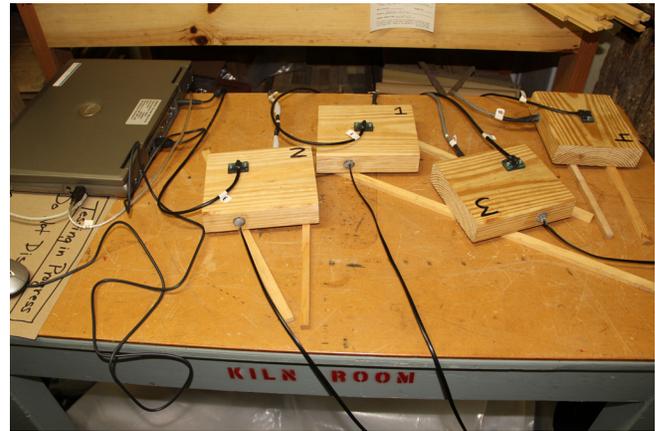
Figure 2.7. Specimens in the 20% equilibrium moisture content room.

The specimens were subjected to varying moisture conditions to evaluate the survivability and response of the sensors. All moisture testing was done at FPL in Madison, Wisconsin, USA. First, the four specimens were placed in an environmentally controlled room with a temperature of 80 °F and 90% relative humidity. These conditions correspond, theoretically, to an EMC of 20%. Figure 2.7 shows the four specimens in the 20% EMC room. After the EMC was reached, the specimens were placed in a drying room at 80 °F and 37% relative humidity until the corresponding EMC of 7% was reached. Lastly, the specimens were placed back in the 20% EMC room. As a reference, the MC was periodically checked with a commercially available moisture meter. Additionally, the specimens were periodically weighed to obtain gravimetric MCs; however, the wires attached to the sensors are believed to have absorbed moisture, resulting in inaccurate readings, although this was not experimentally confirmed.

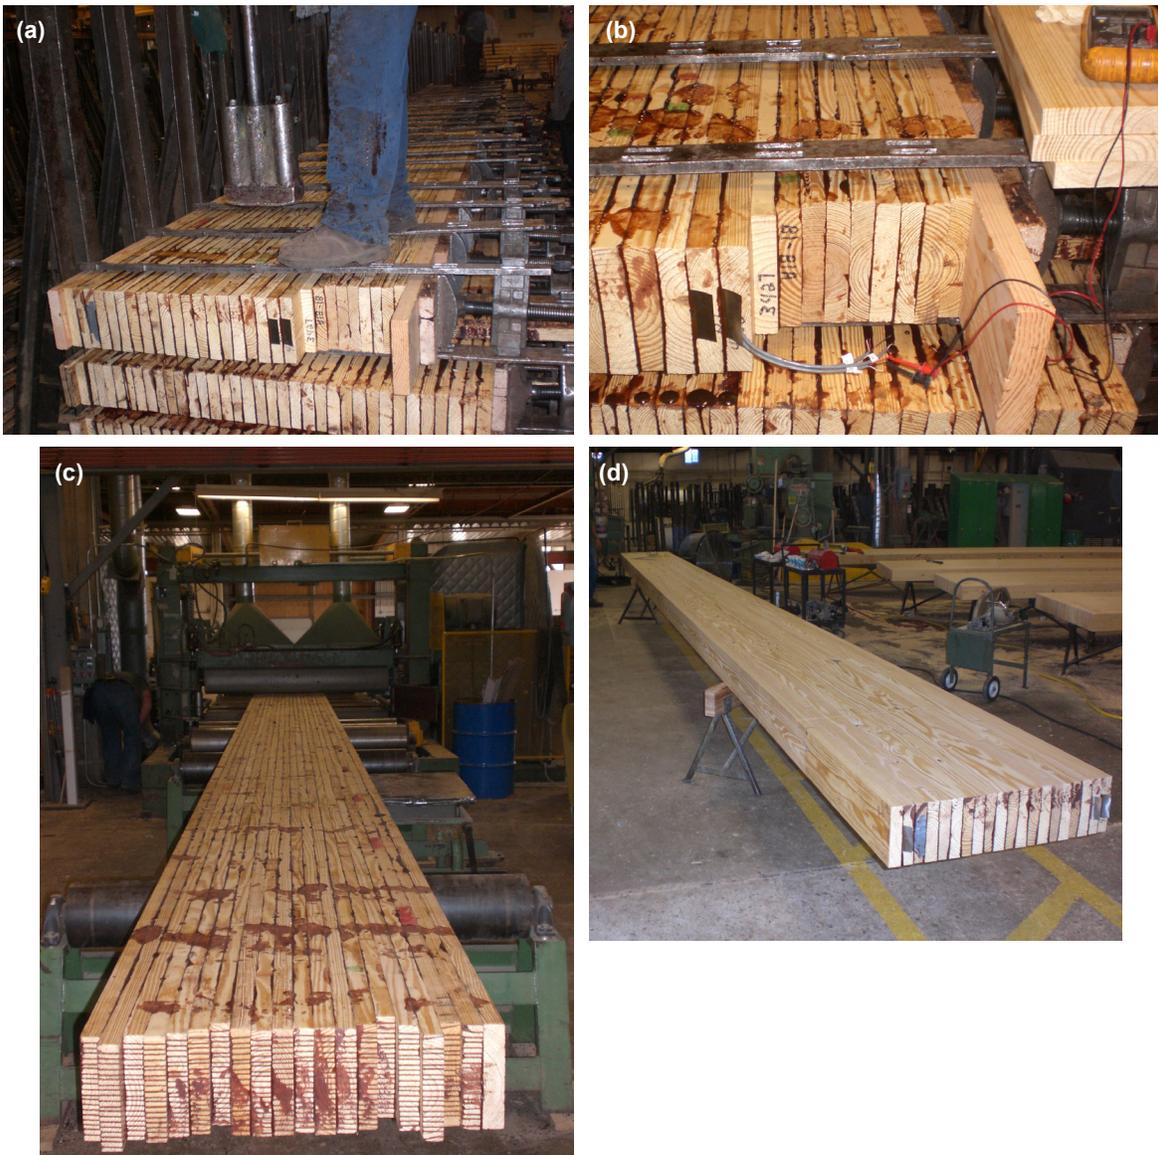
Figure 3.7. Clamping and planing the girder: (a) aligning the laminates in the clamping apparatus; (b) checking the gages with a volt meter; (c) planing the beam; (d) finished beam.
