Development and Evaluation of the Teal River Stress-Laminated Glulam Bridge

MICHAEL A. RITTER, JAMES P. WACKER, KIM STANFILL-McMILLAN, AND
JAMES A. KAINZ

The Teal River bridge was constructed in late 1989 in Sawyer County, Wisconsin, as part of the demonstration timber bridge program of the U.S. Department of Agriculture Forest Service. The bridge is a stress-laminated deck structure with a 9.91-m length and a 7.23-m width. The design is unique in that it is the first known stress-laminated timber bridge in the United States to be constructed of full-span glued-laminated timber beams rather than the traditionally used sawn lumber laminations. The performance of the bridge was continuously monitored for 2 years, beginning at the time of installation. The performance monitoring involved gathering data relative to the moisture content of the wood deck, the force level of stressing bars, the deck dead load deflection, and the behavior of the bridge under static-load conditions. In addition, comprehensive visual inspections were conducted to assess the overall condition of the structure. On the basis of 2 years of field evaluations, the bridge is performing well with no structural or

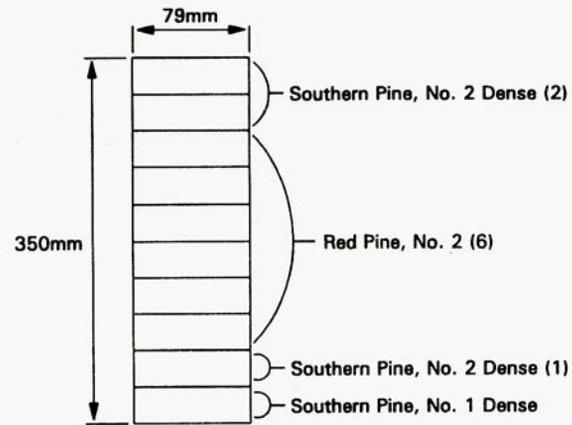
FIGURE 1 Southern pine–red pine beam laminations used for Teal River bridge.

Design of the Teal River bridge was a two-part process involving the development of the glulam timber beams followed by the design of the bridge superstructure. As with most stress-laminated timber bridge decks, it was anticipated that stiffness rather than strength would be the primary design concern. To serve as a basis for designing the glulam timber beams, a preliminary analysis of the Teal River bridge indicated that an acceptable deck depth could be obtained if a minimum design modulus of elasticity (MOE) of 11 204 MPa could be achieved. Analysis conducted at FPL indicated that a glulam timber beam manufactured entirely of red pine was feasible. However, little information was available on the properties of red pine lumber, and no information was available on red pine glulam timber. Therefore, the FPL engineers proposed that southern pine lumber be combined with red pine lumber to provide additional beam stiffness. No design information on southern pine–red pine glulam timber beams was available in current American Institute of Timber Construction (AITC) standards (2). However, the concept of developing beams using lower stiffness species for the inner lumber laminations and higher stiffness species for the outer lumber laminations had been used for other species in this standard. The same concept was used to develop a proposed beam design with southern pine outer laminations and red pine inner laminations. The proposed beam design was subsequently approved by AITC and was used in the Teal River bridge (Figure 1).

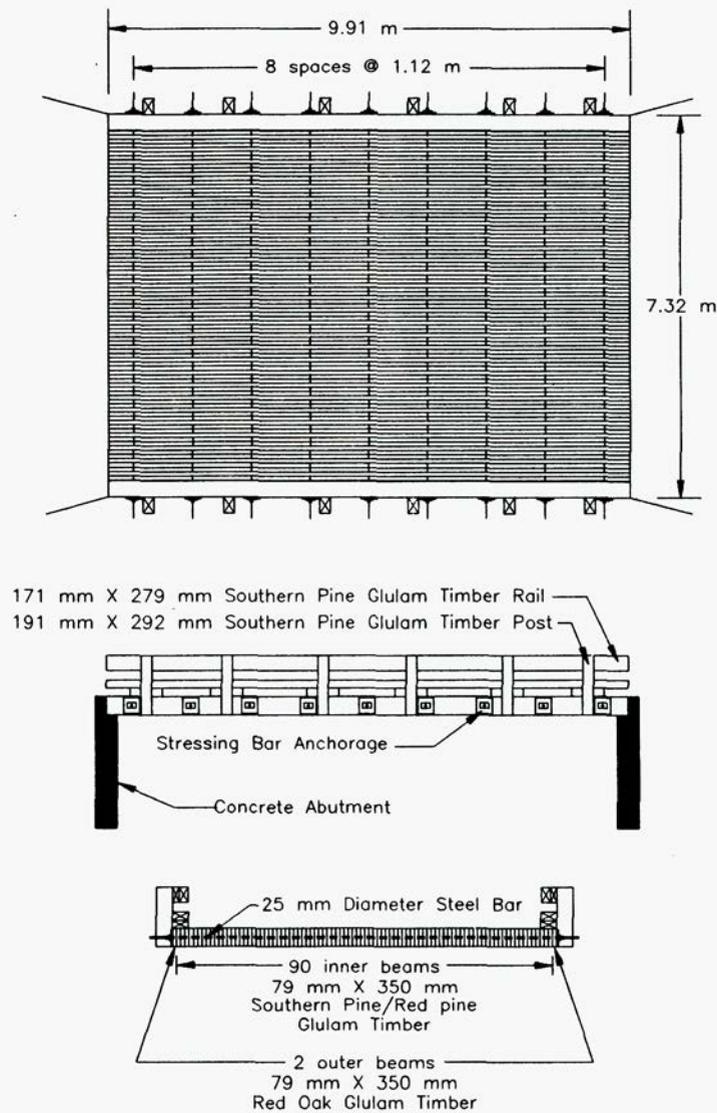
FIGURE 2 Design configuration of Teal River bridge: *top*, plan view; *middle*, profile view; *bottom*, cross section.

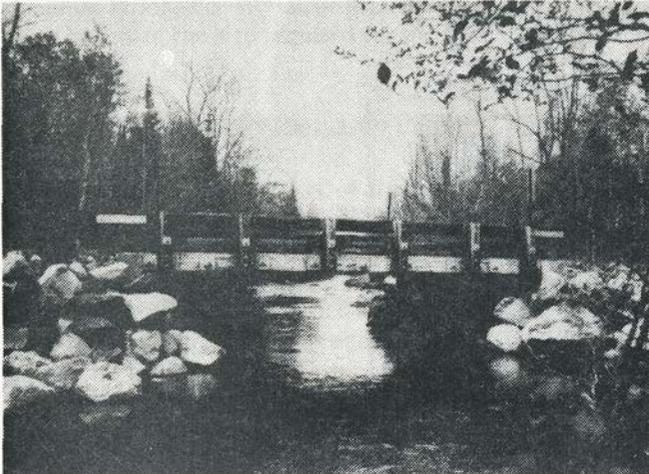
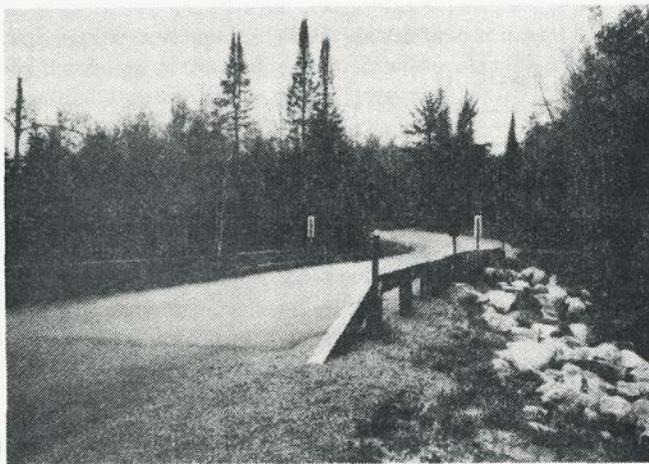
FIGURE 3 Completed Teal River bridge.

Following the initial stressing, the timber curb and rail system was installed, and a glulam timber approach rail was constructed. Approximately 1 week after the initial stressing, the bridge was restressed to compensate for anticipated losses in the bar force. Approximately 7 weeks after the second deck stressing, the third and final deck stressings were completed. An asphalt wearing surface was subsequently applied in June 1990. The completed bridge is shown in Figure 3.

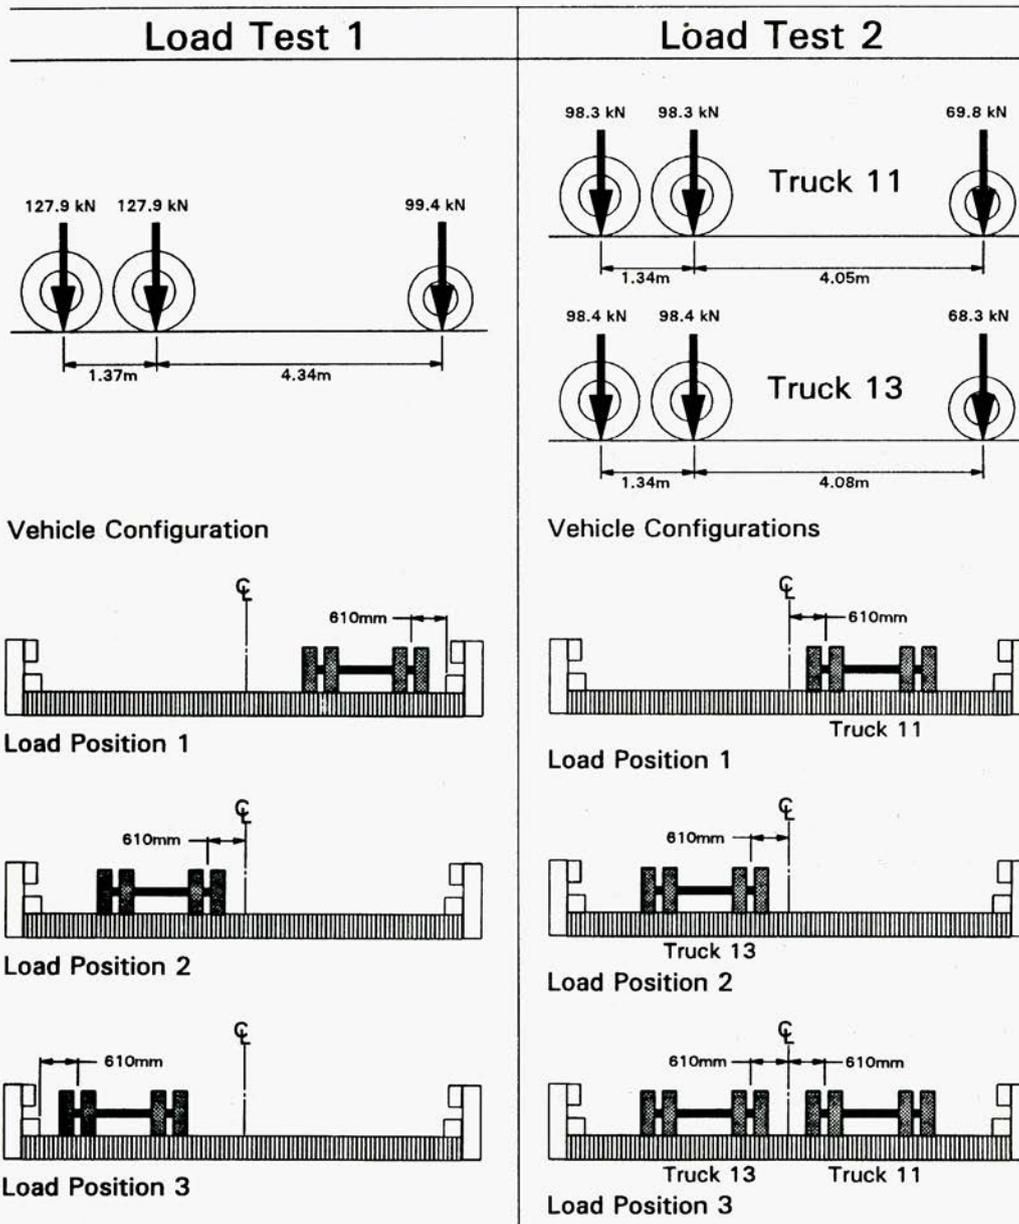
FIGURE 4 Load test vehicle configurations and positions. Vehicles in the right lane face north, into the page; those in the left lane face south, out of the page. For Load Test 1, the longitudinal centroid of the vehicle was placed over the bridge centerspan. For Load Test 2, the rear axles were centered over centerspan and front axles were off the bridge. The transverse track width for all vehicles was 1.83 m, measured center-to-center of the rear tires.

The second load test, on April 26, 1991, involved two test vehicles: Truck 11 with a gross vehicle weight of 265.1 kN and Truck 13 with a gross vehicle weight of 266.4 kN. For this test, the vehicles were positioned longitudinally with the two rear axles centered over the bridge centerspan (front axles

were off the bridge), and three transverse load positions were used (Figure 4). Measurements of bridge deflections were obtained by suspending calibrated rules from the deck underside and reading values to the nearest 1.5 mm with a surveyor's level.

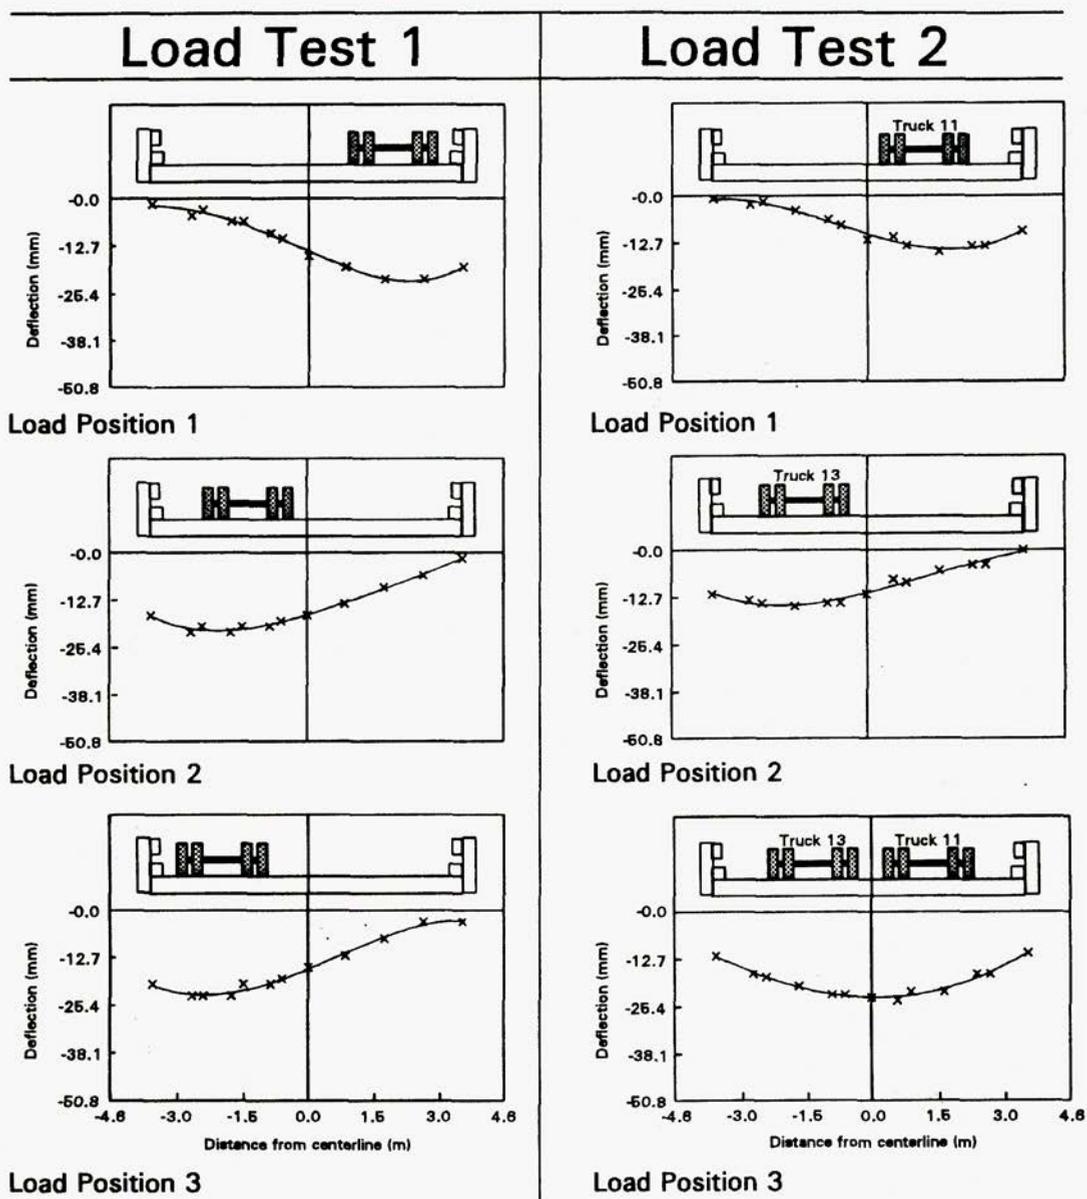
FIGURE 5 Load test transverse deflections, measured at the bridge centerspan. Bridge cross sections and vehicle positions are shown to aid interpretation and are not to scale.

Transverse deflection values for Load Test 1 are shown in Figure 5. For Load Position 1, the maximum deflection of 21 mm occurred under the outside wheel line, 915 mm from the downstream deck edge. For Load Position 2, the maximum deflection of 22 mm was measured 254 mm from the outside wheel line, toward the upstream deck edge. For Load Position 3, the maximum deflection of 22 mm occurred under the outside wheel line, 915 mm from the upstream deck edge.

Transverse deflection values for Load Test 2 are shown in Figure 5. With a single truck on the bridge, both Load Positions 1 and 2 produced a maximum deflection of 15 mm approximately midway between the truck wheel lines. With

both vehicles on the bridge, the maximum deflection for Load Position 3 was 24 mm under the inside wheel line of Truck 11.
