# Simplified Analytical Model for a Queen-Post Covered Timber Bridge

**Keywords:** historical, timber, Queen Post, finite element, splice joints; joint eccentricities.

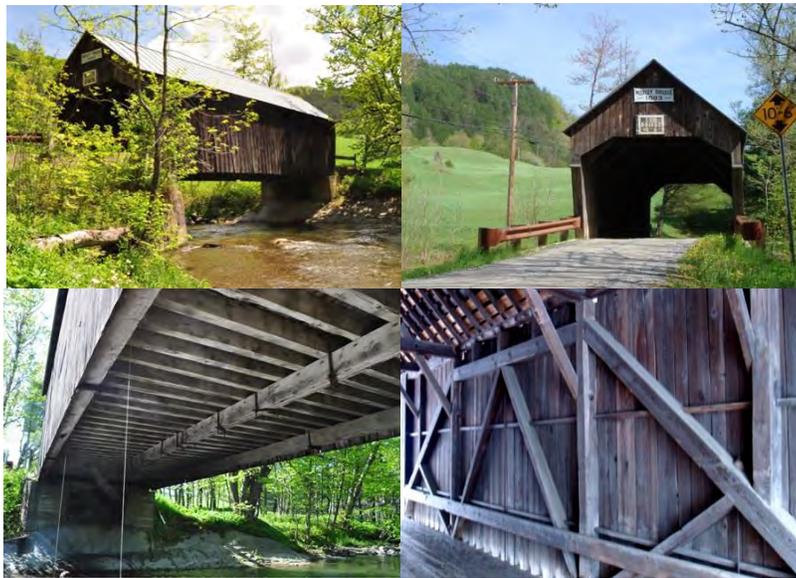
*Fig. 1 Different views of the Moxley Bridge*

The Moxley covered bridge is located 2.5 miles south of junction then 0.1 mile in the town of Chelsea in Orange County of the State of Vermont. The bridge was constructed in 1883. Fig. 1 shows different photographic views of the bridge.

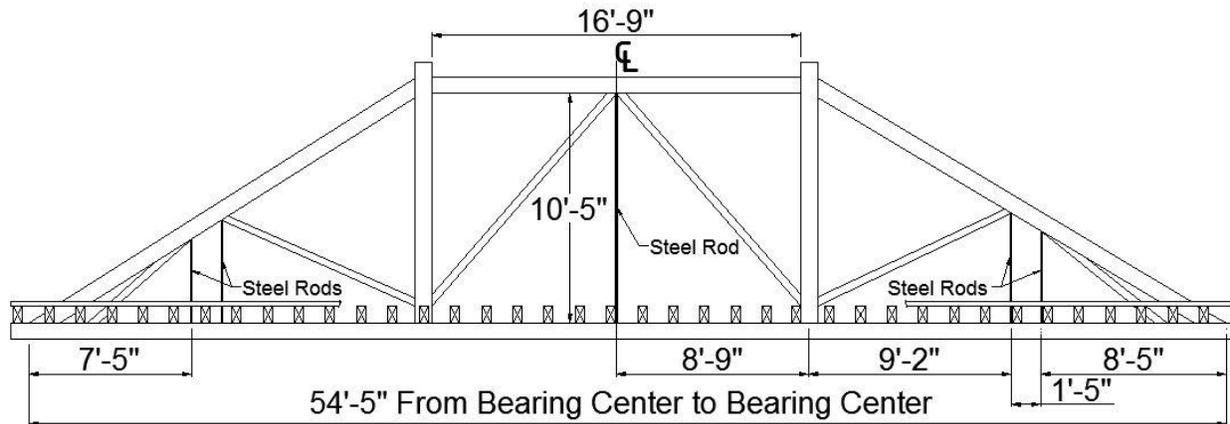
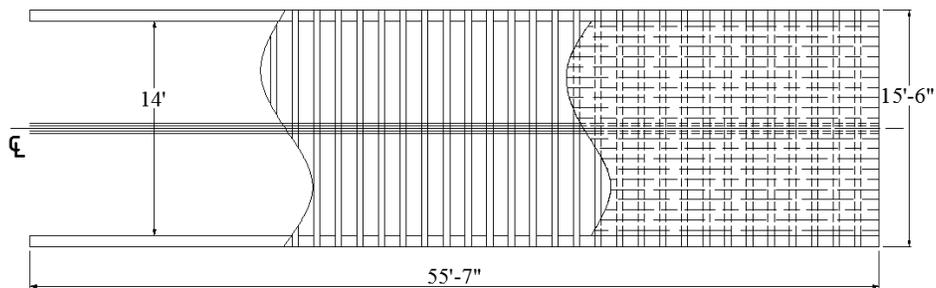
a. Elevation View

a. Plan View

Fig. 2 Schematic elevation and plan views of the Moxley covered Timber Bridge

The bridge span is approximately 54 ft. - 5 in. (see Fig. 2) and is 13 ft.-9 in. wide. The bridge deck is made of continuing 7 to 10 in. wide, 2 in. deep and 15 ft. long timber planks placed closely to each other. The bridge deck is seated on 5 in. by 9.5 in. floor beams which are about 1 ft. - 3 in. spacing from each other. All floor beams are supported on the two trusses bottom chord and a beam that is located at the middle of the bridge deck. The bottom chords of the two trusses of the bridge are 9 in. by 9 in., while the middle beam is formed by four 2 in. by 10 in. that are bundled together. However, the contribution of the middle beam to transfer any of the applied loads to the end supports was excluded in the following analysis. This was justified by the small flexural stiffness of such a long beam.

Figure 2 shows schematic elevation and plan views of the Moxley Bridge. Notice that Queen-Post truss system was provided by tension rods and were provided to act as additional supports to the trusses bottom chords. In addition, diagonal members were also provided as additional supports to the trusses top chords as shown in Fig. 2. The dimensions of structural members are listed in Table 1.

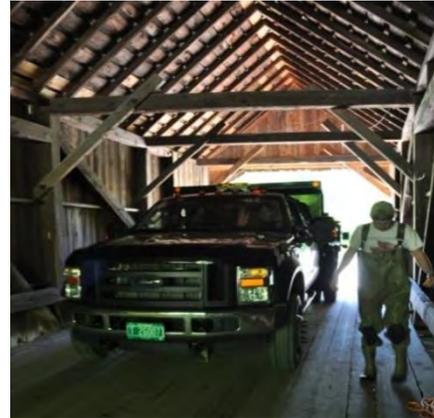
Fig. 3 Photo of the Truck used in testing of the Moxley Bridge

The vehicle that was utilized in the load testing of the Moxley Bridge is shown in Fig. 3. The front and back axles of the truck weigh 20.9 kN and 50.9 kN, respectively. The distance between the two axles was spaced at 4,470 mm.

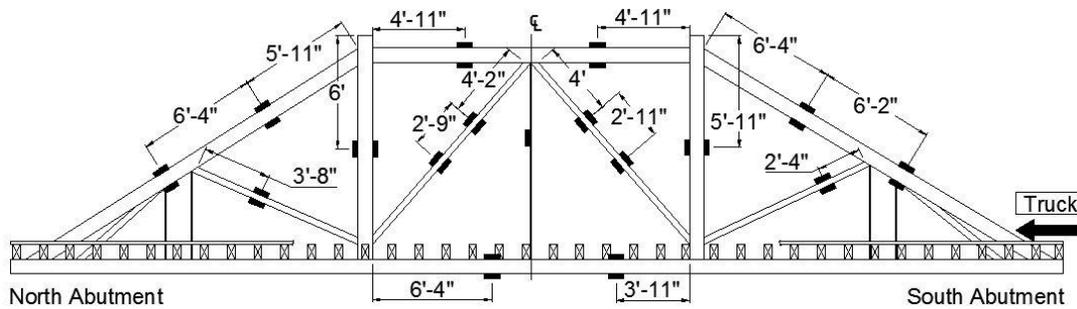
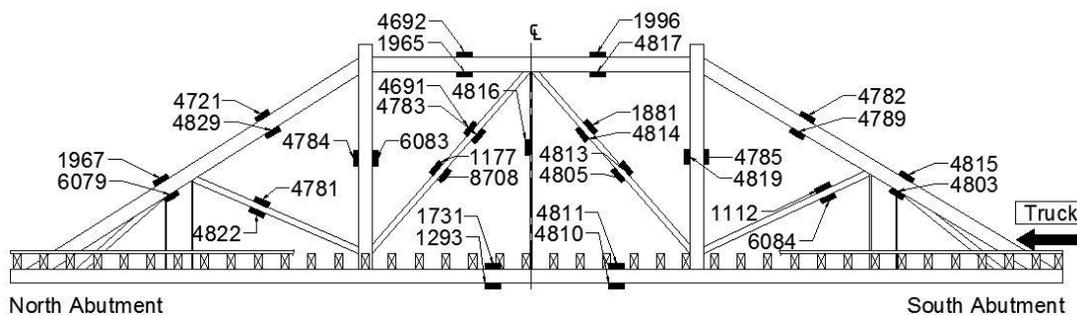
i) Strain Sensor Locations

ii) Strain sensor numbers

Fig. 4 Strain sensor truss locations for the Moxley Bridge

Instrumentation used in testing the Moxley historical bridges consisted of BDI [1] strain sensors (referred to hereafter as strain sensors) with a resolution of 1 micro-strain  $\pm 1$  and the BDI testing software from Bridge Diagnostics Inc. Displacement data were obtained from Unimeasure PX string potentiometers having a resolution of 0.001 inches  $\pm 0.001$  connected to a Megadac logger. Both systems recorded data at 20 samples per second per sensor. Syncing of the data between the two systems was accomplished with a simultaneous data mark inserted into the files at the appropriate truck location positions. Several members of the Moxley Bridge were instrumented to measure the induced strain when a truck travels over the bridge. The locations and the identification number of these sensors are shown in Fig. 4. Sensors were also provided to measure the global displacements at the quarter and mid span of the Queen-Post truss.

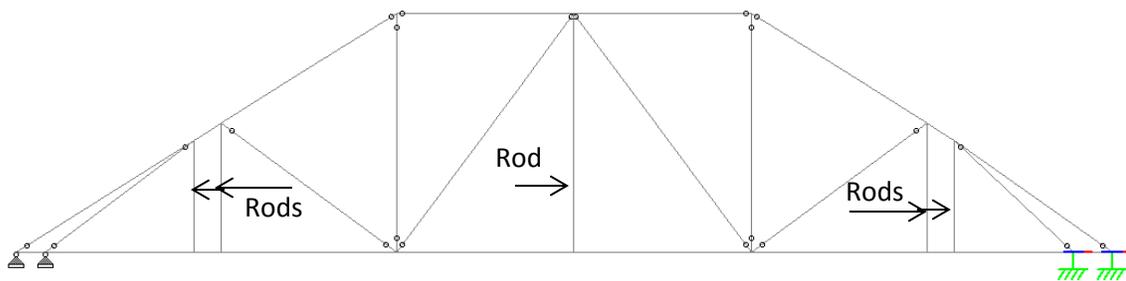
Fig. 5 STAAD two dimensional finite element model of the Moxley Bridge

The STAAD computer software was selected to perform the analysis of the covered timber bridges studied in this work. This program was selected due to its simplicity in creating the required input file, to model the splice connections and to simulate a moving load. The Bridge was analyzed using two dimensional idealizations (see Fig.5). Beam elements were used to idealize the top and bottom chords of the Moxley Bridge. All diagonals were modeled as axial load members. Tension members only were utilized to represent the tie rods that were used in the construction of the Moxley Bridge. Figure 5 below illustrates the finite element model of the bridge as was utilized in the STAAD analysis. Internal hinges were inserted at specific locations to release the moments where elements were discontinued.

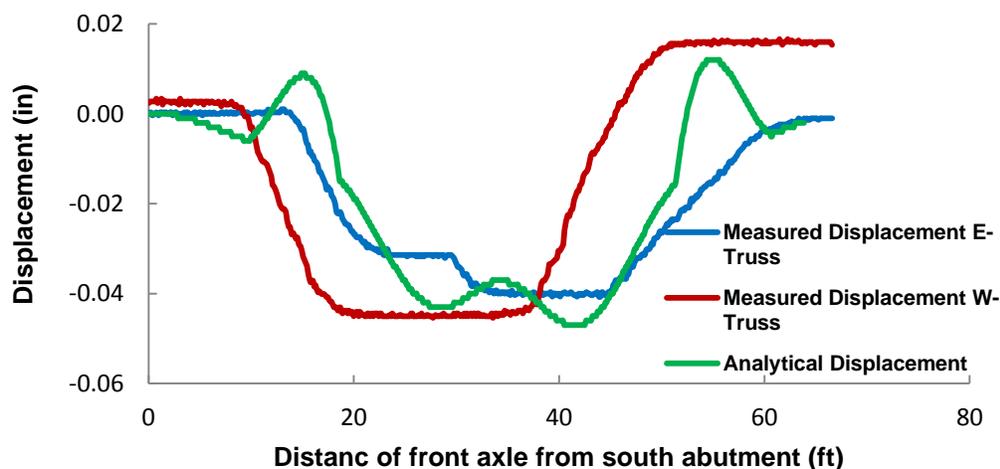
Fig. 6 Variation in the mid-span displacement as the truck travels along the Moxley Bridge

Figure 6 shows the variation in the displacement at the midpoint of the truss bottom chord as the truck was driven across the bridge. The figure shows that there is a lag between the field measured displacements in the east and west trusses, but they are similar in magnitude. This lag is caused by the skew angle for the bridge structure. Also, the figure illustrates that there is a slight difference between the analytical and the measured displacements near the locations of the tension rods. These differences could have resulted from the behavior of the idealized connection between the tension rods and the truss top and bottom chords at these locations. In the analytical model, the two chords of the truss and the rods were assumed to be connected to these rods at common nodes. However, this idealization does not allow for local deformation that occurs in top and bottom chord members in the vicinity of the nuts at the end of these rods. These deformations result from the application of the tie rod forces which act perpendicular to the wood grain of the top and bottom chord members. Such deformation can be significant since the timber of the elastic modulus in the direction perpendicular to the wood grain is approximately one-tenth of the longitudinal elastic modulus in the direction parallel to the wood grain. The differences in the material moduli were not considered in the analytical model.

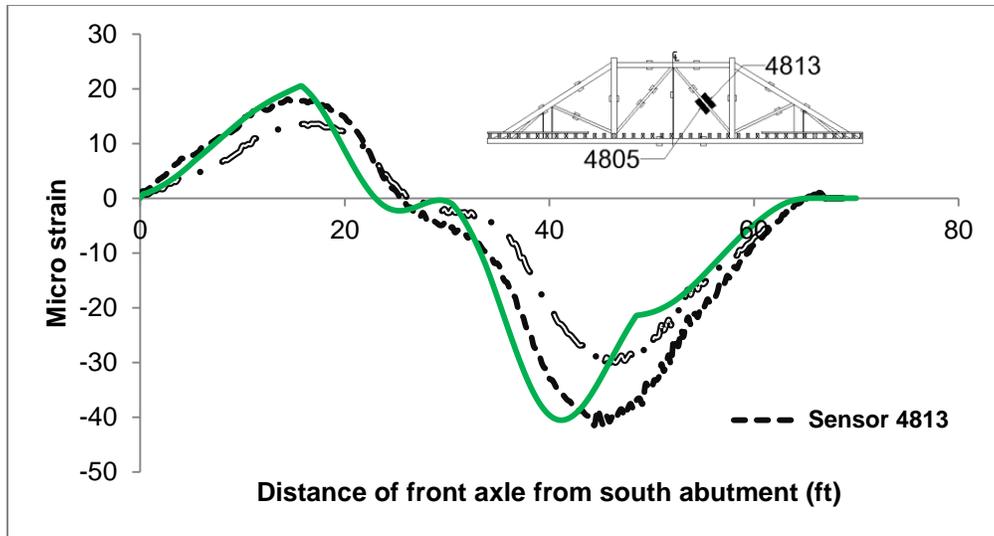
Fig. 7 Analytical and field strains in the diagonal member just to the right of the middle rod

Figures 7 to 11 document the agreement between the measured and analytical strains in all members except in the bottom chord. For example, Fig. 7 depicts the variation in the strains in a diagonal member just to the right of the middle rod as truck travels along the center of the bridge deck. One may notice that there are differences of the locations of the peaks of the analytical and the recorded strains. This was due to the inability to match the exact truck locations when the field data was recorded to the analytical locations where the truck was positioned on the bridge in the STAAD analysis. Similar behavior was also noticed when examining the strains in the timber post to the right of the middle rod (see Fig. 8).

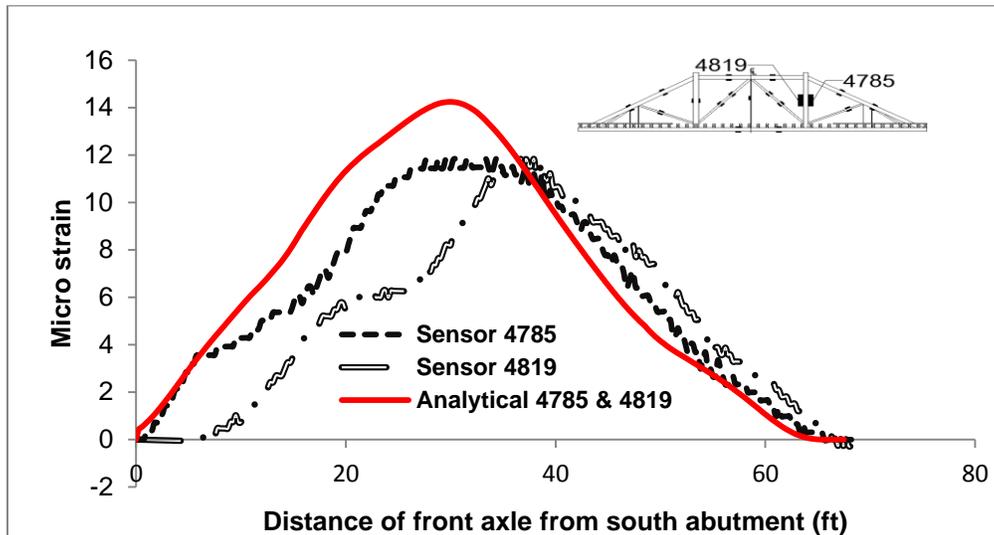
Fig.8 Analytical and field strains in the left timber post

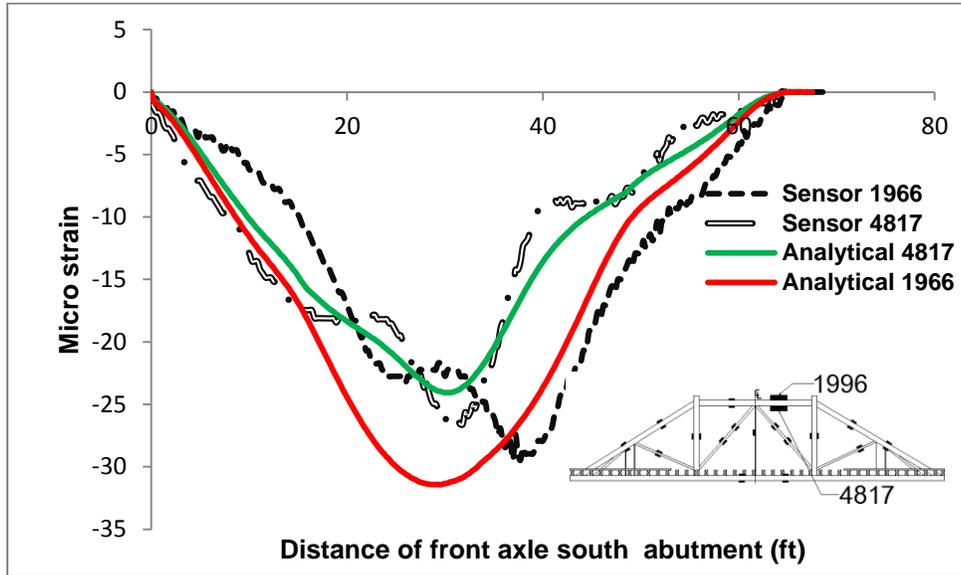
Fig.9 Analytical and field strains the left diagonal member

Figure 9 illustrates that there is a slight difference in the analytical and recorded field strains in the first top chord member (see Fig. 9). These differences can easily result from not using the actual material modulus of the members in the analytical model. On the contrary, large differences between the field measured and the analytical strains were observed when investigating the performance of the middle rod (see Fig. 10). This could have resulted from the method used to mount the strain sensor on the element. In the field test two clamps were used to mount the flat sensor on the round bar. Another disagreement between the field measured and the analytical strains was noticed when examining the behavior of the truss bottom chord member just to the right of the middle rod (see Fig. 11). Both analytical and field measurements showed that the bottom chord is subjected to direct axial and bending strains (see Fig. 12). However, the effect of the bending strain was very noticeable in the analytical results. Examining the photo from the field of the location in the vicinity of these strain sensors showed

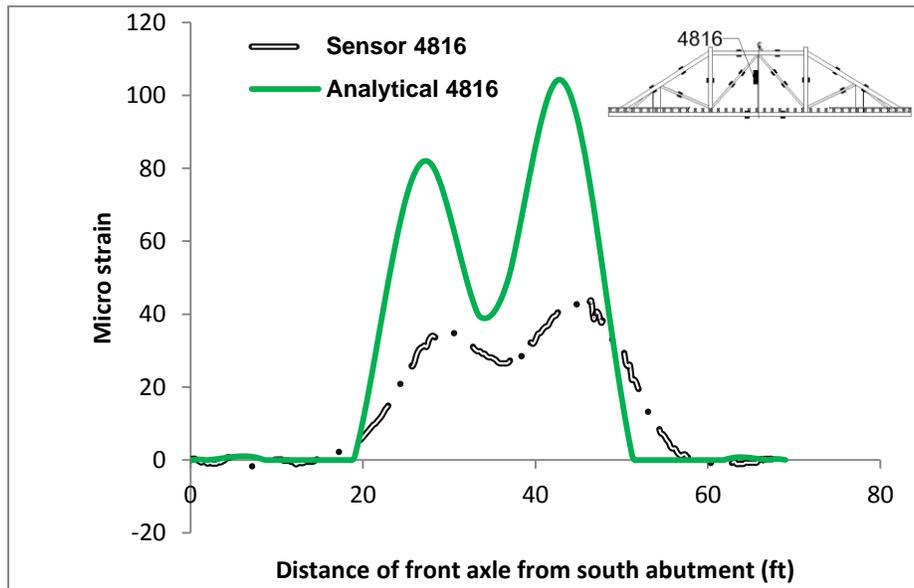
Fig. 10 Analytical and field strains in the middle rod

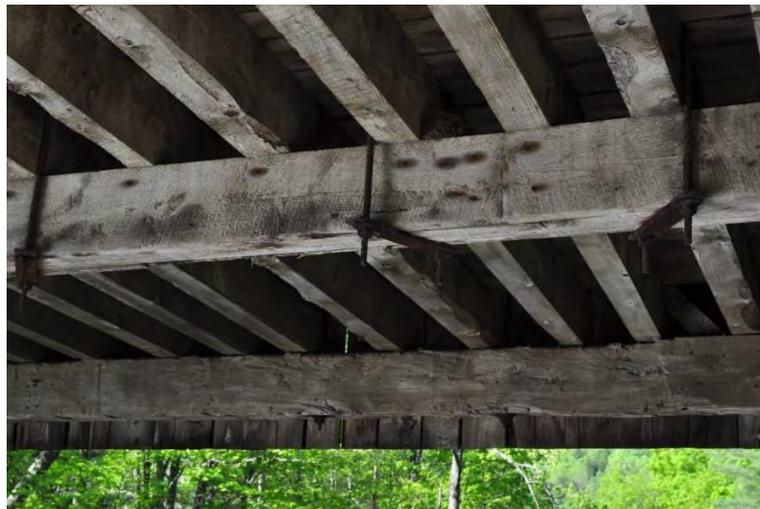
Fig. 12 Photo showing the condition bottom chord member of the Moxely- south truss

that there was a noticeable check and irregularity in the chord cross section in the vicinity of the sensors that were located on the bottom chord of the Moxley truss (see Fig. 12). This could be one of the reasons for the large differences between the measured and the calculated strains. Additional comparison between measured and calculated strains in other members is summarized in [2].
