Structural Evaluation of the Second Oldest Glued-Laminated Structure in the United States

Abstract

FPL-GTR-226

Proceedings 18th International Nondestructive Testing and Evaluation of Wood Symposium

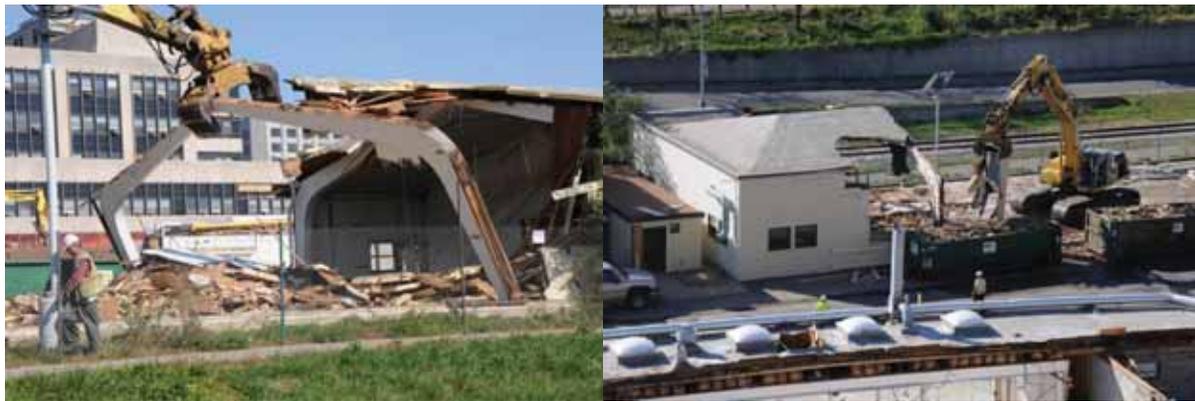
Figure 2—Deconstruction of FPL's glued-laminated arch building.

After decades of use, this structure was deconstructed in the fall of 2010 (Figure 3). Since these arches represent the first generation of both construction adhesives and glued-laminated development, the

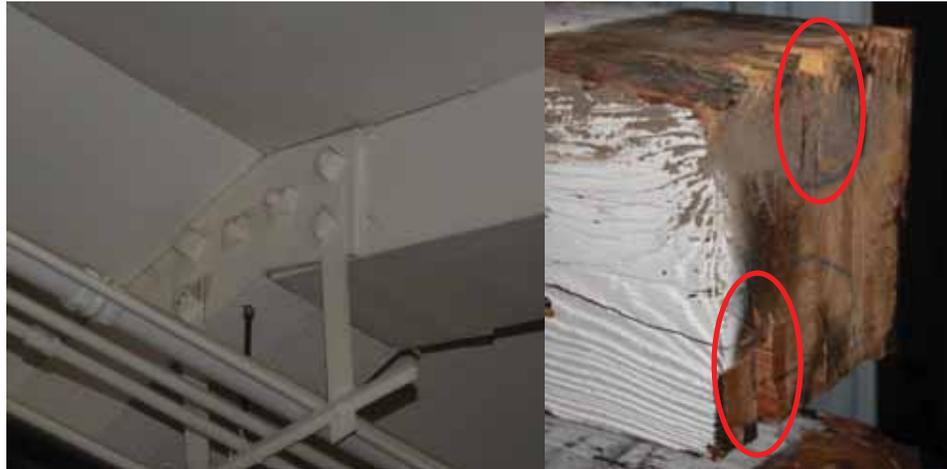
Figure 10— Peak connection in building and glued-laminated peak with connection plate removed

The most consistent problem observed after deconstruction of the glued-laminated arch structures was the condition of the crown connection. Figure 10 shows the crown connection consisted of steel side plates attached to the each arch arm with three 25.4-mm bolts in a triangular pattern. Measurements revealed inner bolt end spacing was 2.5d, lower than the minimum 4d required by contemporary design standards. As a result, most of the arch had cracks, splits, or wood plugs emanating from the inner bolts. Figure 10 also shows missing wood material associated with the lower bolt line though this condition was less common. Unlike the middle bolt, sufficient end spacing was provided. There is two possible

explanations for this damage. One, after the failure of the inner bolts, the remaining capacity of the connection was insufficient to carry a maximum event load that occurred during the service life to the structure. Two, the connection was damaged during deconstruction due to possible out of plane twisting of the arch while it was lowered to the ground (Figure 2). In either case, the damage to the connection had little influence on the vertical loading response of the arches because the splits did not go completely through the cross section. Under a lateral loading scenario, or as the arches reach maximum loading conditions, the connection condition could have a strong influence on behavior.
