# **Nondestructive Evaluation of a 75-Year Old Glulam Arch**

## **Marko Teder**

## **Xiping Wang**

# 18th International Nondestructive Testing and Evaluation of Wood Symposium

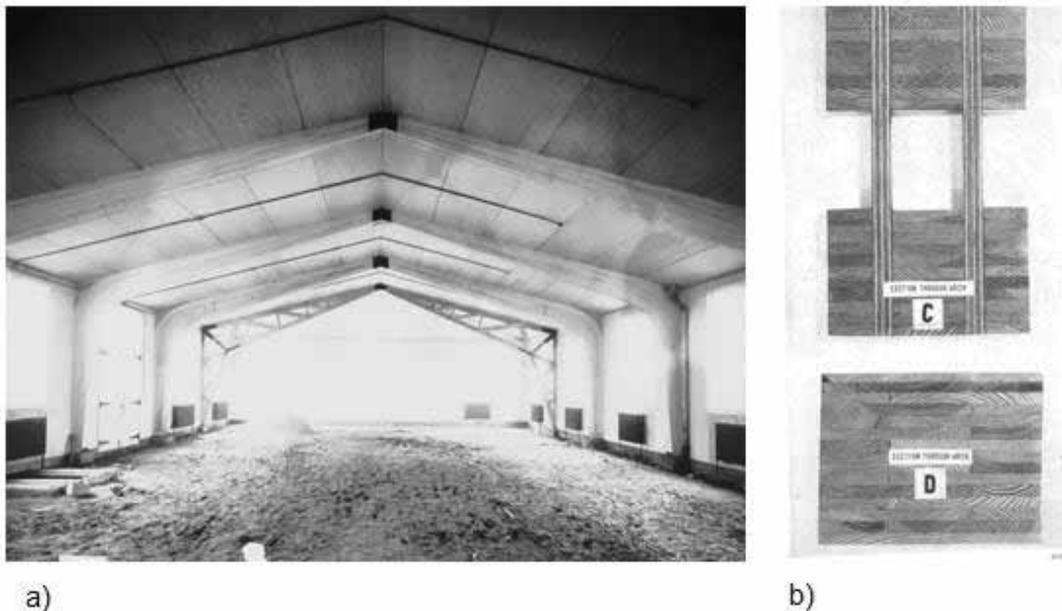
**Figure 1**—a) Inside view of the USDA Forest Products Laboratory service building, b) Cross-section views of C-type and D-type glulam used as the bearing structural components in the building.

A research building incorporating glued laminated wooden arches was erected on the USDA Forest Products Laboratory's campus in 1934 (Figure 1). As one of the first examples of glulam structures in the United States, this building represented FPL's early efforts on developing arches from thin, individual wood laminations that could be bent into flowing shapes. In addition to its primary service function, this building was also intended to demonstrate the adaptability of wood to modernism in both design and construction. The construction embodied special features developed or adopted through research at the FPL. One special feature was to create unobstructed floor space and ample overhead clearance for sawmill and other industrial projects. For this reason, arched supports were chosen in preference to column-and-girder or standard truss construction (Wilson 1939).

Three types of arch supports were used in the building—one solid glulam, one of double I-beam section, and one of trussed arch held together at the joints with split-ring and hinge-and-plate connectors. Five solid arches and two each of the composite types were built and symmetrically disposed in the building, solid arches at the middle bays, double I-beam arches next, and trussed arches at the ends. The halves of the large glued arches were bent at the knee but were straight below and above the knee, and were held together at the apex with bolted plates. Flanged plate bearings for all arches were provided at the foundations.
