## Structural Performance of the Second Oldest Glued-Laminated Structure in the United States

Douglas R. Rammer<sup>1</sup>, Jorge de Melo Moura<sup>2</sup>, and Robert J. Ross<sup>1</sup>

In: *Proceedings of the Structures Congress 2014, Boston, Massachusetts, April 3-5, 2014*. Structural Engineering Institute of ASCE, 2014; pp. 1233-1243.

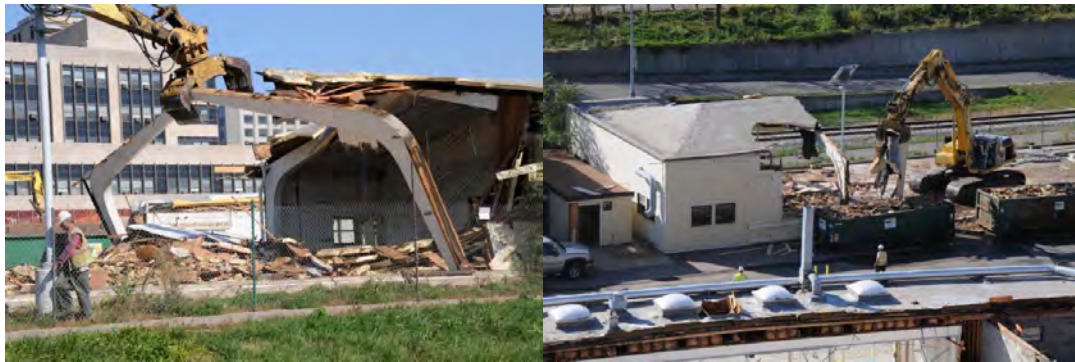
**Figure 2**—Deconstruction of FPL’s glued-laminated arch building in 2010.

After 75 years of use, this structure was deconstructed in the fall of 2010 (Figure 2). Since these glued laminated and double I section arches represent the first generation of both construction adhesives and glued-laminated development, the durability of these arches was mechanically evaluated in a manner similar to the originally 1935 structural loading of the arched building.

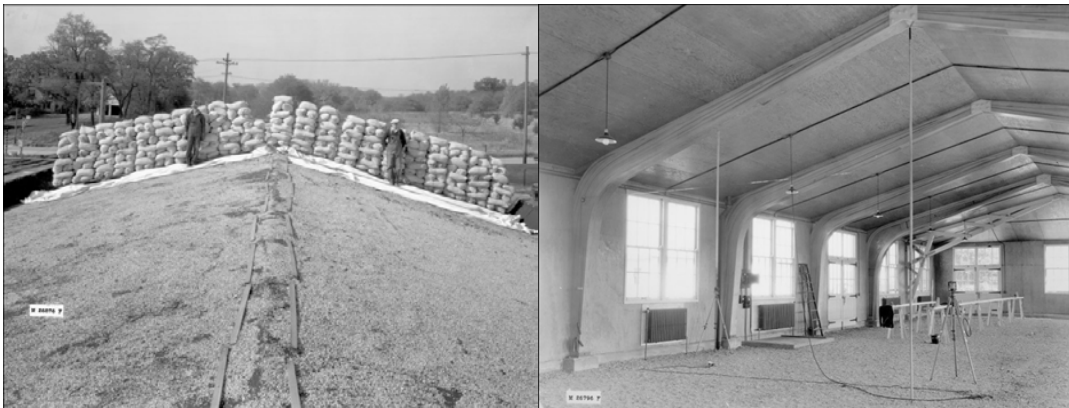
**Figure 3**— Loading of arch building and measurement techniques for live loading of building.

In the fall of 1935, the glued-laminated arch structure was evaluated by incrementally applying sand bags over the center, full arch until a full 140kN load was achieved (Figure 3). This load is equivalent to a 295 kN/m<sup>2</sup> on the tributary roof area to one arch and 42% higher than the assumed design live load. Both immediate and

sustained deformations were measured from September 1935 to May 1936 (224 days). Deformations were measured on the loaded arch at the peak and quarter points, while only the peak deformations were measured for the two adjacent arches (Figure 3). Based on these measurements, it was determined that the load was distributed to the adjacent arches by the stressed-skin panels (Wilson 1939). Data from this structural evaluation was used to establish both the short term and long-term test procedures used in this study and validated the structural models.

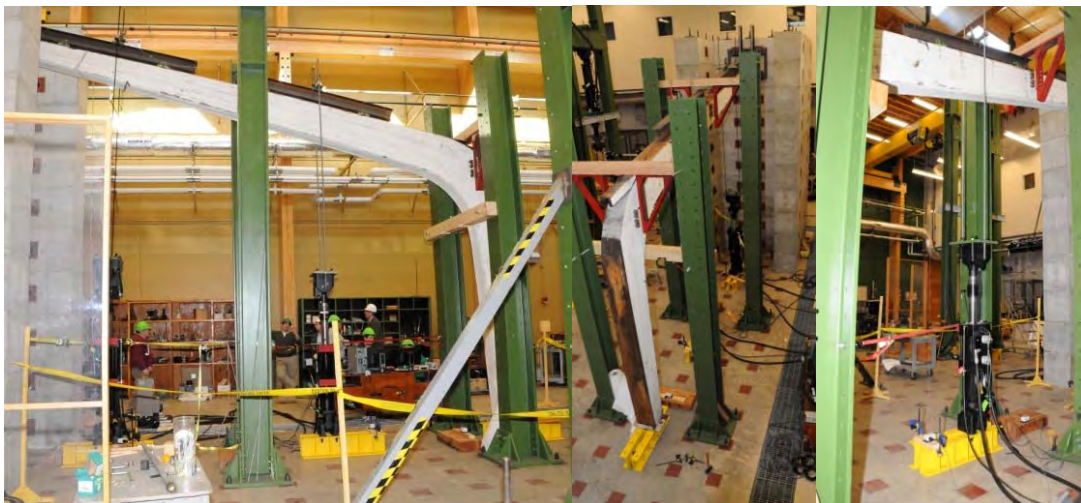
**Figure 6**—Testing setup of one half of single arch with a four-point loading configuration.

Load was applied to the arch using two 245-kN MTS actuators in tandem under load control until the maximum load of 53kN was reached. This represents half of the original sand bag loading adjusted for distributional effects. Four cycles of load were applied as shown in Table 1 with no pauses at the transitions between cycles. Loading duration in cycle 3 for arches 3 and 10 was extended to 138 and 168 hours, respectively. Figure 6 shows the images of the test setup to achieve the 4-point concentrated load condition. Both load and deformation were continually recorded

for the duration of the tests, at variable rates. Vertical deformations were measured at all quarter points and one horizontal deformation of the arch leg was measured 3.3 m above the support.
