**Durability and Wood Protection for Historic Covered Bridges in
the United States**

Poster paper prepared for 45th Annual Meeting
St George, Utah, USA
11-15 May 2014

This study is part of the Research, Technology and Education portion of the **National Historic Covered Bridge Preservation (NHCBP)** Program administered by the Federal Highway Administration. The NHCBP program includes preservation, rehabilitation and restoration of covered bridges that are listed or are eligible for listing on the National Register of Historic Places; research for better means of restoring, and protecting these bridges; development of educational aids; and technology transfer to disseminate information on covered bridges in order to preserve the Nation's cultural heritage.

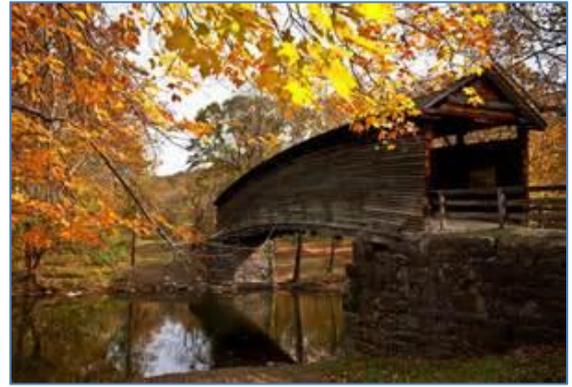
Figure 2: Humpback covered bridge in Virginia

NHCBP's highest office recognizes the historic properties of covered bridges and nominates covered bridges for National Historic Landmark status. Two bridges have been granted the status of National Historic Landmark. They are Knight's Ferry covered bridge in California, a 1864 Howe truss design (Figure 1) and Humpback covered bridge in Virginia, a 1857 multiple Kingpost truss design (Figure 2).

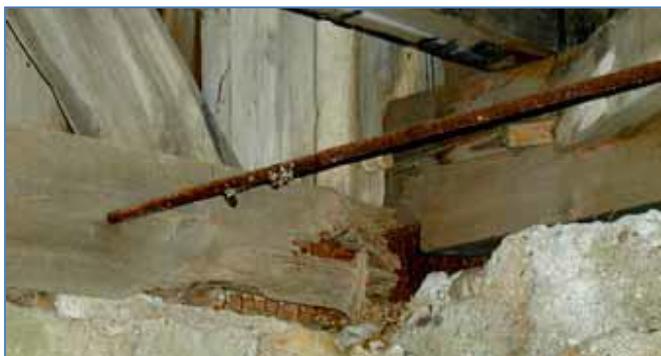
Figure 3: Deterioration of a covered bridge support joint

Covered bridges built in the 18th century were constructed without modern preservatives to protect the wood. Despite the roof and sides providing protection from moisture, biodeterioration in the bridges is inevitable in weatherboarding, wood components near the ends of the bridges that are chronically wetted from wind driven rain, and places where moisture is trapped inside the wood; joints are particularly susceptible (Figure 3). The support timbers, the roof, the deck and the connection members are all vulnerable to deterioration under high moisture conditions (Lebow 2012).

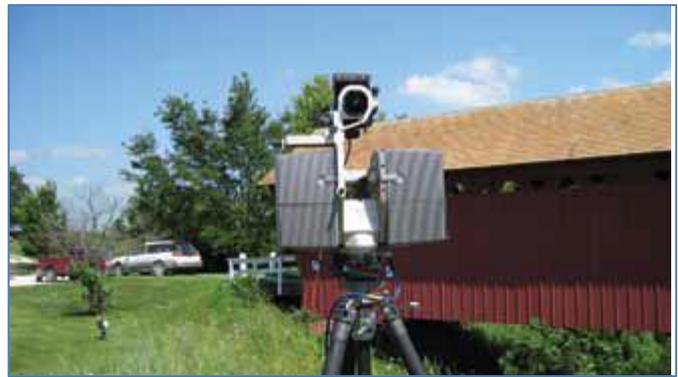
Figure 4: 3D laser scanner documents as-built details

In order to increase awareness of the covered bridges' place in American history, documentation is important to preserve their service life histories. Under a cooperative study between FPL and University of Minnesota, a new laser scanning technique has been developed to record physical dimensions and construction features for several bridges in a rapid, accurate and cost-effective manner. Figure 4 shows 3D laser scanning technology being used to document as-built conditions of historic structures. This bridge was built in 1905 by A.Y. Bayne & Co. (Brashaw and Ross 2009).
