A Field Assessment of Timber Highway Bridge Durability in the United States

J. P. Wacker¹; B. K. Brashaw²; and F. Jalinoos³

Structures Congress 2015

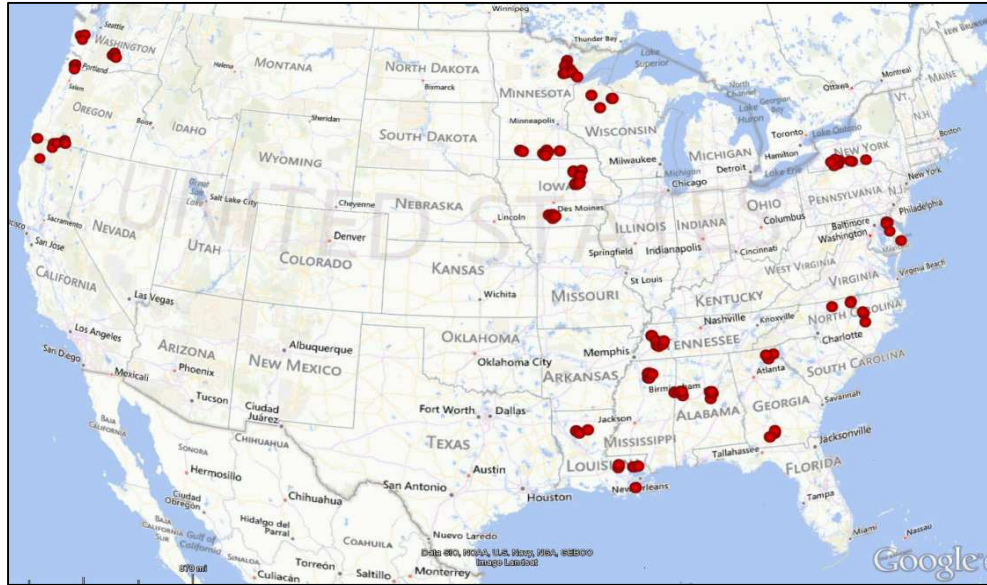
Figure 2. Location of all 132 bridges inspected within this study.

upgrades or replacement activities. See Figure 2 and Table 1 for a summary of bridges evaluated.

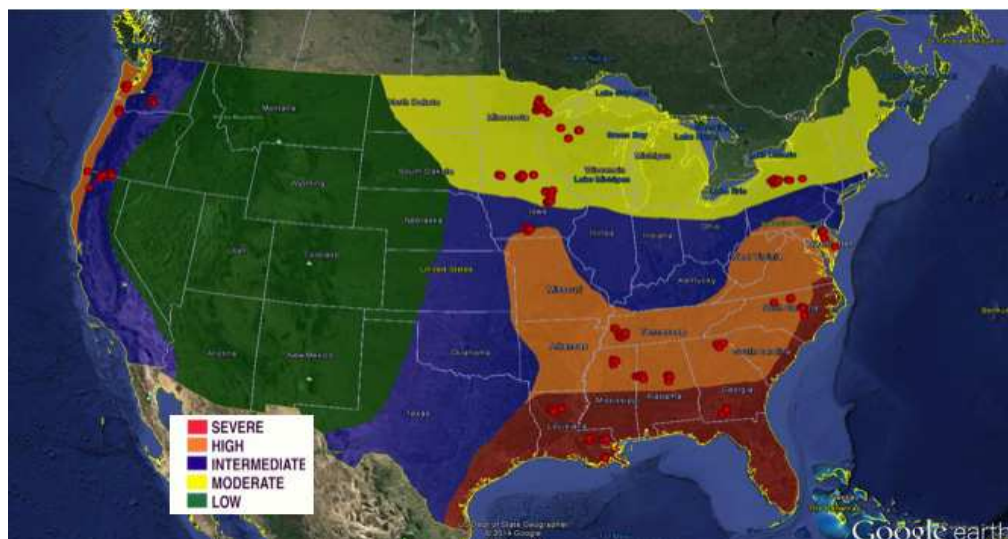
Figure 3. Bridge locations within the five AWWA-defined hazard decay zones.
