EFFECTIVENESS OF SEVERAL NDE TECHNOLOGIES IN DETECTING MOISTURE POCKETS AND: ARTIFICIAL DEFECTS IN SAWN TIMBER AND GLULAM

ABSTRACT: Several nondestructive evaluation (NDE) technologies were studied to determine their efficacy as scanning devices to detect internal moisture and artificial decay pockets. Large bridge-sized test specimens, including sawn timber and glued-laminated timber members, were fabricated with various internal defects. NDE Technologies evaluated in this research were ground penetrating radar (GPR), microwave scanning, ultrasonic pulse velocity, ultrasonic shear wave tomography, and impact echo methods. Each NDE technology was used to evaluate a set of seven test specimens over a 2-day period and then raw data scans were processed into two-dimensional, internal defect maps. Several parameters were, compared including the relative size, orientation, and moisture conditions of the internal defect. GPR was the most promising NDE technology and is currently being more rigorously evaluated within the laboratory. The study results will be useful in the further development of a reliable NDE scanning technique that can be utilized to inspect the primary structural comp

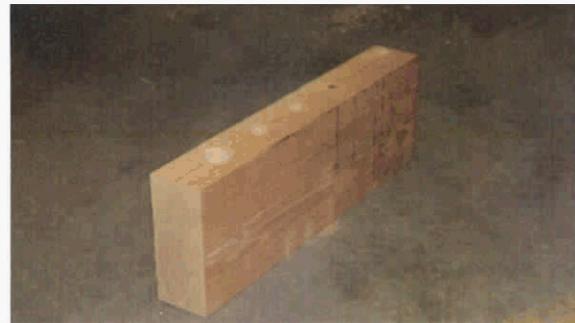
Figure 1: Specimen FPL-1 sawn lumber beam with defects through depth.

Sawn lumber beam specimens were fabricated to a finished size of 140 x 337 x 914 mm. Specimen FPL-1 included a total of five uniformly spaced through-bored holes of increasing diameter, orientated parallel to the beam depth and aligned with the neutral axis (Figure 1). Specimen FPL-2 included a series of 5 through-bored holes which were orientated at oblique angles to the beam depth and width (Figure 2). Specimen FPL-3 included a total of five uniformly spaced through-bored holes of increasing diameter, orientated parallel to the beam width (Figure 3). The row of bored holes was offset from the neutral axis so defects could be inspected from both sides at either a shallow or a deep penetration depth.

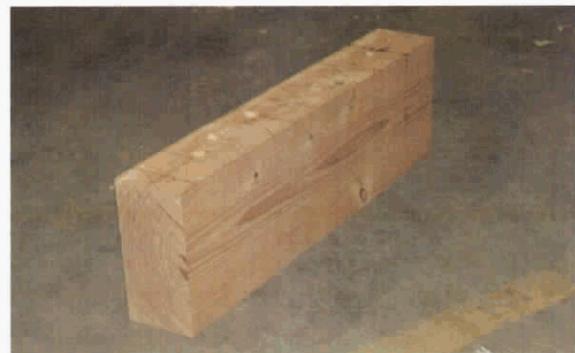
Figure 2: Specimen FPL-2 sawn lumber beam with angled defects.

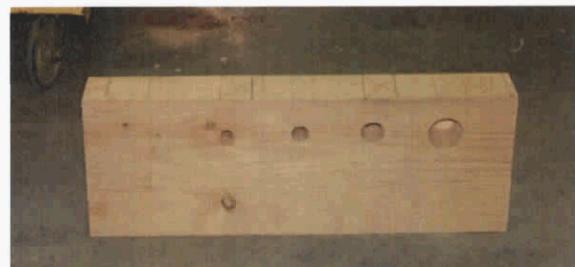
Figure 3: Specimen FPL-3 sawn lumber beam with defects through width and offset from beam neutral axis.

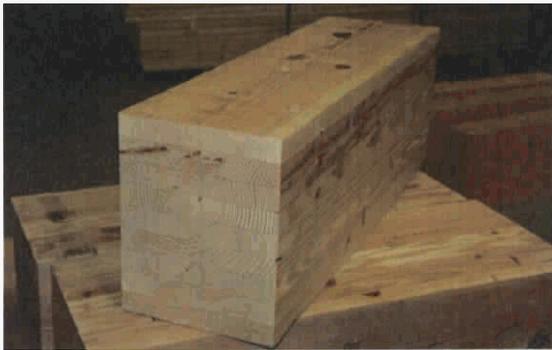
Figure 5: Specimen FPL-5 glulam beam.

Glued-laminated timber (glulam) beams were fabricated to a finished size of 273 x 343 x 914 mm. Specimen FPL-4 included a total of five uniformly spaced through-bored holes of increasing diameter that were orientated perpendicular to the glue lines but aligned with the neutral axis (Figure 4). Specimen FPL-5 included a series of 5 through-bored holes which were orientated at oblique angles to the beam depth and width (Figure 5). Specimen FPL-6 included a total of five uniformly spaced through-bored holes of increasing diameter and were orientated parallel to the glue lines (Figure 6). The row of through-bored holes was offset from the member neutral axis so that the defects could be inspected from both sides at either a shallow or a deep penetration depth.

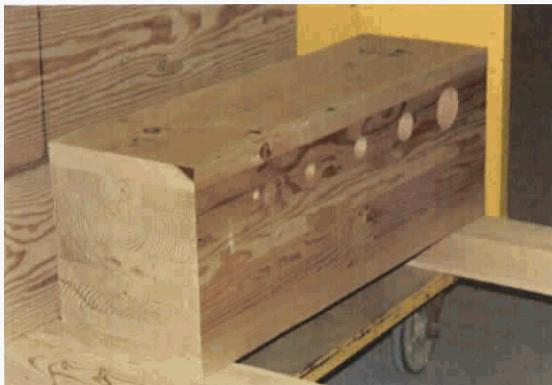
Figure 6: Specimen FPL-6 glulam beam.

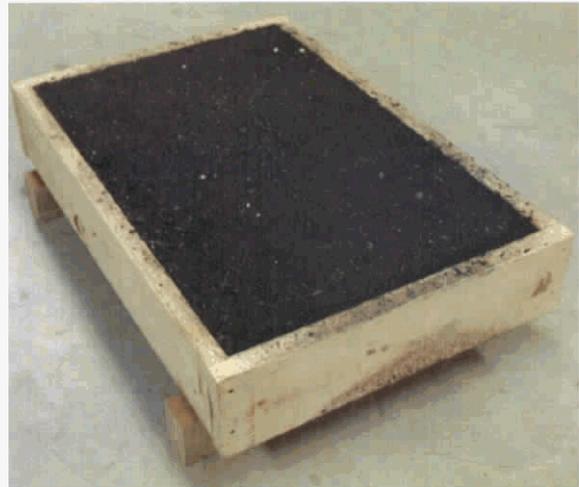
Figure 7: Specimen FPL-7 glulam deck panel with 76mm asphalt overlay. Side, forms are to conceal defect locations.

A single deck specimen was fabricated with a glulam panel measuring 610 x 191 x 914mm (Figure 7). It also had an asphalt overlay measuring 76mm deep installed following typical construction practice. A series of three uniformly spaced bore holes of increasing diameters were aligned along the mid-depth of the glulam deck. This specimen allowed for top-down inspection through the asphalt as would be required for a timber bridge deck, especially longitudinal “slab-type” systems.

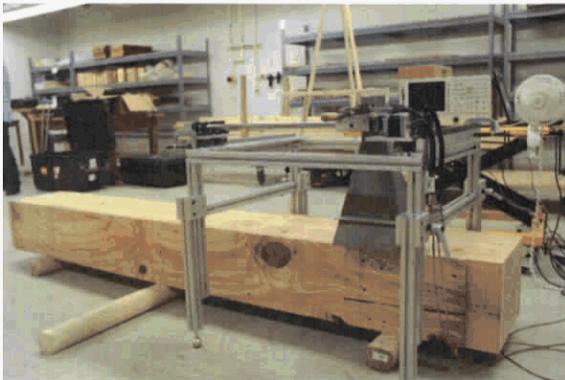
Figure 8: Inspecting specimen FPL-4 with a 2.75 GHz microwave antennae mounted on an automated test frame.

use of one or more NDE technologies to evaluate all seven test specimens within a 2-day inspection timeframe (See Figures 8-12). All NDE investigations were conducted in identical environment conditions controlled at 21 degrees Celsius and 65 percent relative humidity. Approximately 24 hours prior to NDE evaluation work commenced, a few specimens had saw dust and moisture packed into the bored hole artificial defects. With exception of ultrasonic pulse velocity measurements, none of the other NDE technologies required any coupling agent during testing. After data scanning was completed, each investigator was asked to prepare a detailed inspection report and to post-process their datasets into two dimensional internal defect maps.

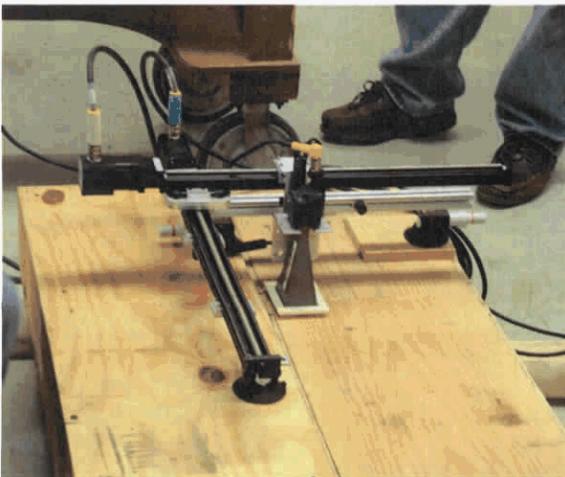
Figure 9: Inspecting specimen FPL-1 with a 10 GHz microwave antennae mounted on an automated test frame.

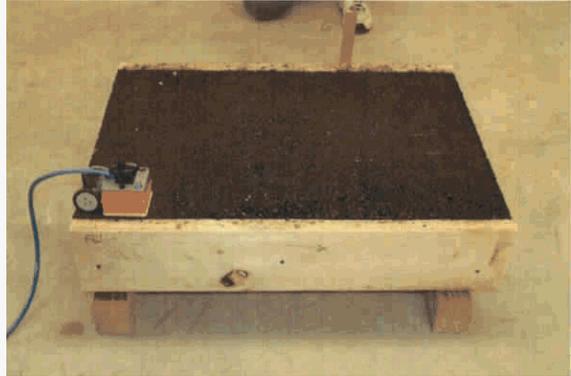
Figure 10: Inspecting specimen FPL-7 with a 2GHz handheld ground penetrating radar (GPR) antennae.

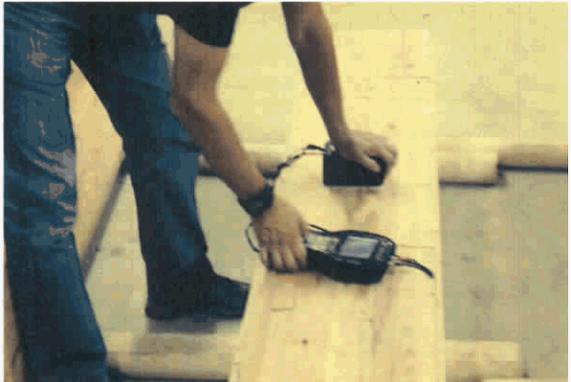
Figure 11: Inspecting a specimen with ultrasonic shear wave tomography device.

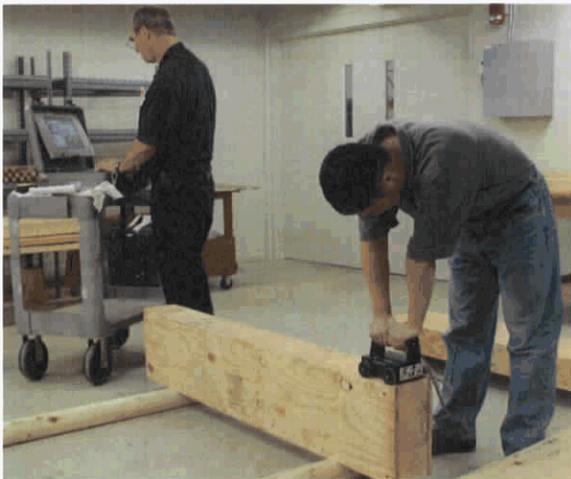
Figure 12: Inspecting specimen FPL-3 with handheld impact echo scanning device.

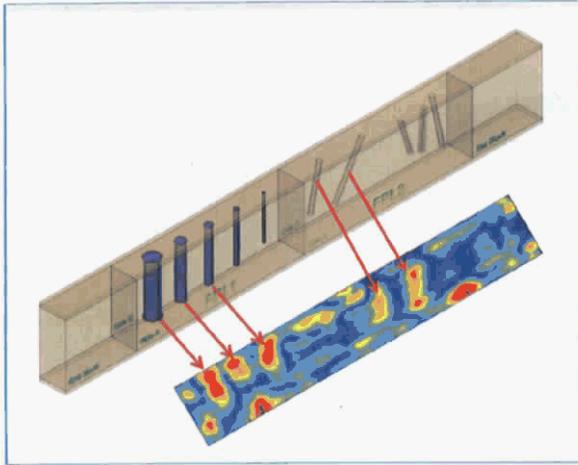
Figure 13: 2-dimensional defect mapping of specimens FPL-1 and FPL-2 positioned end-to-end generated from the 2.75 GHz microwave device. (blue indicates moist sawdust filled holes)

The resulting 2-D defect map resulting from the 2.75 GHz microwave device is presented in Figure 13. In this testing, specimens FPL-1 and FPL-2 were positioned end-end, with end blocks added and defect locations concealed by plywood side plates. The horizontally drilled holes in FPL-1 were filled with compacted wet sawdust, and were discernible for those bored hole diameters greater than 38mm. In addition, some of the angled drilled holes that were air-filled were discernible at diameters of 25mm.

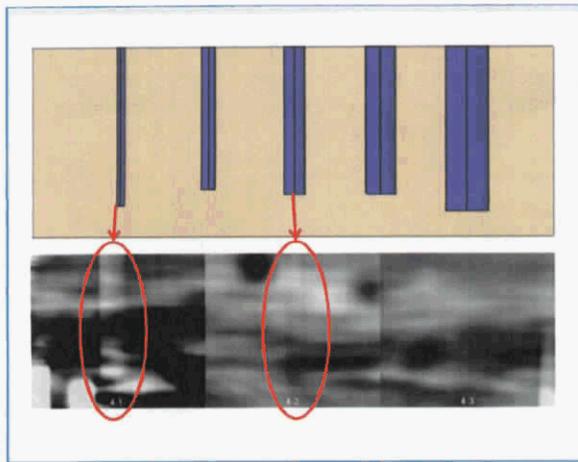
Figure 14: 2-dimensional defect mapping of Specimens FPL-4 generated by the 10GHz microwave device.

The resulting defect imaging results from the 10 GHz microwave device is presented in Figure 14. In this testing, specimen FPL-4 included several bored holes with different diameters and were packed with wet sawdust prior to testing. However, these defects were not discernible by the microwave device even for the largest hole diameters.

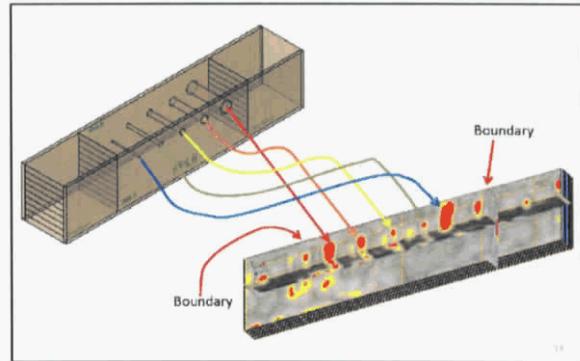
Figure 15: 2-dimensional defect mapping of specimen FPL-6 generated from the 2.0GHz GPR device.

Figure 15 shows the results of testing scans for specimen FPL-6 using the 2 GHz ground penetrating radar (GPR-A) equipment. The specimen was constructed of glulam materials and the artificial defects (drilled holes of increasing diameter and depths) were orientated perpendicular to the scanning direction for best results. Scanning direction was oriented perpendicular to the glue lines in the beam but was still able to identify all holes.

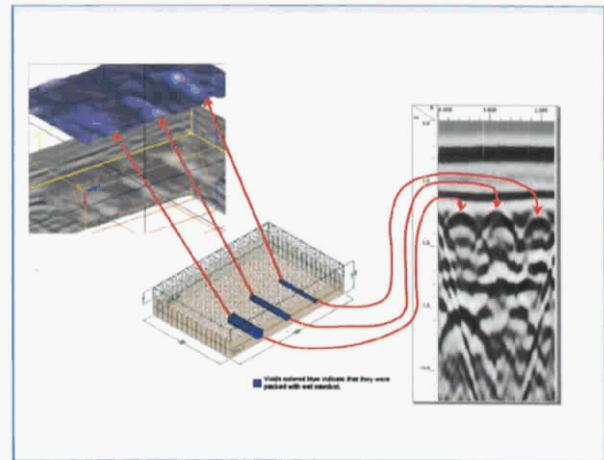
Figure 16: 2-dimensional defect mapping of specimen FPL-7 generated from a 2.75 GHz microwave antennae.

Figure 16 shows the results of testing scans for specimen FPL-7 using ground penetrating radar (GPR-A) equipment. The specimen was constructed of glulam materials and included an asphalt overlay. Testing was performed from asphalt side viewing through into the glulam panels. It is evident that all three moist sawdust filled holes were identified by this GPR device. Raw data scans are provided on the right side showing the characteristic peaks expected for round anomalies.

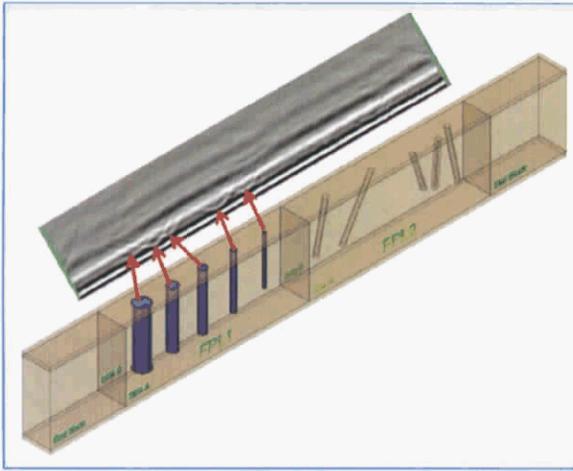
Figure 17: Two-dimensional defect mapping of specimens FPL-1 and FPL-2 positioned end-to-end generated by the 2.0 GHz GPR device.

The resulting 2-D defect map resulting from the 2.0 GHz ground penetrating radar device is presented in Figure 17. In this testing, specimens FPL-1 and FPL-2 were positioned end-end, with end blocks added and defect

locations concealed by plywood side plates. The horizontally drilled holes in FPL-1 were filled with compacted wet sawdust, and were detectable for nearly all bored hole diameters.
