## Potential Impact of Subterranean Termites on Cross-Laminated Timber (CLT) in the Southeastern U.S.

### ABSTRACT

Stokes, CE, Tang, JD, Shmulsky, R. 2017. Potential impact of subterranean termites on cross-laminated timber (CLT) in the southeastern U.S. *Proceedings of the American Wood Protection Association Meeting*. 113:214-219

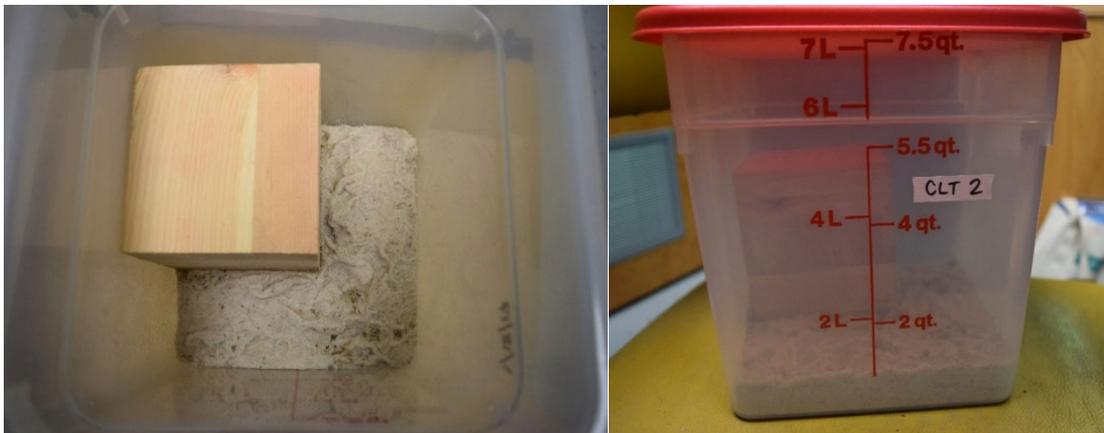
Figure 1. Test containers for subterranean termite testing. Termites introduced into corner diagonally opposite of the test block location.

Native subterranean termites (*Reticulitermes* spp.) were collected from the one log found in the Sam D. Hamilton National Wildlife Refuge, Brooksville, MS, United States, and used within one month of collection. On the day of the test, sterilized containers with sand substrate were labeled according to treatment and moistened with 200 mL of sterile distilled water. One conditioned, weighed test block was added to each of the 20 containers. The average mass of 400 worker termites was determined and then multiplied by a factor of 2.5 to obtain the mass of termites (approximately 1000 termites with less than 10% soldiers), which was added to each of the 15 containers requiring termite exposure. Treatment containers were sealed with a lid that had a hole plugged with sterile cotton for air exchange, weighed, and placed in the environmental chamber in which the blocks had been conditioned (Figure 1).

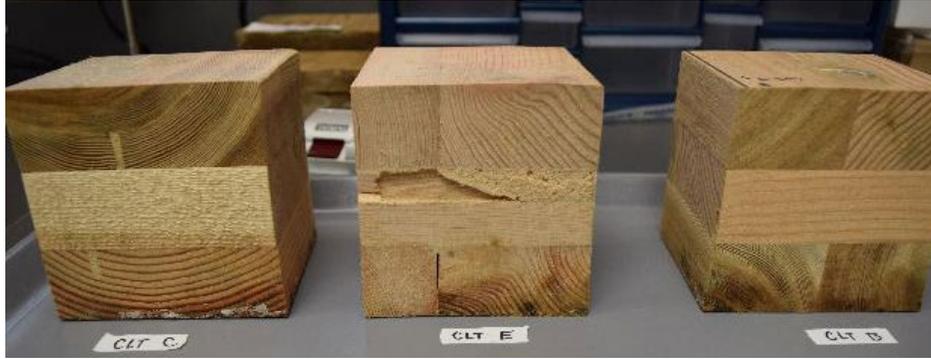
**Figure 2. Water staining on exposed (bottom) face of control (no termite) CLT blocks after 8 weeks. Average water uptake of control blocks was 39.5 g.**

All CLT control blocks gained mass over the course of the 8-week test (39.5 g average). This uptake was attributed to the capillary action of water from the sand substrate moving into the blocks over the course of the test, which stained the face exposed to the damp sand on each block (Figure 2). Termite-exposed blocks also increased in mass over the course of the test, aside from copper azole treated pine (CA-P) (Table 2). Weight increase in test blocks may partially be the result of water uptake, but may also be a result of debris left behind during termite excavation. Some, but not all, of this debris may have been removed during disassembly. How much is difficult to determine at this time.

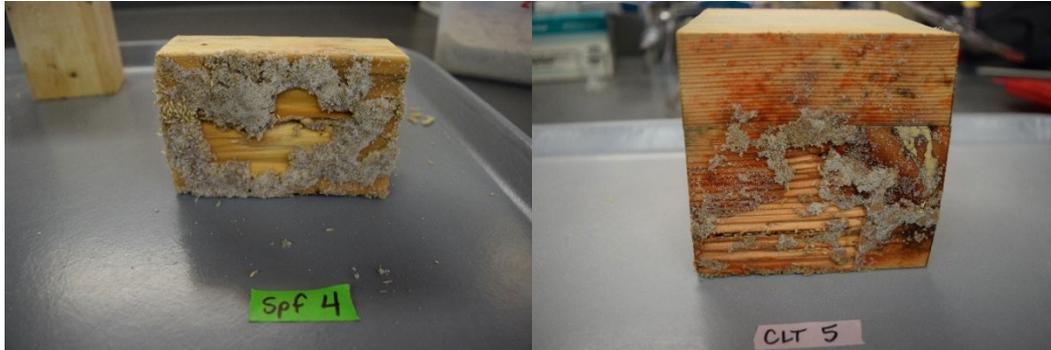
Figure 3. Termite excavations on the exposed (bottom) face of spruce/pine/fir and CLT test blocks. Termites and mud tubes intact on test blocks.

Photographs of test blocks show indications of termite excavations on the exposed surface of CLT and spruce/pine/fir (SPF) blocks (Figure 3). The maximum depth of termite excavations into CLT was measured and found to be 1/8” (3.2 mm). Termites also constructed mud tubes on multiple vertical faces of CLT and SPF test blocks apparently to reach openings into other areas of the wood such as non-glued internal board faces or adhesive overflow channels. Copper azole blocks showed no signs of excavation or construction of mud tubes.

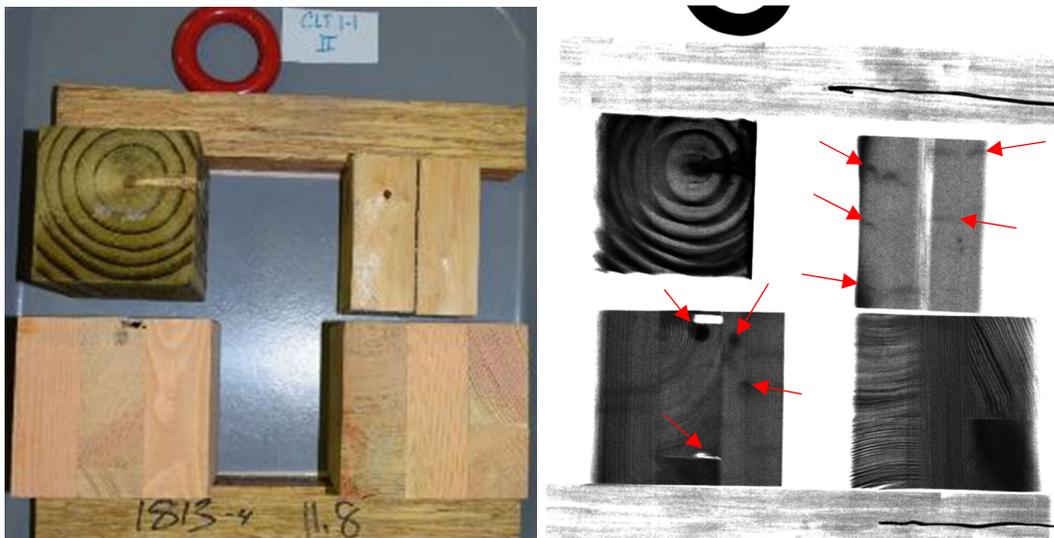
Figure 4. X-ray scan analysis. Red arrows on right indicate suspected termite damage areas. Top left = copper azole treated pine; Top right = spruce/pine/fir; Bottom left = CLT exposed to termites; Bottom right = CLT control.

X-rays were taken to compare blocks and images show less dense areas that were suspected to be termite excavations and higher density areas that could be excavations filled with waste and debris (Figure 4). However, when sliced, only some of the samples indicated potential excavations that could be confirmed as having been opened up by termite feeding activity. This may be a result of damage done to the excavated areas while cutting test blocks on a band saw.
