Durability of cross laminated timber against termite damage

Proceedings of the 61st International Convention of the Society of Wood Science
and Technology and Japan Wood Research Society
November 5-9, 2018 – Nagoya, Japan

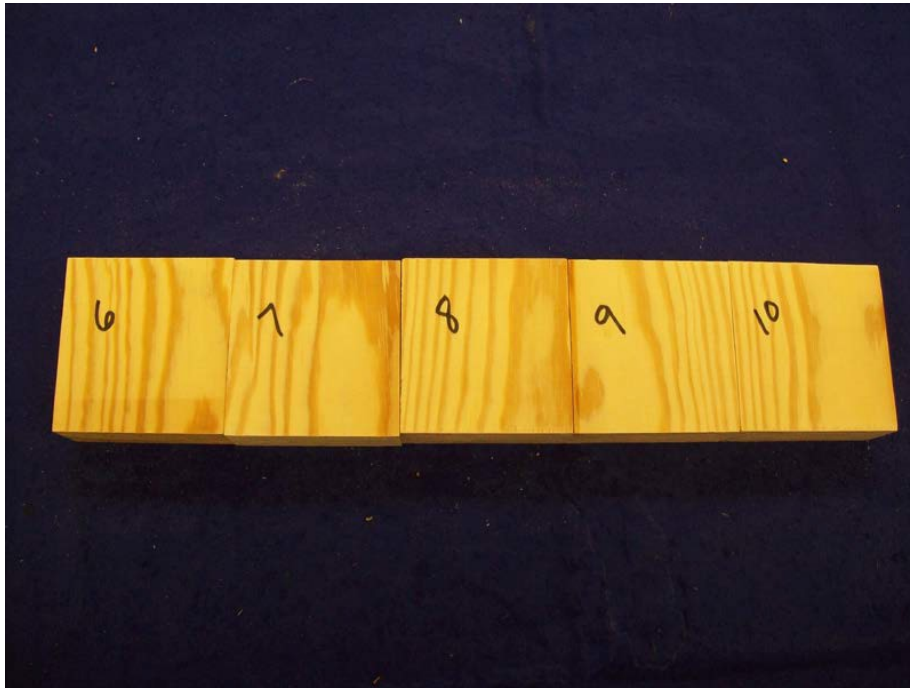
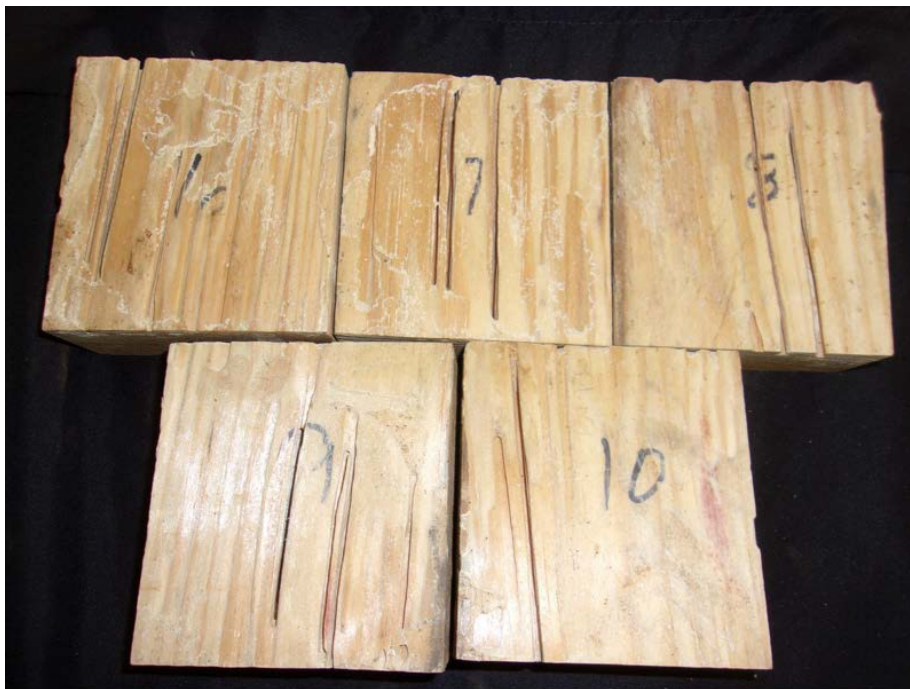
Figure 2 – Group 1 untreated southern yellow pine: (a) samples prior to exposure to *C. formosanus*; (b) samples after exposure to *C. formosanus*.

Photographs documenting the damage appear in Figures 2, 3, and 4. Even though CLT samples had significantly less percent mass loss than control pieces (untreated pine), the CLT samples exhibited slightly more damage as they received a lower average visual rating (7.5) compared to the untreated pine blocks (8.0). The damage caused by termite attack on CLT samples was considered moderate to severe, with penetration. For untreated pine samples the damage was classified as moderate.

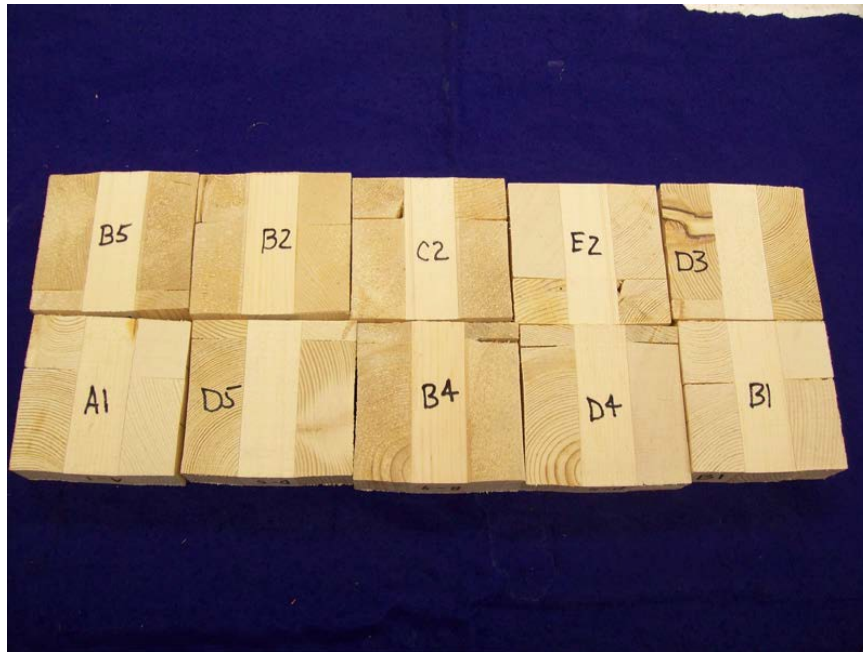
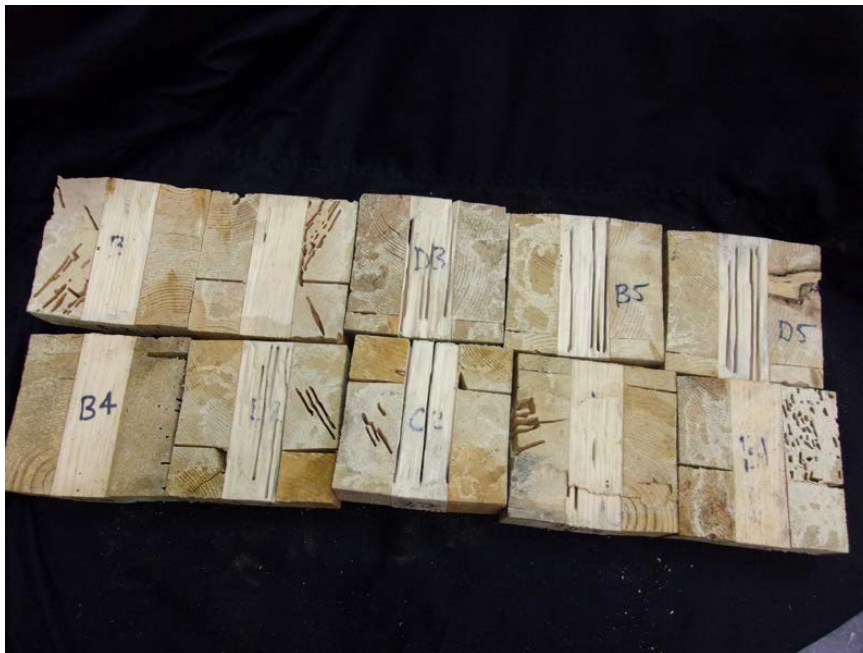
Figure 4 – Group 3 CLT blocks: (a) samples prior to exposure to *C. formosanus*; (b) samples after exposure to *C. formosanus*
