DURABILITY OF MASS TIMBER STRUCTURES: A REVIEW OF THE BIOLOGICAL RISKS

Keywords: Mass timber, cross-laminated timber, durability, wood protection.

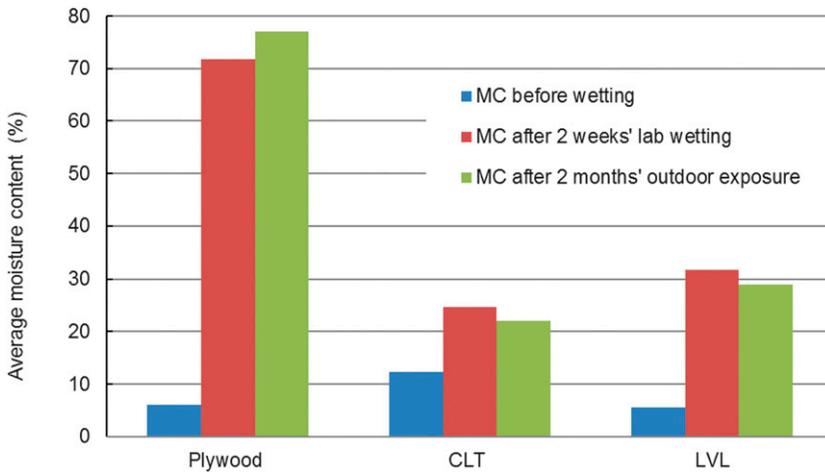
Figure 1. MC of spruce-pine-fir plywood, cross-laminated timber (CLT) and laminated veneer lumber (LVL) following an 18-d simulated rainfall exposure and 2-mo natural exposure in Vancouver (Wang 2014).

Moisture exposure is common during construction in North America, and there is a perception that moisture entering a structure during construction can be easily removed naturally or through application of heat before finishing the interior. This may be true with dimensional lumber; however, CLT and plywood have markedly different wetting and drying rates. Wang (2014) exposed edge-sealed 3 ply spruce-pine-fir (SPF) CLT (boards 33 × 140-mm-wide with polyurethane adhesive), 13-ply LVL, and 19-mm-thick SPF softwood plywood to an hourly 5-s water spray for 18 d (delivering ~35 L of water per specimen) in the laboratory or to natural weather during a 2-mo period in Vancouver, British Columbia, Canada. The MC of the plywood increased from <10% to more than 70% under both exposure conditions, whereas the LVL MC increased from 6% to 30% (Fig 1). The average MC of CLT samples also increased over the wetting period, but the increases were much

smaller, moving from 12% before wetting to 24% after wetting. The results highlight that LVL and plywood have characteristics such as lathe checks that can channel humid air and water into the inner plies, leading to rapid wetting (Van den Bulcke *et al.* 2011).

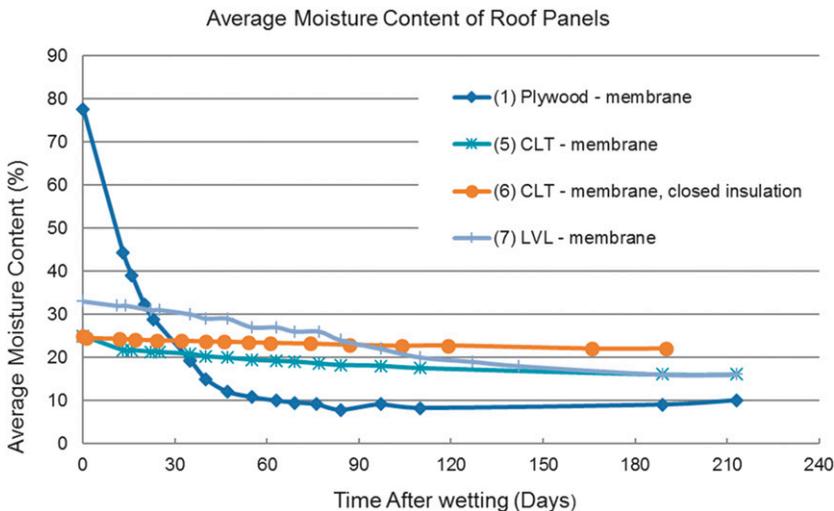
Figure 2. Moisture changes in spruce-pine-fir plywood, cross-laminated timber (CLT) and laminated veneer lumber (LVL) samples that were first wetted over an 18-d period then covered with a membrane and/or closed-cell foam before drying under cover (Wang 2014).

Redrying of wetted materials can also vary widely. For example, plywood samples with an impermeable membrane on one side went from nearly 80% MC to less than 10% in approximately 60 d (with no supplemental heating source that would encourage drying) (Fig 2). CLT samples did not start out as wet as the plywood, but their moisture loss rates were far slower. The moisture contents of CLT samples covered with the same membrane on the top were still greater than 15% at the end of the 180-d drying period and greater than 20% when the underneath surfaces were also covered with 3 in. of closed cell foam. These areas could be susceptible to mold or insect attack.

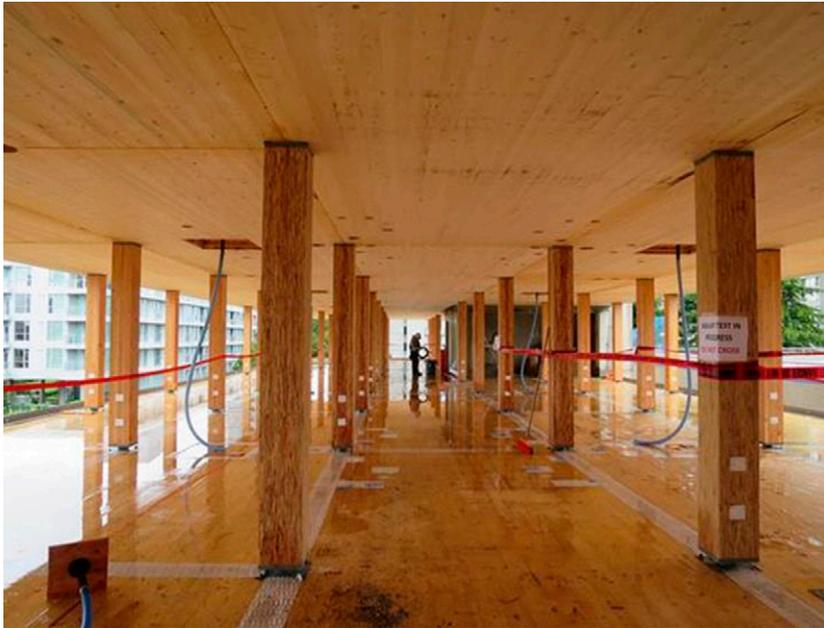
Figure 3. Water accumulating on a cross-laminated timber floor following a rainstorm.

conditions would not be representative of the cool, wet winter conditions in this climate. MC was assessed on CLT floor panels immediately after installation, then 1, 4, and 14 d after heavy rain showers to assess the impact of a rain event on wood MC (Fig 3).

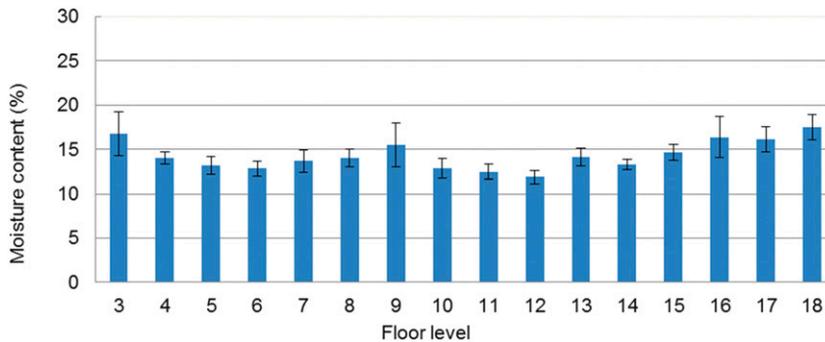
Figure 4. Moisture levels in cross-laminated timber panels on different floors during construction of an 18-story mass timber building as measured using electric resistance moisture meters (Wang and Thomas 2016). Error bars added to show that variations in MC were relatively small (Wang and Thomas 2016).

Wang and Thomas 2016). The building has 17 stories of mass timber construction sitting on a one-story concrete podium with five ply (169-mm thick) CLT floors point supported by multiple columns, mostly composed of glue-laminated timber, but with PSL columns on the lower floors.

Erection of mass timbers (glulam/PSL columns, CLT floors) started in early June and was completed in mid-August 2016. An average of two

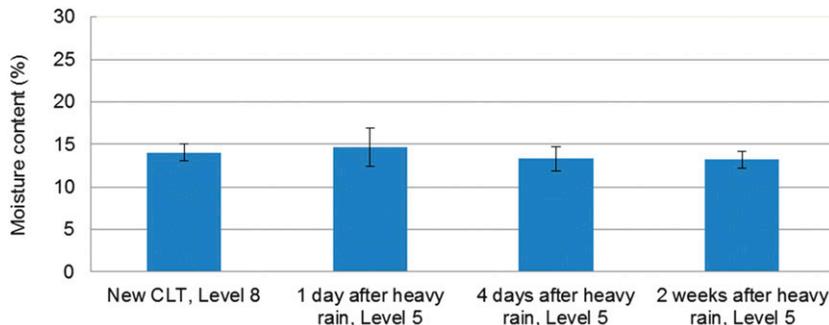
Figure 5. Moisture levels in cross-laminated timber (CLT) immediately after installation in an 18-story mass timber building compared with moisture levels 1, 4, and 14 d after heavy rain on level 5 as measured using a resistance-type moisture meter (Wang and Thomas 2016).

The measurements covered “normal” wood (ie no visible defect, away from end grain), end grain close to finger joints, and blue-stained sapwood of beetle-killed lodgepole pine. About 20 readings were taken 5-mm inward from the surface at random locations on CLT panels located in the southeastern part of each floor. Moisture levels varied slightly between floors, but the differences were small (2-4%) (Fig 4). Examination of moisture levels at selected times after a rainfall showed a slight increase immediately afterward but then a slow decline with time (Fig 5). It is important, however, to note that these measurements were only taken to a depth of 5 mm from the surface. Moisture levels further inward may increase more slowly, but drying rates in these zones will also be slower.

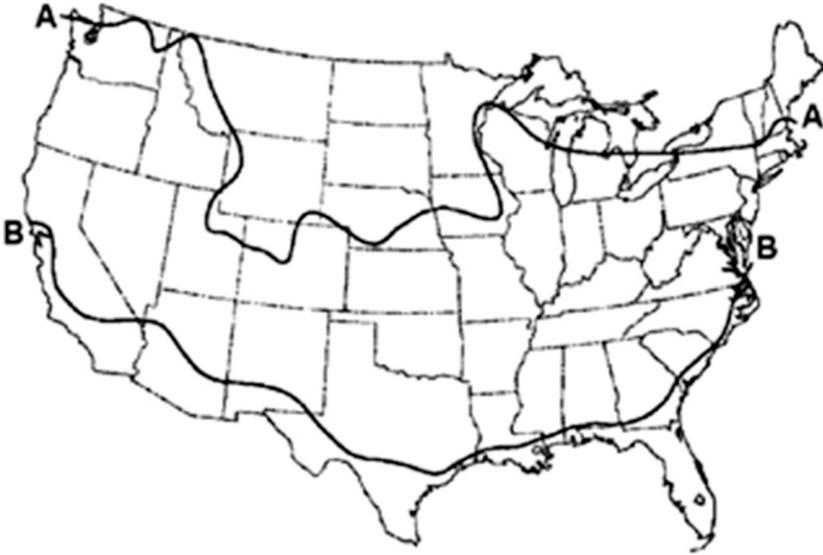
Figure 6. (a) The northern limit of recorded damage done by subterranean termites in the United States; (b) the northern limit of damage done by dry-wood termites (Moore 1979). Note: Termite damage has also been noted in southern British Columbia and Ontario, Canada (PI Morris, FPInnovations, Vancouver, British Columbia, Canada).

Dry-wood termites (*Kalotermitidae*) nest in wood with low MC and thus could potentially be a problem for untreated CLT in service. Dry-wood termites can live in wood without exogenous moisture. Colonies of these termites are generally smaller than subterranean termites, but dry-wood termites can cause considerable localized damage because they are difficult to detect and reinfestation often occurs. In the United States, dry-wood termites only occur in a narrow strip of territory extending from central California around the southern edge of the continental United States to Virginia (Fig 6) and in the West Indies and Hawaii. They can be excluded by
