Research
Note
FPL-0251

Performance of a Press-Lam Bridge

A 5-Year Load-Testing and Monitoring Program

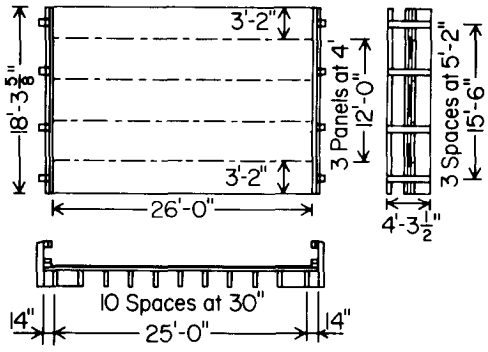
Figure 2.—Construction of Press-Lam bridge. (ML85 5007)

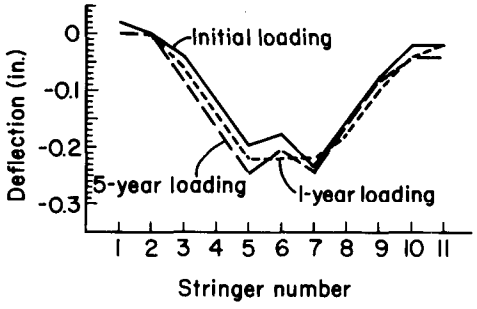
Results of the deflection readings are summarized in Table 1, and an example of the deflection profile under one loading is shown in figure 3. The bridge became slightly more flexible with age. Total deflection increased 9 percent after 1 year and 17 percent after 5 years. This might be expected, as moisture content of the bridge members has increased by up to 5 percent since 1977 (fig. 4).

Examination of deflection profiles for the 3 load tests for all 13 load positions confirmed the increase in flexibility. However, some of the increase in deflections appears to be a “smoothing” of the deflection profile (especially between the wheel loads) rather than an overall increase in deflections across the bridge.

Figure 3.—Typical deflection profile for the truck positioned near the center of the bridge. (ML85 5006)

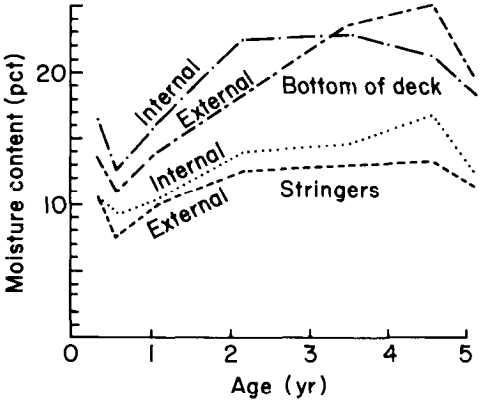
Figure 4.—Change in moisture content of various bridge components. (ML85 5004)

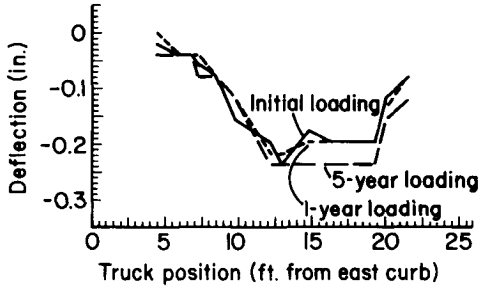
If the deflections are plotted as influence lines for the stringers (fig. 5), other observations are apparent. The first is that the same smoothing effect that was indicated in the deflection profiles occurs in the influence lines. A second, more significant, observation is that the maximum deflection observed in the 1977 load test was not exceeded in the 1978 or 1982 load tests for 7 of the 11 stringers. For the other four stringers, the 1977 maximum was exceeded by 8 to 17 percent in subsequent tests.

Figure 5.—Typical influence line for stringer deflection related to truck position. This shows the deflection of a stringer located at about 13 feet from the east curb when the load is located at different positions. (ML85 5005)
