Research
Paper
FPL–RP–552

Field Performance of Timber Bridges

9. Big Erick's Stress-Laminated Deck Bridge

November 1996

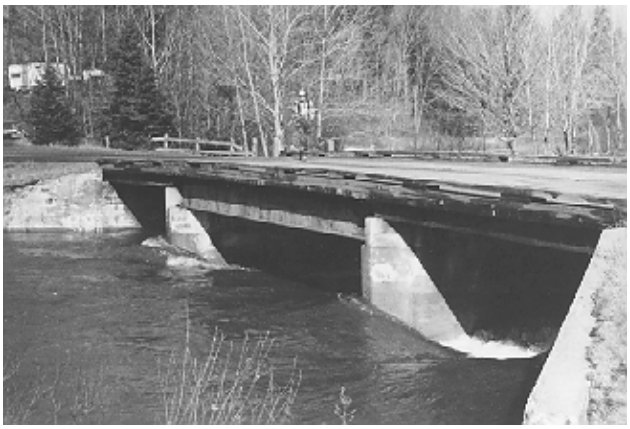
Figure 2—Big Erick's bridge prior to replacement (1980).

The original Big Erick's bridge was constructed in 1957 by the MI–DNR Fire Division to provide access for administrative vehicles, fire equipment, and logging trucks. This bridge was 20 ft wide and consisted of two 20-ft-long approach spans and a 32-ft-long center span (Fig. 2). Beneath two layers of timber plank deck, the approach spans were supported by untreated sawn lumber stringers and the center span was supported by steel stringers. Failure of the deck material in 1980 alerted MI–DNR officials to structural problems with the bridge. After the decking material was repaired, an annual inspection in 1989 revealed cracked and decayed wood stringers on the approach spans. Several options were examined to repair or replace the structure. As a result of uncertainty regarding the extent of rehabilitation required to restore full-load capacity, replacement of the bridge was deemed the most feasible solution.

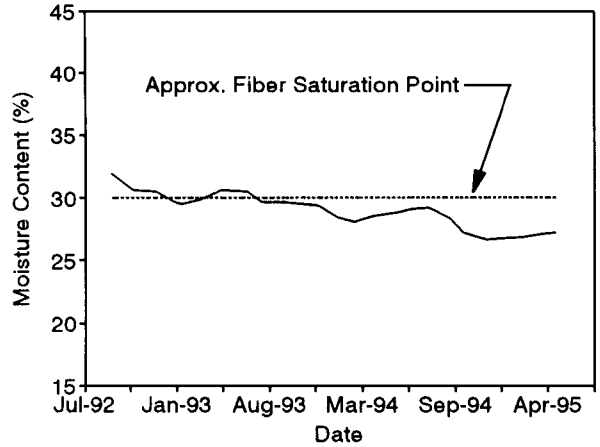
Figure 17—Average trend in electrical resistance moisture content readings.

The average trend in electrical resistance moisture content readings is shown in Figure 17. Readings taken at the beginning of the monitoring period indicate an average moisture content of approximately 33 percent. During the monitoring period, an overall decrease in moisture content was observed, with seasonal changes of ±2 percent. At the end of monitoring, moisture content was approximately 28 percent, a 5-percent decrease. The laminations remained within ±3 percent of the fiber saturation level for Eastern Hemlock, which is generally assumed as 30 percent but can range from 25 to 30 percent (FPL 1987).

- The sawn lumber components of the Big Erick's bridge were initially installed at 33-percent moisture content. The average trend in moisture content indicates that changes are occurring slowly, with an average decrease of 5 percent during the monitoring period. The high moisture content contributed to bar force and camber loss during the monitoring period. It is expected that the moisture content will gradually decrease and lamination dimensional change should be expected. Future bridges constructed of this type should utilize laminations with moisture content at or below 19 percent.

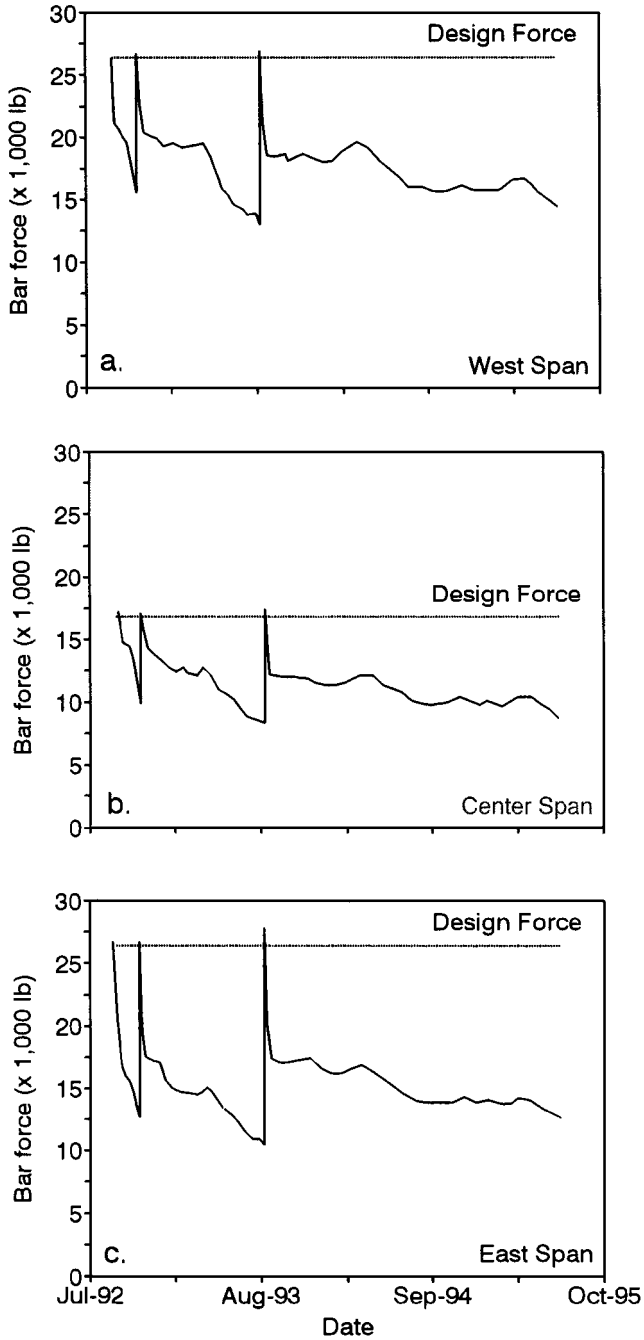
The average trend in bar force, starting at the third stressing, is shown in Figure 18. At the third stressing, all bars were tensioned to the design level of 100 lb/in^2, or 26,400 lb for the approach spans and 16,800 lb for the center box. After 2 months, all three spans lost 40 to 50 percent of the design bar force and the bars were retensioned. Eleven months after installation, all three spans lost 50 to 60 percent of the design bar force and were tensioned again. Approximately 2 weeks after this fifth bar tensioning, the bar force stabilized at approximately 70 percent of the design bar force, then decreased slowly for the remainder of the monitoring period. At the conclusion of monitoring, bar force values were 14,800 lb

Figure 18—Average trend in bar force, starting at the third bar tensioning for (a) west, (b) center, and (c) east spans.

for the west span, 8,700 lb for the center span, and 12,500 lb for the east span, which is 45 to 55 percent of the design bar force. With each bar tensioning, the rate of bar force loss decreased, although the overall amount of bar force lost between stressings remained relatively equal.

The bar force loss was probably the result of three factors: stress relaxation, prefabrication methodology, and crushing of the timber laminations. The majority of bar force loss was the result of stress relaxation, a time-dependent phenomenon caused by the long-term compressive force of the steel bars acting on the wood microstructure. The rate of stress relaxation was greater on the Big Erick's bridge when compared with other stress-laminated bridges and was probably the result of the high moisture content in the timber laminations. An additional factor affecting bar force loss was the prefabrication methodology of completing two of the recommended bar tensionings on partial-width sections. This methodology diminished the positive effects of repetitive tensionings, because the bars were not full width until the third tensioning. Another plausible cause of bar force loss was crushing of the exterior laminations on the approach spans. Crushing was observed under the bearing plates during construction and the monitoring period. The rate of crushing and the corresponding bar force loss decreased with each subsequent bar tensioning. This is discussed in detail in the Condition Assessment section.

The observed bar force on the center and approach spans behaved similarly, as displayed in Figure 18. The center and approach spans have different bar force design values; therefore, percentage of bar force loss was used for comparison. All spans exhibited similar bar force losses of 40 to 50 percent before the fourth stressing, 50 to 60 percent prior to the fifth stressing, and 45 to 55 percent at the end of monitoring. These similarities between the approach spans and the center span suggest that stress-laminated decks and boxes, built from comparable materials, perform alike when subjected to the same environmental conditions.

- Following the final design bar tensioning, two additional bar tensionings were required due to rapid loss of bar force. The decrease in bar force was primarily attributable to transverse stress relaxation in the wood laminations with additional effects from crushing of the approach span exterior laminations near the bar anchorages. It is anticipated that the bridge will require retensioning in the near future. In addition, as the moisture content decreases, the bar force will also decrease until an equilibrium moisture content is reached. Therefore, bar force should be checked annually and retensioned as necessary until it reaches a constant level.

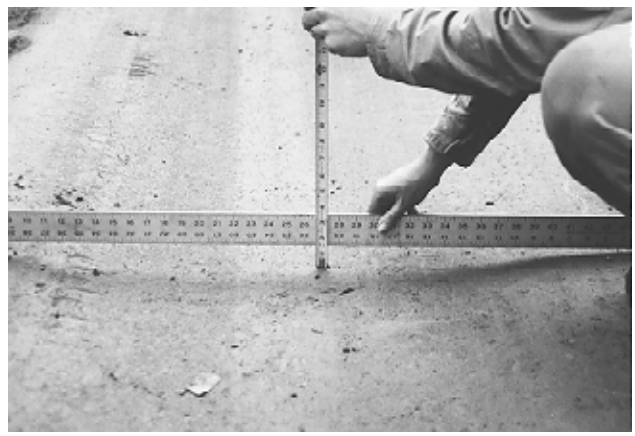
The asphalt wearing surface was observed to be in poor condition at the conclusion of the monitoring period. Large transverse cracks were observed at the piers and at the west abutment. At the west pier, transverse cracking has heaved 1 to 2 in. above the roadway grade. Longitudinal rutting was also observed along two vehicular wheel lines in the asphalt on the bridge and the approach roadway, which varied from 0.5 to 1.5 in. in depth. The rutting is most severe at the center span (Fig. 28). Rutting was first observed 11 months after bridge installation and increased during the monitoring period. The heaving and rutting were probably caused by a poor asphalt mix and will cause rain water to remain on the deck for extended periods. This condition also tends to trap a substantial quantity of gravel and other debris on the surface from the unpaved road. The debris accumulations could lead to premature deterioration of the wearing surface.

Figure 28—Rutting of asphalt wearing surface measured at the center span during a site visit for load test 2.

- The asphalt wearing surface has longitudinal ruts and heaving at the piers, which contribute to increased standing water and debris on the surface of the bridge. These conditions could lead to premature deterioration of the wearing service.

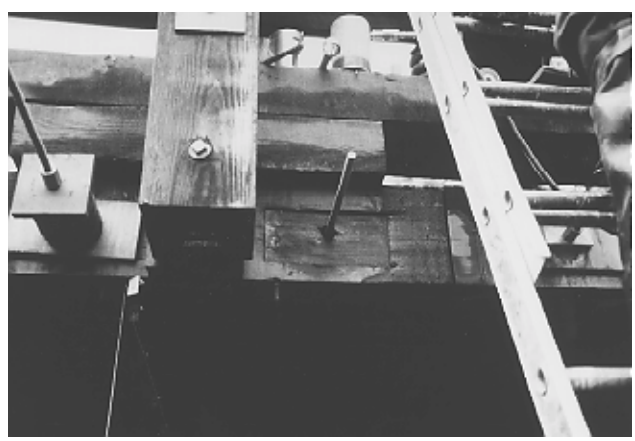
bearing plates into the Southern Pine glulam exterior laminations of the center span. However, crushing of the Eastern Hemlock laminations on the approach spans was first observed during bridge construction and continued progressively until the end of monitoring (Fig. 29), and seems to have contributed to short-term bar force loss after bar tensioning. This crushing occurred even though the bearing plates were properly designed, based on published values for compression perpendicular to grain adjusted for wet-use conditions. This indicates that the published design values for compression perpendicular to grain may not be representative of the material for use in this application. The use of a treatable hardwood species, such as oak or maple, on the outer laminations has been shown to perform well without crushing problems (Ritter and others 1995).

Figure 29—Visible crushing of approach span, Eastern Hemlock lumber lamination, observed after the removal of the bearing plate at the final site visit.

- The use of high moisture content Eastern Hemlock sawn lumber on the outside laminations of the approach decks adversely affected the performance of the bar anchorages. The wood crushing observed was approximately 0.75 in. underneath the bearing plates. The inclusion of hardwood laminations for the two exterior laminations would have greatly enhanced the bar anchorage performance.
