In: ASHRAE Transactions. 95(1). 10 pp. 1989.

Overview of Moisture-Related Damage in One Group of Wisconsin Manufactured Homes

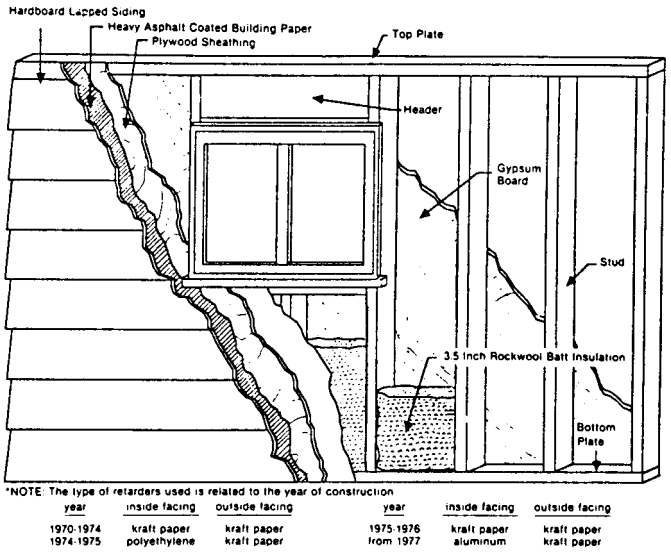
Figure 1 *Wall construction of tri-state homes (ML87 5395)*

A sketch of typical wall construction is shown in Figure 1. The interior surface material was 1/2 in (13 mm) sheet rock nailed to nominal 2- by 4-in (50 by 100 mm) studs. Mineral fiber insulation was installed between the studs. The insulation had an exterior kraft paper facing. The interior facing material was polyethylene, kraft paper, or aluminum, depending on the year of construction. The interior facing on the insulation was secured to the studs on the exterior side. The 1/2 in (13 mm) plywood sheathing was installed on the outside of the studs. For many homes, a layer of asphalt-coated building paper was installed over the sheathing. This was covered with hardboard lapped siding.

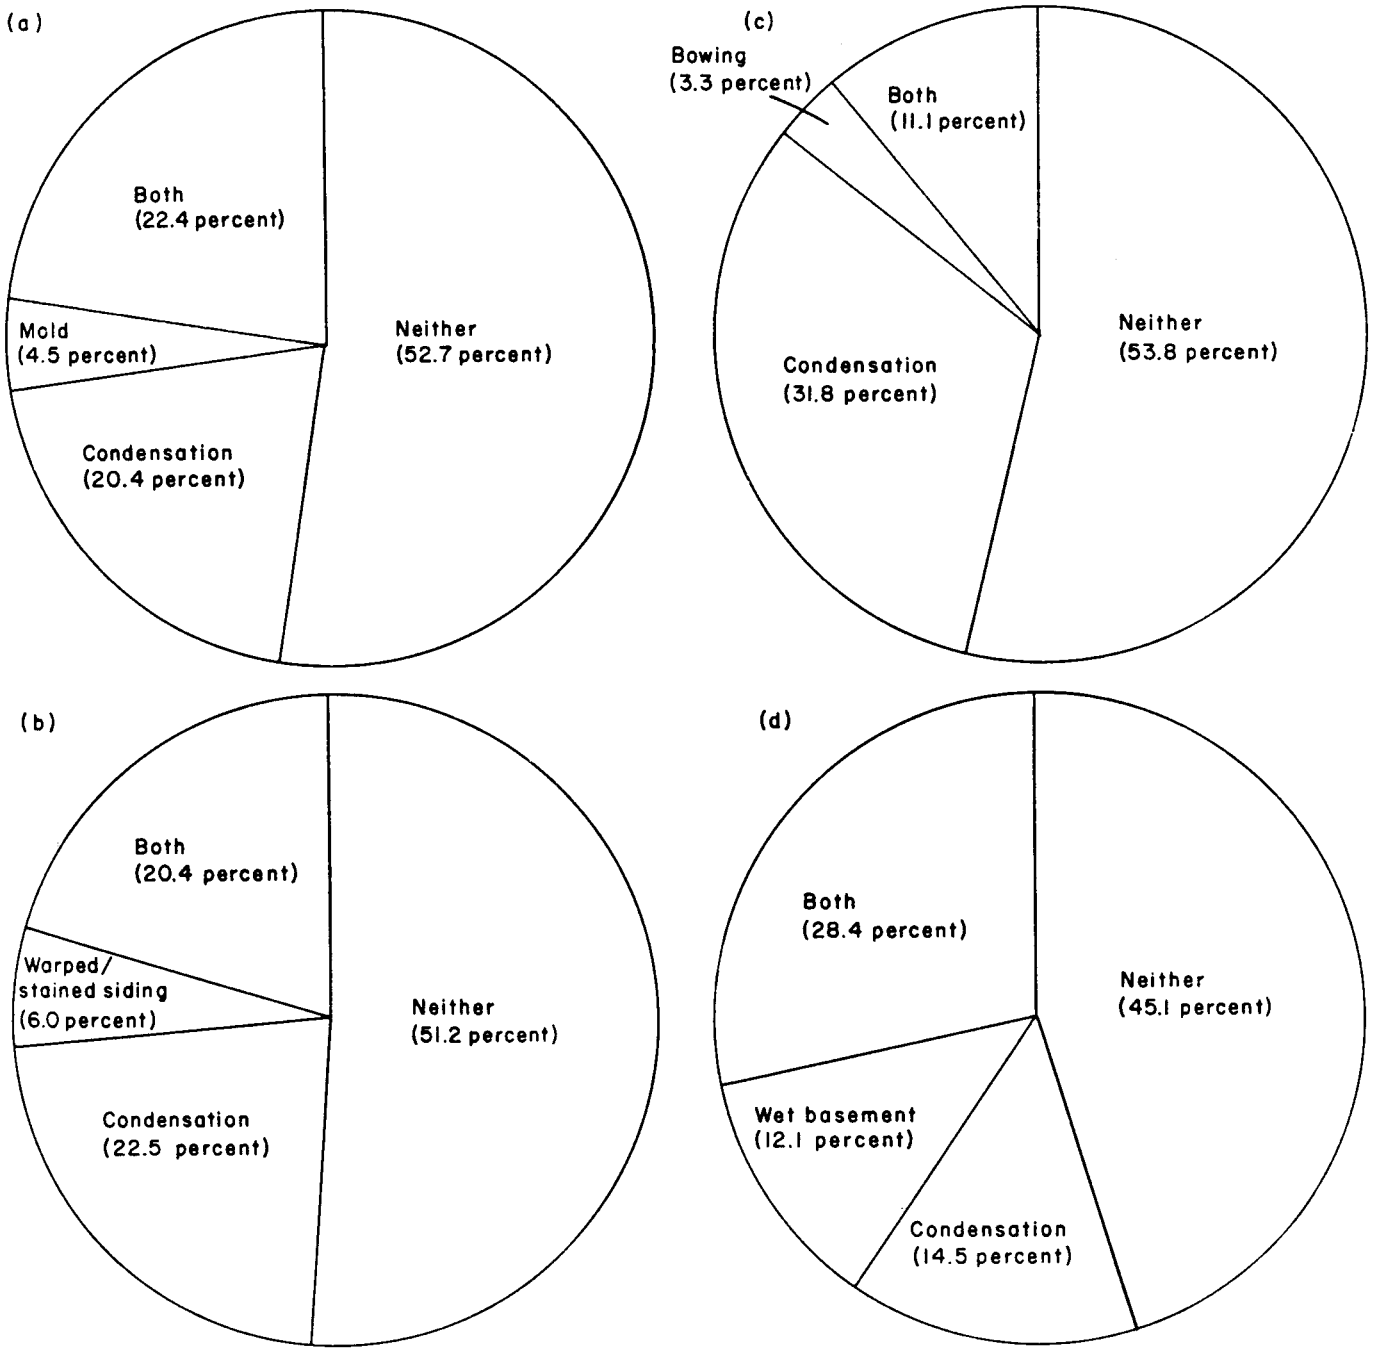
Figure 2 *Reported concurrent moisture problems: (a) current condensation on windows and mold or mildew on walls or ceilings, (b) warped or stained siding, (c) bowing or crumbling of walls or ceiling, and (d) damp or wet basement (ML88 5610)*

Figure 2a shows that 42.8% of the respondents reported condensation and 26.9% reported mold. Only 4.5% reported mold without reporting condensation as well. This means that 83% of those who reported mold also had problems with heavy Condensation. Conversely, of those with a condensation problem, 52% also reported mold. Condensation without mold was reported by 20.4%. These results suggest that mold indicates a more severe humidity problem than heavy condensation and that heavy condensation on windows may serve as an early warning of excessive indoor humidity.

Figure 2b relates the incidence of heavy condensation with reports of warped or stained siding. Of those reporting condensation, almost half (47%) mentioned siding problems. Only 6% reported siding problems without condensation (23% of respondents with siding problems). This suggests that the majority of siding problems were related to indoor humidity problems and that heavy condensation apparently is associated with an increased risk of damage to the siding.

The incidence of current condensation and bowing of walls or ceiling is shown in Figure 2c. A relatively small number of respondents (14%) reported bowing of walls or ceiling. Of these, 77% also reported heavy condensation on the windows. A stronger correlation was expected because a causal relationship was anticipated between condensation (indoor relative humidity) and bowing of the gypsum board. This suggests that other reasons for wetting of the gypsum board, such as voids in the insulation, roof leaks, or leaking from ice dams, may play a significant role. However, as with the siding, heavy condensation does raise the probability of bowing of the gypsum board on the walls or ceiling.

Figure 2d presents the concurrent incidence of condensation and damp or wet basements. Wet basements are reportedly often the cause of high indoor humidity and condensation. Forty percent of all respondents reported damp or wet basements. However, a substantial number of respondents (14.5%) reported condensation without a wet basement. This suggests that wet basements may help create indoor humidity problems but are by no means the only contributing factor. It may also be argued that a damp basement during winter is the result of a low ventilation rate and high indoor humidity; the basement is not allowed to dry out from high moisture conditions in the summer.

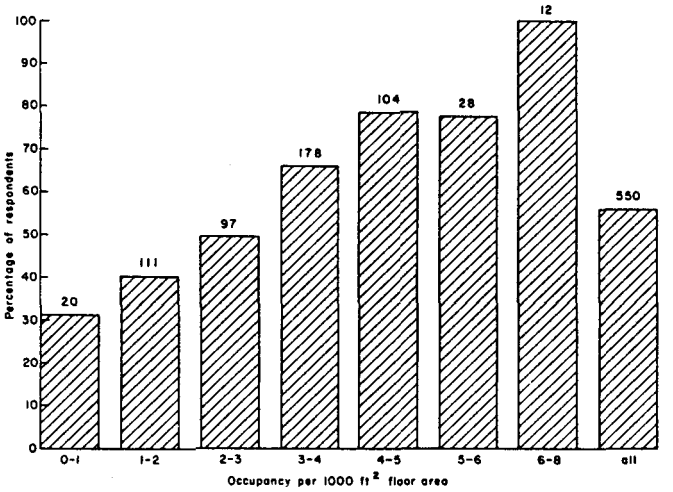
One factor that proved to have a profound effect on condensation potential is occupancy load, the number of persons living in the household per square foot of living area as reported by the respondent. A number of respondents provided square footage responses that were outside the expected range of values. We excluded these values from the analysis by including only cases where the square footage value was between 800 and 1400. This included 80% of the cases in which data on square footage were available (see Table 2). Table 7 shows the distribution of occupancy load, and Figure 3 shows the incidence of moisture problems as a function of occupancy load; the problems included condensation on windows, warping of siding, bowing of sheet rock, mold, and condensation. Calculations confirm that with extremely low ventilation rates, indoor humidity can be very high from normal activities, with moderate occupancy load and without unusual sources of moisture. Nevertheless, Figure 3 also shows a significant number of moisture problems in homes with a relatively low occupancy load, indicating other causes for condensation.

Figure 3 *Incidence of moisture problems as a function of occupancy load, expressed as percentage of total respondents in each occupancy load class. Numbers above bar are numbers of respondents reporting problems (ML99 5609)*
