EFFECTS OF CERTAIN DEFECTS AND STRESS-CONCENTRATING FACTORS ON THE STRENGTH OF TENSION FLANGES OF BOX BEAMS

No. 1513

UNITED STATES DEPARTMENT OF AGRICULTURE
FOREST SERVICE
FOREST PRODUCTS LABORATORY
Madison 5, Wisconsin
In Cooperation with the University of Wisconsin

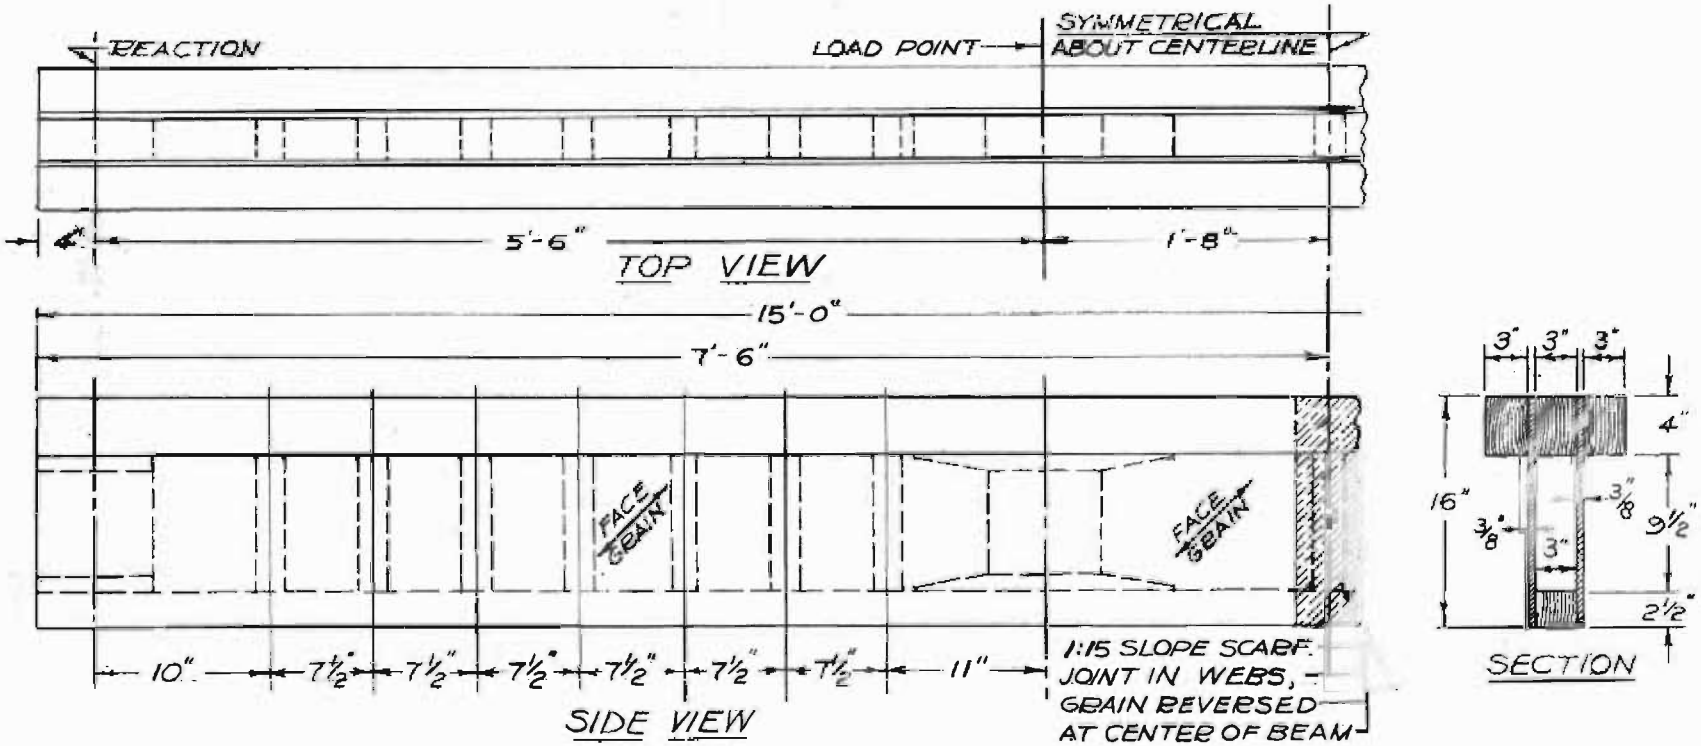
2 M 56744 F

Figure 1.--Details of construction of beams. Webs were 5-ply yellow-poplar plywood as specified in table 2 of Specification AN-NN-P-511-b. Grain of plywood was at an angle of 45° with the axis of the beam. Compression flanges were Douglas-fir, with annual growth rings vertical. Tension flanges were Sitka spruce, with annual growth rings vertical.

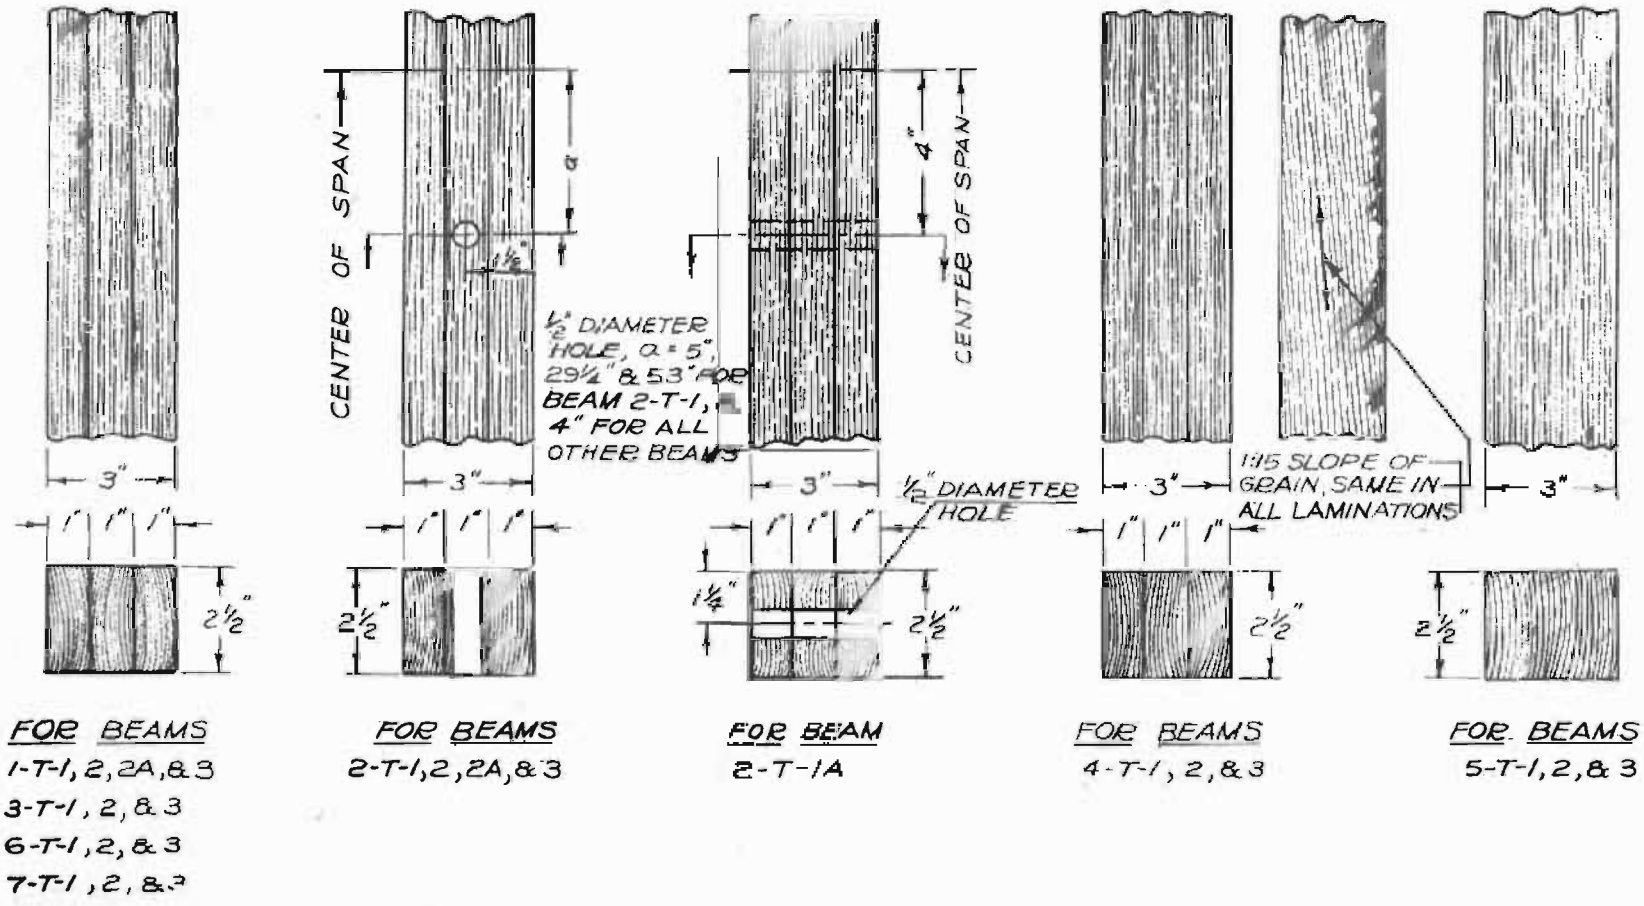
Z M 56745 F

FOR BEAMS
1-T-1, 2, 2A, & 3
3-T-1, 2, & 3
6-T-1, 2, & 3
7-T-1, 2, & 3

FOR BEAMS
2-T-1, 2, 2A, & 3

FOR BEAM
2-T-1A

Figure 2.--Details of construction of tension flanges of beams.

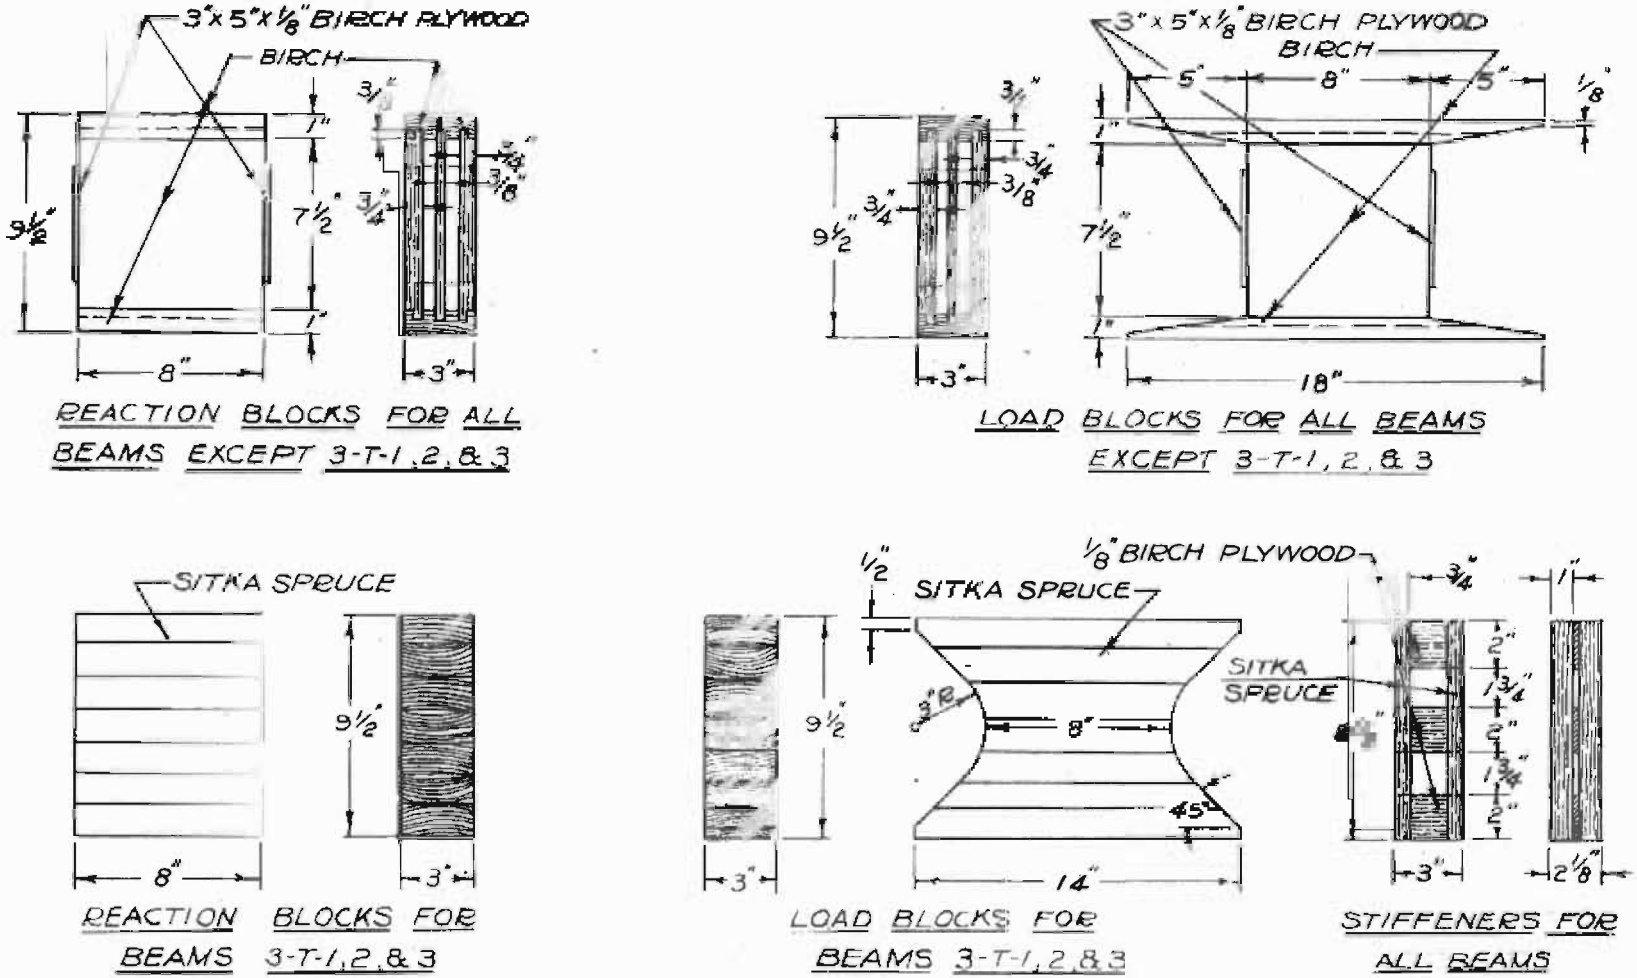
Z M 56746 F

Beams with rigid load blocks.--Beams 3-T-1, 3-T-2, and 3-T-3 were designed with short heavy load blocks (fig. 3) to accentuate any stress concentrations which could be attributed to this type. No stress concentration, however, was evidenced by observation of the brittle lacquer coating or by other behavior characteristics of the beam during test.

Figure 3.--Details of construction of load blocks, reaction blocks, and stiffeners of beams.

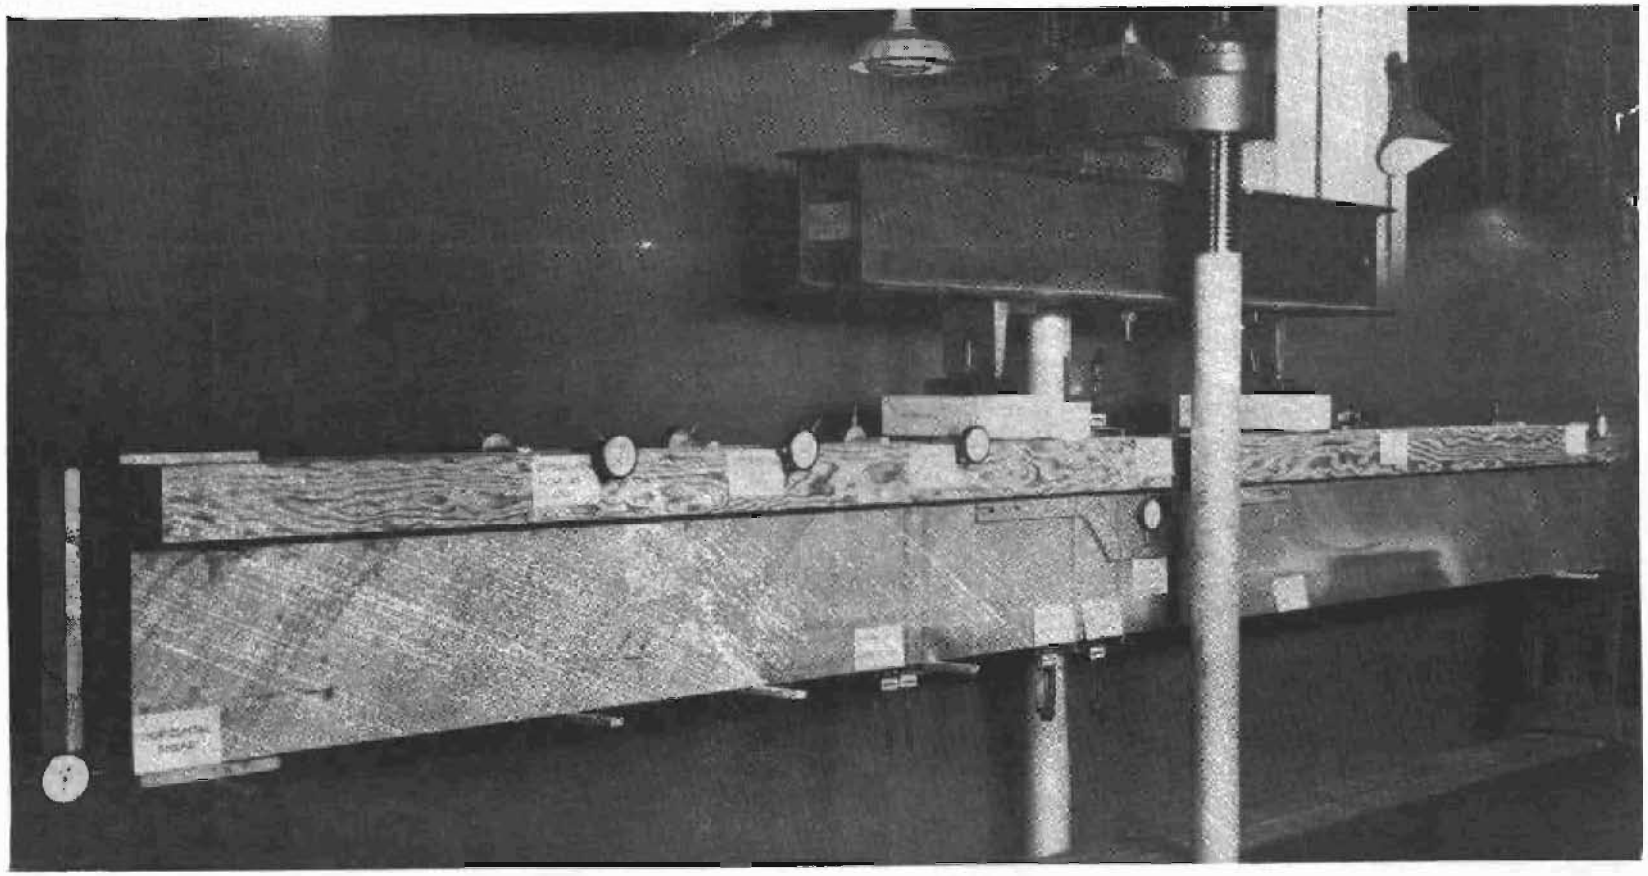
Z M 56747 F

The beams were tested in a 200,000-pound, screw-type testing machine by loading at points 20 inches on either side of the center of a 14-foot 4-inch span. Figure 4 shows a beam in the testing machine ready for test with the dials, strain gages, and deflection-measuring instruments in place. The discolored area in the center part of the beam near the tension flange is a "brittle lacquer" applied to the critical tension area of the beam as an aid in discovering regions of early stress concentration. The lacquer was also helpful in locating defects and areas of partial failure. The lacquer was applied to each beam the evening preceding test in order to allow time for proper setting but not sufficient time for cracking of the lacquer by moisture and temperature changes.

Figure 4.--A beam in the testing machine ready for test with deflection and strain measuring instruments attached.

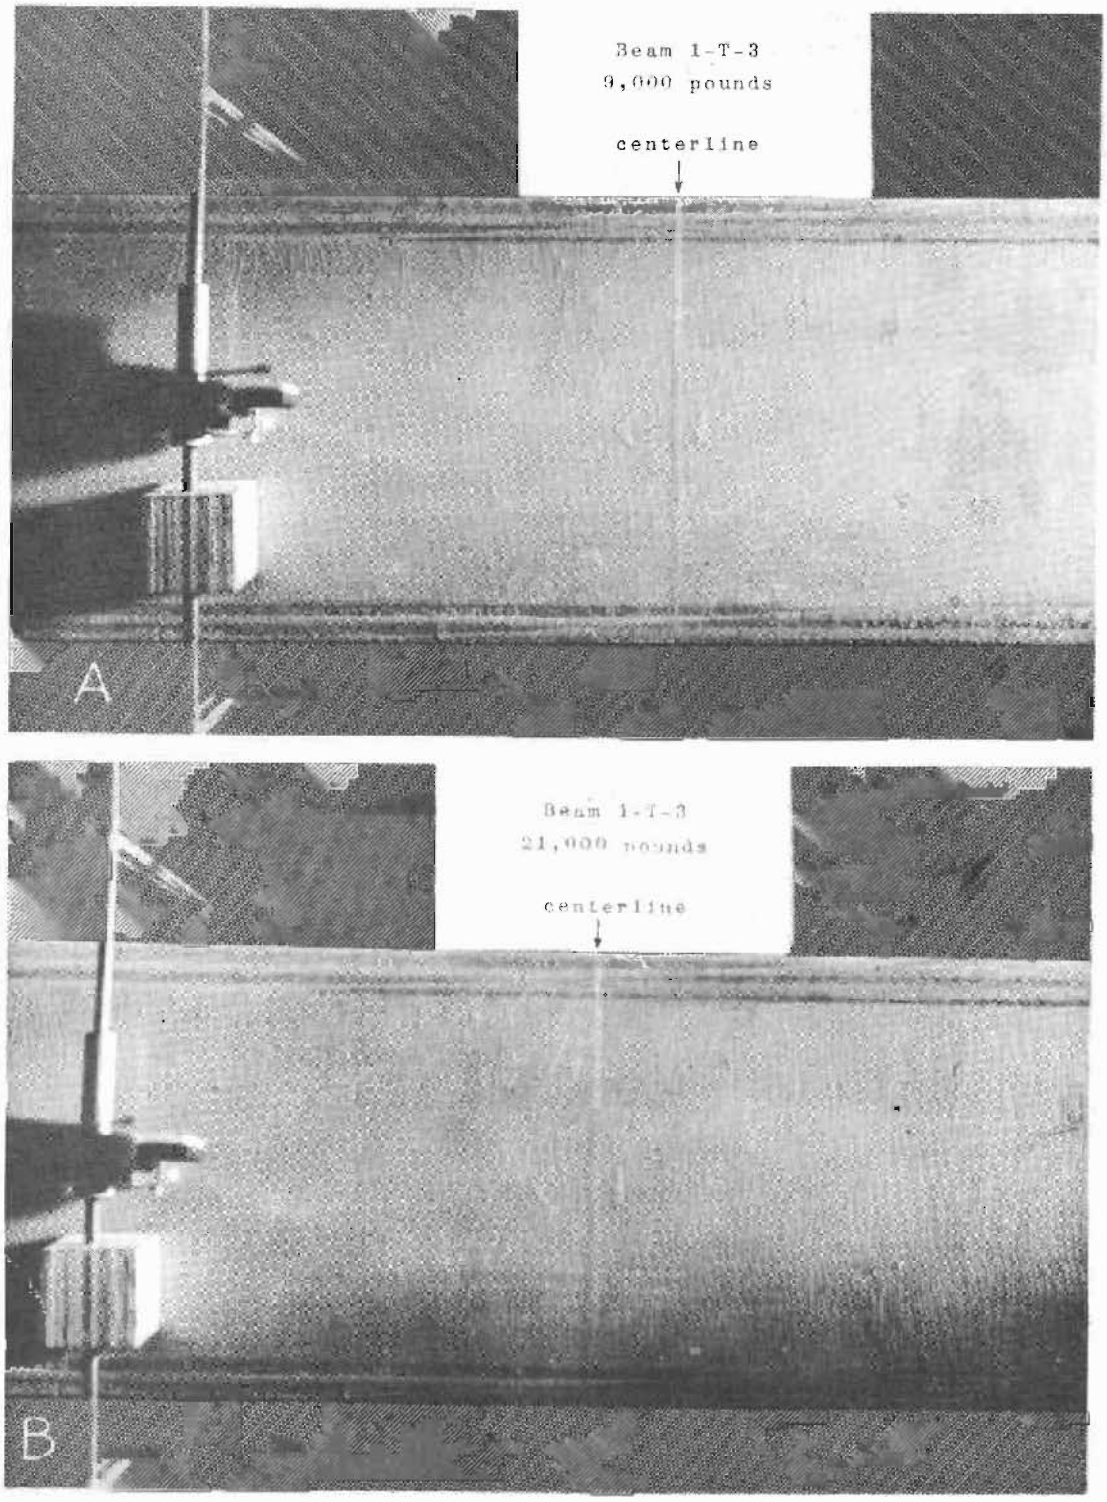
Z M 55712 F

Figure 5 shows the crack patterns in the brittle lacquer at the center-line of beam 1-T-3 at loads of 9,000 and 21,000 pounds. These cracks always form at right angles to the principal tensile deformation and those shown in this figure are typical for the control beams. The cracks are uniformly distributed and, in general, at right angles to the axis of the beam, indicating freedom from stress concentrations and uniformity of stress distribution.

Figure 5.--Cracking of brittle lacquer at the center of the tension flange of box beam 1-T-3: A, at 9,000 pounds total load shortly after cracking was first visible; B, at 21,000 pounds total load, showing fully developed stress cracking pattern.

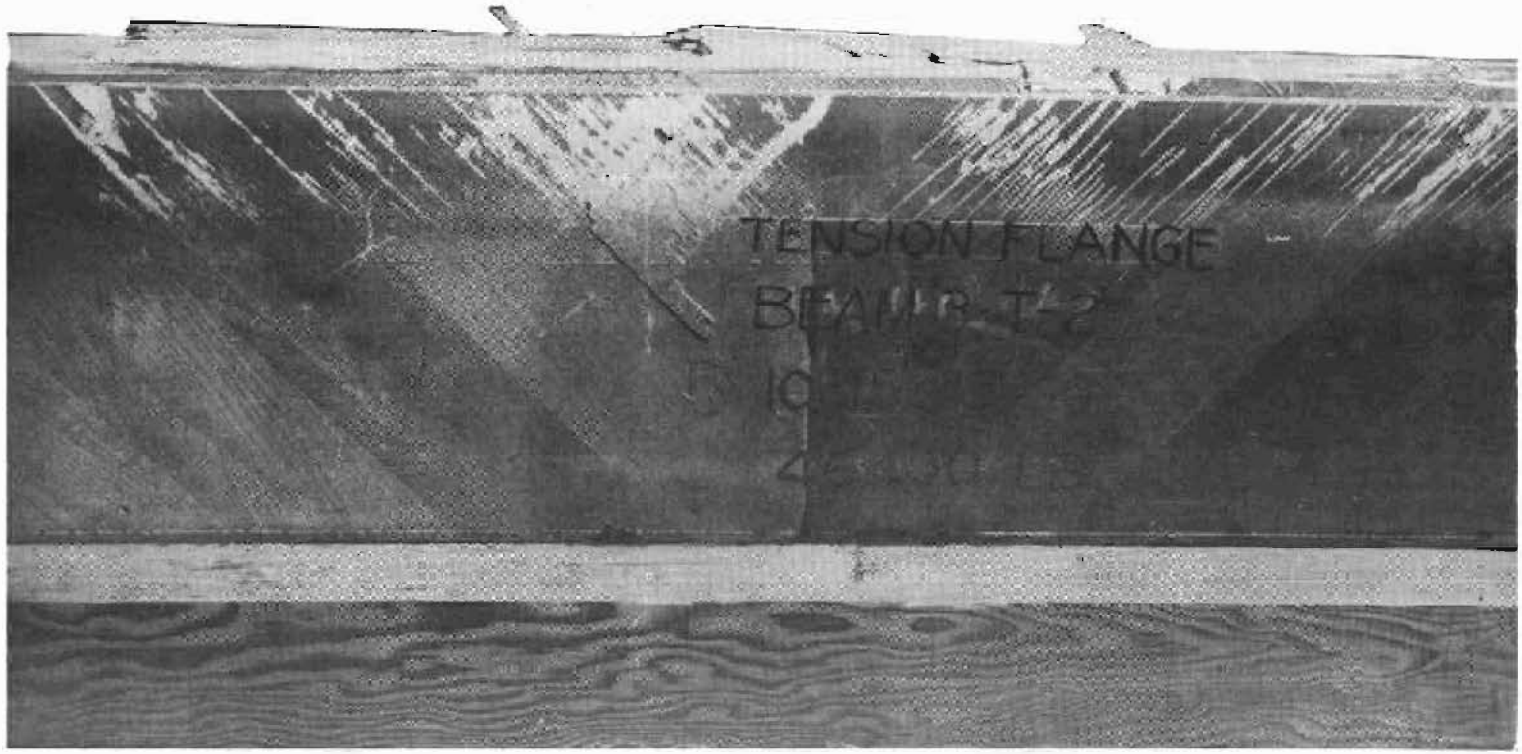
ZM 56748 F

Figure 6 is a photograph of beam 3-T-1 after test and shows a typical failure of a straight-grained tension flange.

Figure 6.--Beam 3-T-1 after failure, showing typical straight-grained tension-flange failure.

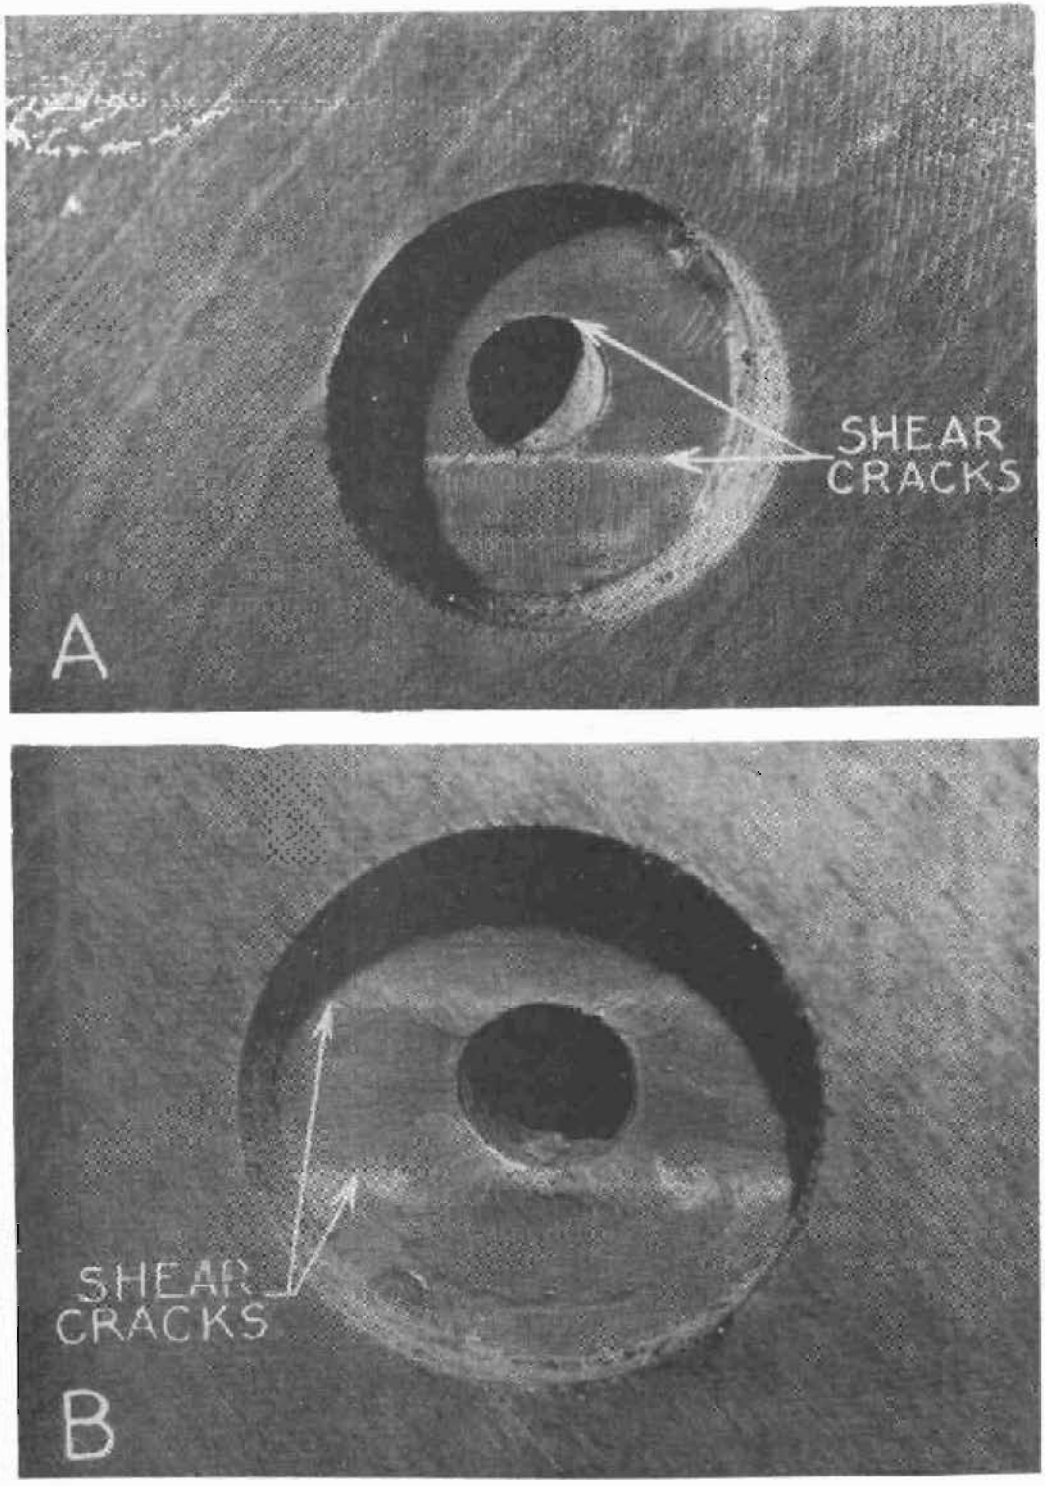
2 M 50749 3

Beams with bolt holes in tension flanges.--The beams of this group developed longitudinal shear cracks approximately tangent to the sides of the bolt holes and parallel to the grain of the wood. Shear failures were first visible at an average calculated tensile stress of 5,610 pounds per square inch of net area of the flange. This value is 49 percent of the modulus of rupture and 37 percent of the ultimate tensile strength shown by tests of specimens representing the tension flanges. Shear failures were progressive, starting at the holes and becoming longer as the load increased until, at failure of the beams, they were often more than 2 feet in length. The holes were stress risers that caused the first cracking. The point of stress concentration then moved along with the crack causing a continuation of the cracking.

A mathematical analysis[5] of stresses around a hole shows that for the conditions here encountered there is a concentration of shearing stress which is a maximum at the ends of radii which are approximately 78° from the direction of applied stress. Figure 7 shows the shear failures at the edges of the horizontal hole in beam 2-T-1A; figure 8 the shear failures at the edge of a vertical hole in beam 2-T-2; and figure 9 the extent of shear cracking in the tension flange of beam 2-T-1 at the failure of the beam. The progression of the shear cracking can also be seen in these figures. These photographs show that the beams acted in agreement with theory.

Figure 7.--Horizontal hole in tension flange of beam 2-T-1A. A, one end of hole soon after shear cracking started. Load on beam was 15,000 pounds. B, other end of hole after shear failures had progressed beyond routed-out portion of the web. Load on beam was 24,000 pounds.

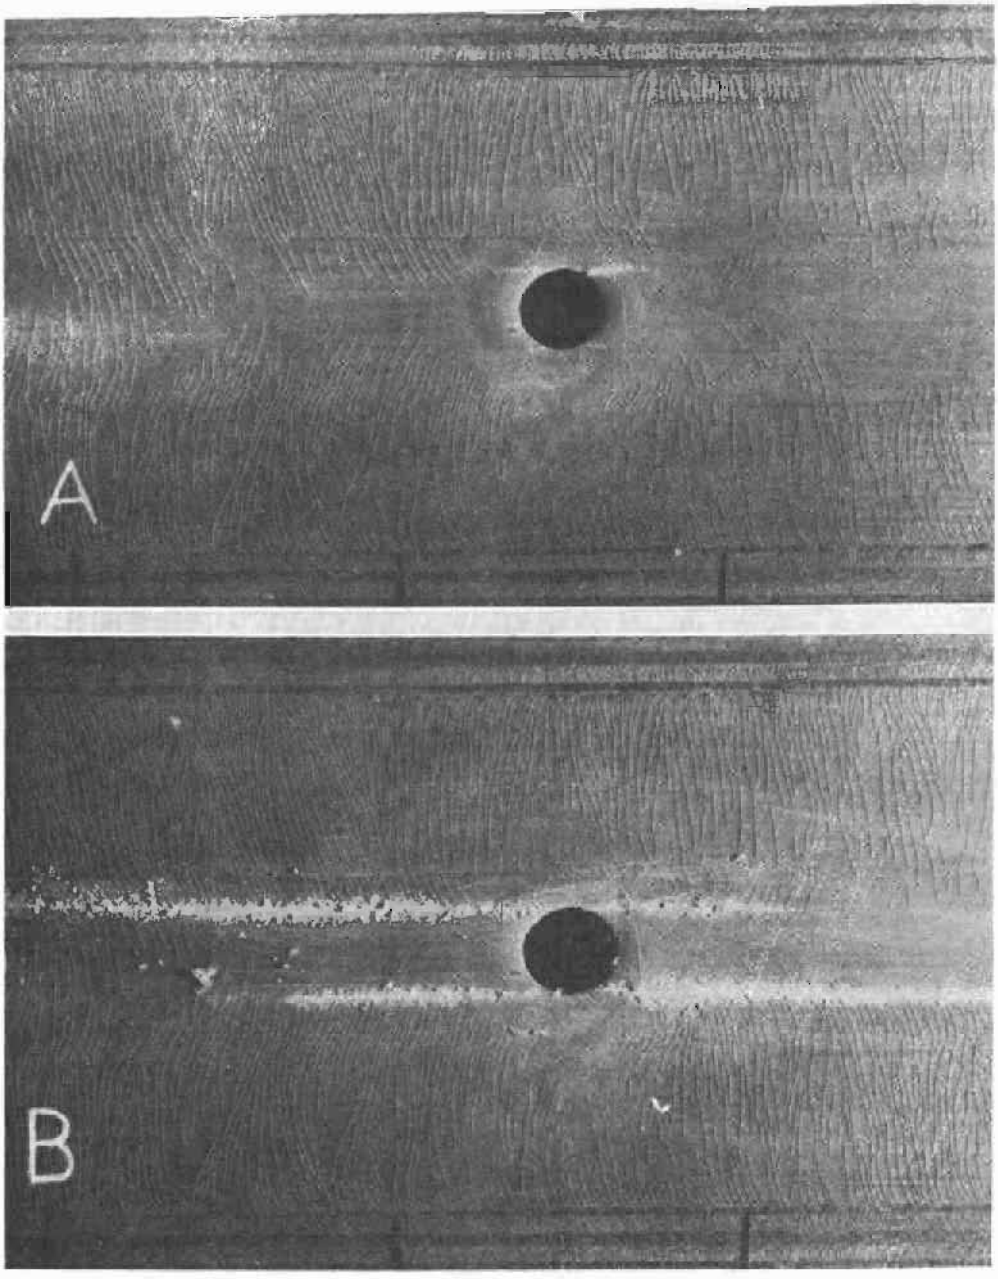
Z M 56750 F

Figure 8.--Vertical hole in tension flange of beam 2-T-2. A, brittle-lacquer stress pattern and start of shear failures at edge of hole. Load on beam was 16,500 pounds. B, increased length of shear cracks due to increase of load. Load on beam was 20,500 pounds.

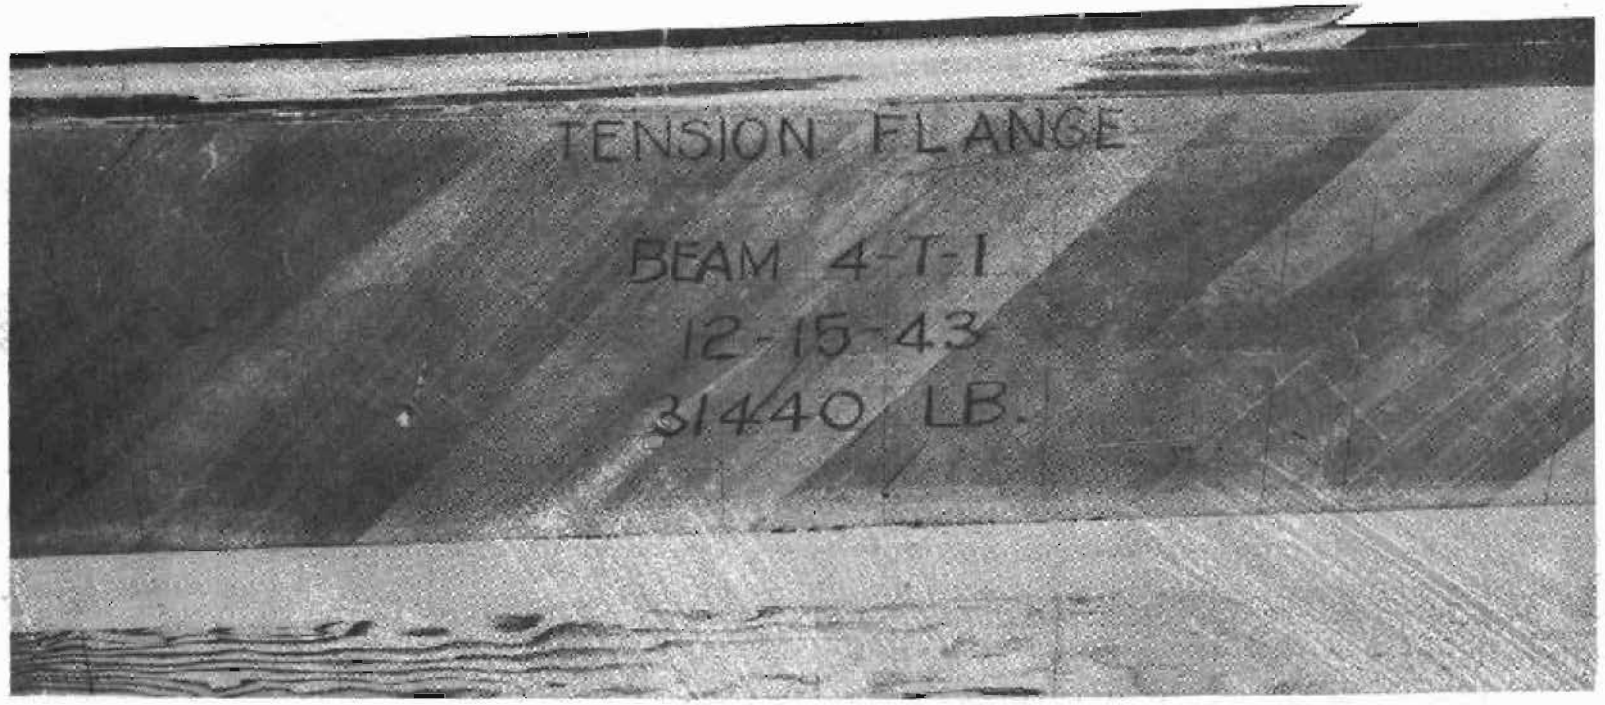
2 M 56752 F

The failures in the tension flanges of the beams with 1 in 15 sloping grain in the tension flanges occurred suddenly without any previous signs of distress. They were complete after which the flanges were incapable of carrying any load. Figure 10 is a photograph of beam 4-T-1 showing the typical failure of a tension flange with a grain slope of 1 in 15 in the vertical plane.

Figure 10.--Beam 4-T-1 after failure, showing typical failure of tension flange when grain slope is 1 in 15 in the vertical plane.

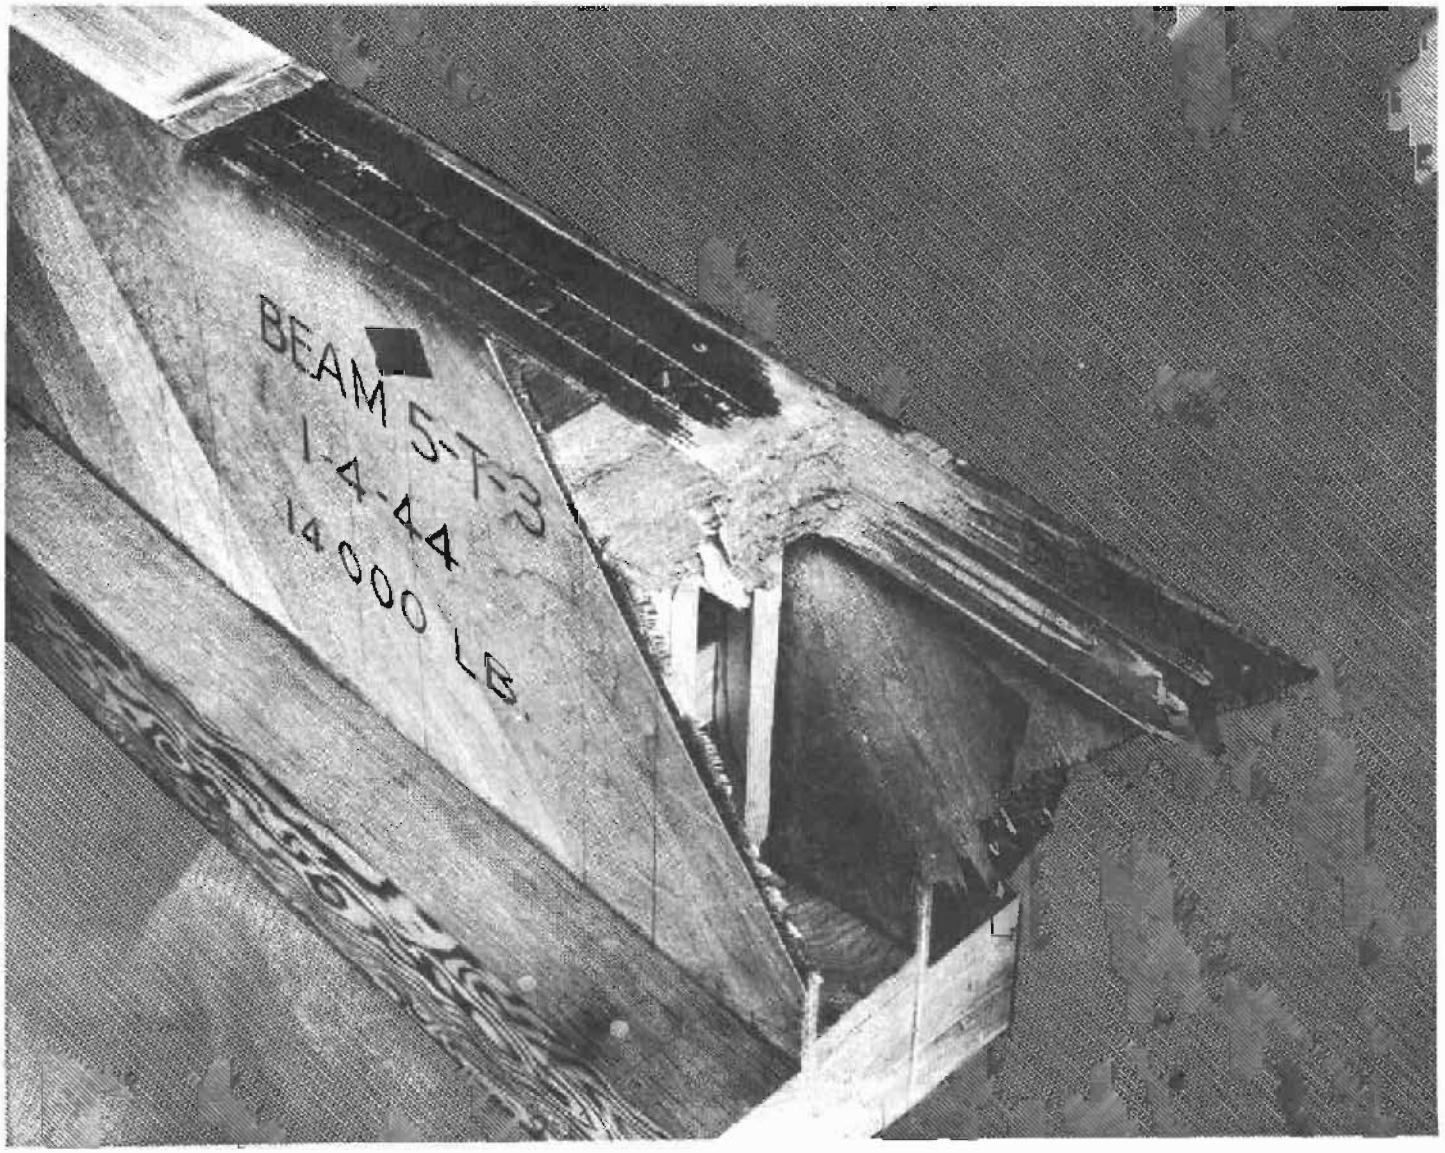
Z M 56753 F

failures is so low that the use of such material in airplane construction is inadvisable. The necessity of taking every possible care to eliminate compression failures is emphasized by these tests.

Beam 5-T-3 after failure is shown in figure 11. The compression flange was cut in two for this photograph to show the brash character of a tension flange failure when preexisting compression failures are present. A comparison of this figure with figure 6 shows the difference in the appearance of tension breaks of straight-grained good quality Sitka spruce and Sitka spruce with preexisting compression failures.

Figure 11.--Beam 5-T-3 after failure, showing brash character of tension flange failure when preexisting compression failures are present. (Part of compression flange removed).
