FOREST SERVICE RESEARCH PAPER • FPL 16 • AUGUST 1964

WOOD STRUCTURE PERFORMANCE IN AN EARTHQUAKE

IN ANCHORAGE, ALASKA

by
L. O. ANDERSON, Engineer
and
J. A. LISKA, Chief,
Division of Wood Engineering Research
FOREST PRODUCTS LABORATORY, [2] FOREST SERVICE
U. S. DEPARTMENT OF AGRICULTURE

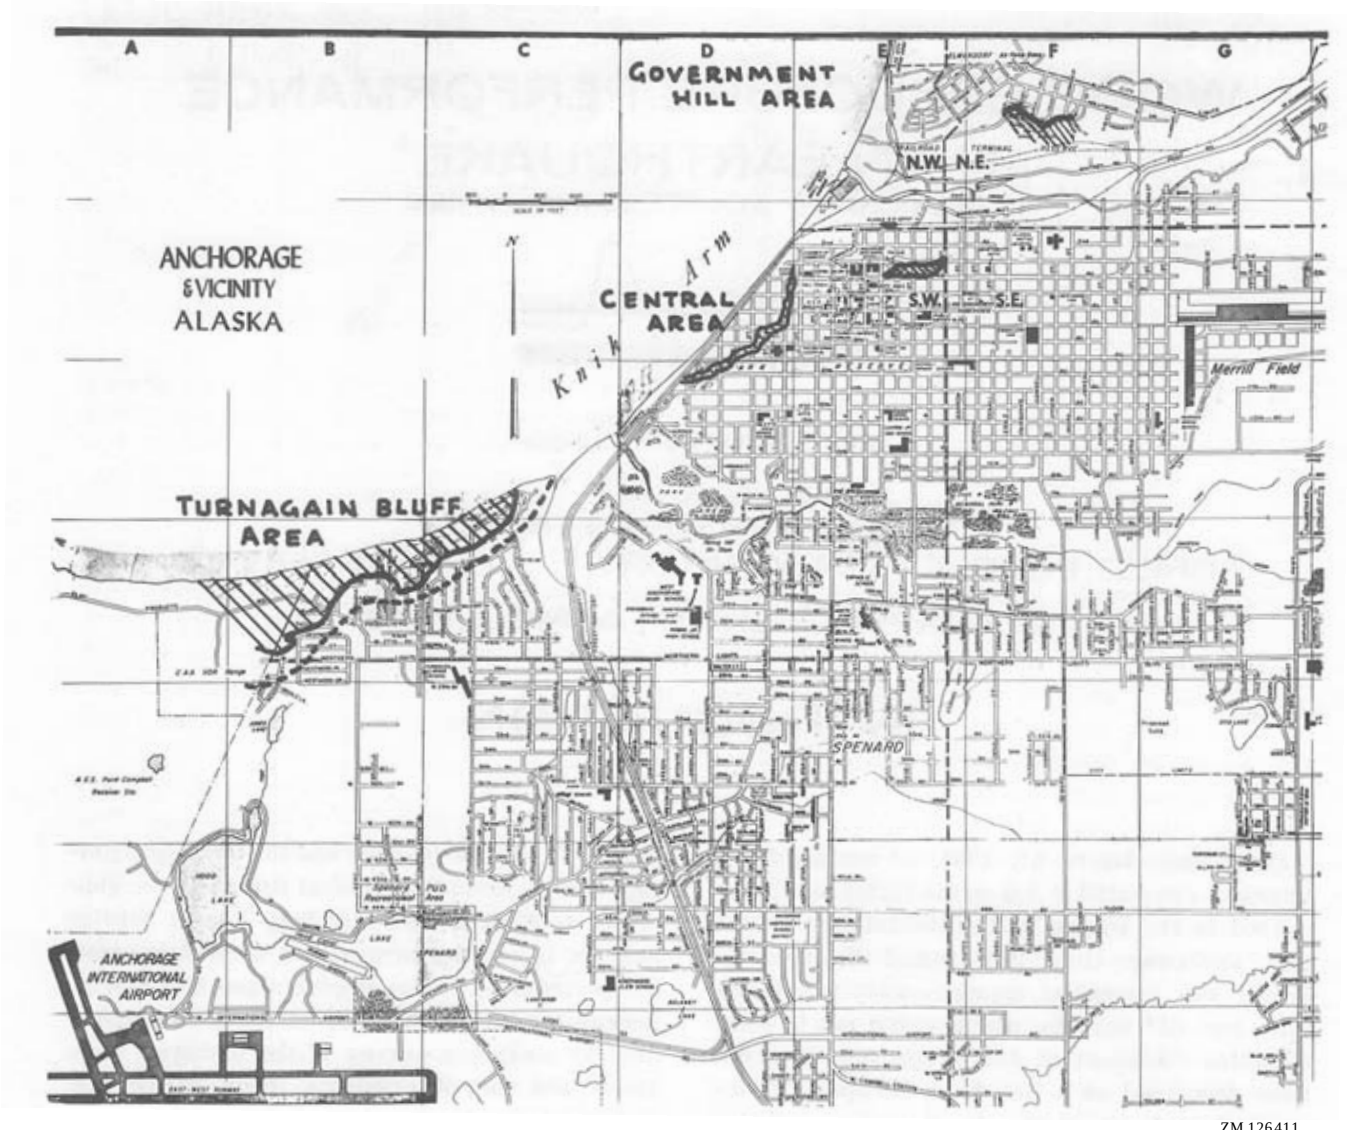
ZM 126411

Figure 2.––Anchorage.The large cross–hatched area on the left is the Turnagain bluff housing area where damage to houses was caused by major earth slides.

The concentrated earthquake damage in Anchorage was confined to three major areas (fig. 2). In the Turnagain bluff area, the earth tended to crack, slide, and fold over toward Cook Inlet with resulting severe damage to 77 houses.

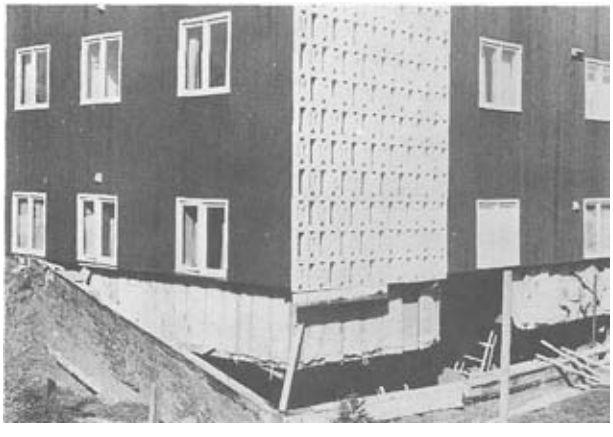
Figure 14.––The impact of the sudden earth subsidence was sufficient to cause shearing of the fiberboard sheathing. ZM 126 433

Of the sheet materials commonly used for sheathing, plywood did an outstanding job in the houses examined (fig. 13). In the majority of cases, it was applied with the 4-by 8-foot sheets placed vertically, with perimeter nailing. Fiberboard sheathing in 25/32-inch thickness, when used properly, seemed to perform satisfactorily except where high stresses had caused shear failures between studs (fig. 14). However, not all fiberboard sheathing was applied properly with good nailing. Often 4- by 8-foot sheets were placed horizontally without edge nailing between studs. Some 2- by 8-foot fiberboard sheathing was also noted. Generally, failures of this type of sheathing consisted of nailhead pullthrough or shearing out at the nails due, in part, to inadequate nailing. These walls were usually racked beyond repair.

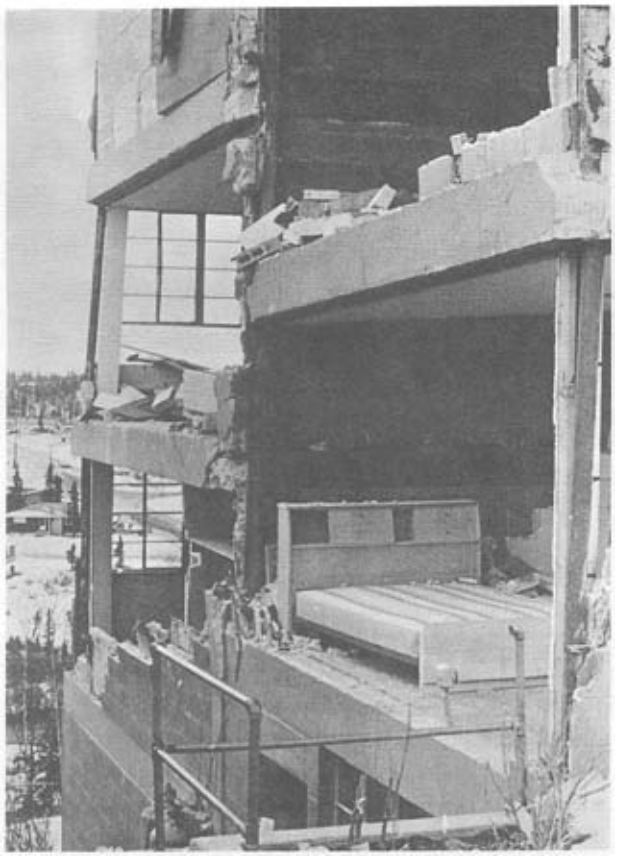
ZM 126 440

The failure of masonry veneer such as concrete block or brick was noted in a number of cases (figs. 20 and 21). In the wood-frame house (fig. 20), the rigid, brittle facings had fallen away, revealing the undisturbed wood framework and sheathing behind them. Even brick or other masonry veneer with the normal amount of metal ties to the wood

Figure 21.—This apartment house was finished with a facing of brick backed by concrete block. Corner windows provided little shear resistance to the walls.

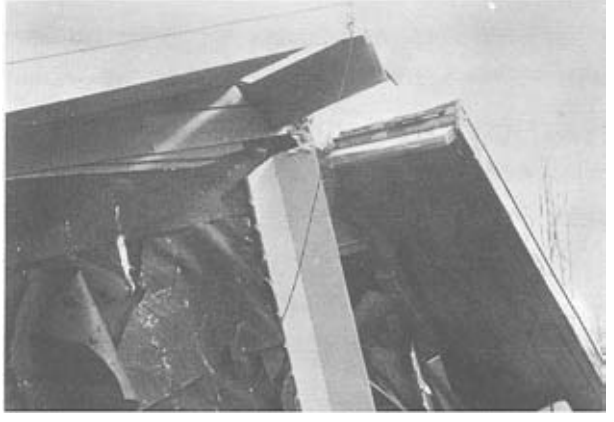
ZM 126 454

Figure 30.––Resistance to racking forces of the earthquake was lacking in this apartment building.

The need for good corner connections in exterior walls was apparent in most types of structures. In addition, openings at or near the corners reduced the racking resistance of the walls (fig. 30) and were partly responsible for damage to many buildings. Buildings with continuous openings or panels along the sides offered little resistance to racking forces (fig. 31).

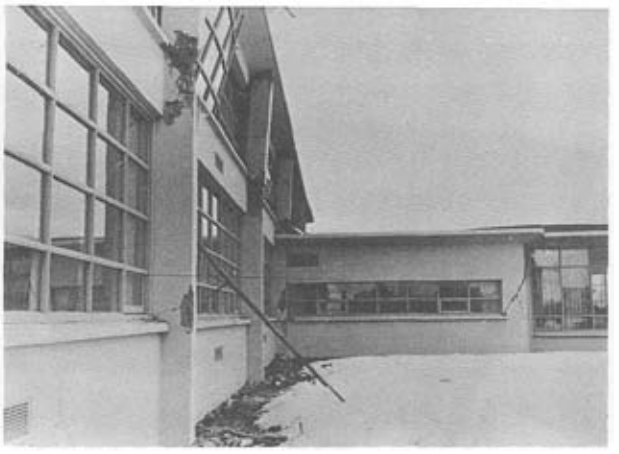
ZM 126 464

Figure 31.—The widely spaced columns of this school offered little resistance and failed at points of fixity at floors and roof line.
