Performance of Stress-Laminated Bridges

Michael A. Ritter, Earl A. Geske, Lola Mason, William J. McCutcheon,
Russell C. Moody, and James Wacker

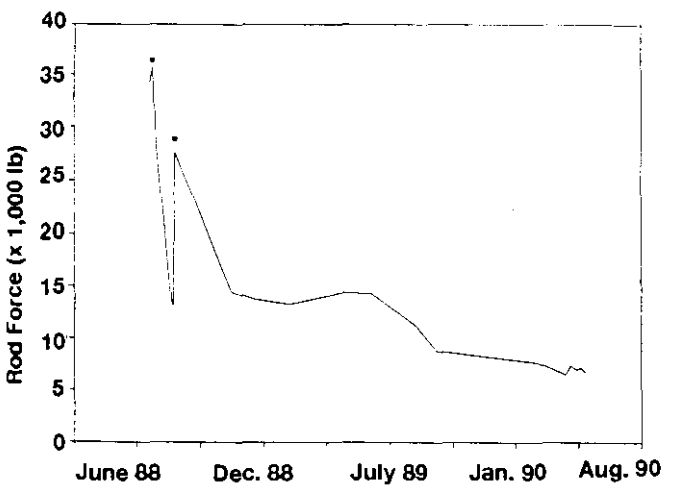
3. ***Wood Crushing.*** Substantial decreases in rod force have been attributable to wood crushing at the anchorages for the stressing rods. Generally, this has resulted from undersizing of the bearing plates during design. Crushing has been most severe when the discrete-plate anchorage system is used in conjunction with softwood laminations at high moisture contents.

Figure 2. Rod force loss in a stress-laminated deck constructed of creosote-treated Douglas-fir (8 in. deep and 26 ft. wide). ● denotes rod restressing completed as a part of the construction procedure.

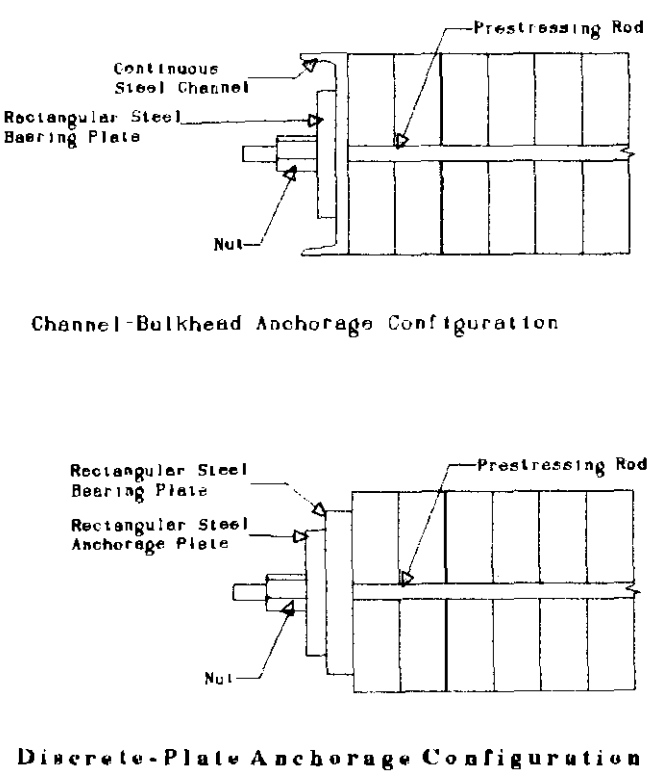
Figure 3. Stressing-rod anchorage configuration commonly used in stress-laminated bridge decks.

Anchorage System. The anchorage system for the stressing rods must distribute the rod forces into the deck without crushing the wood in the outer laminations. If crushing occurs, the rods can lose a substantial portion of their force. In the United States, stress-lam decks have employed either a steel channel or discrete plates to distribute the force (Fig. 3). The channel configuration was developed in Ontario, Canada and is currently a design requirement of the Ontario Highway Bridge Design Code. The discrete plate was developed in the United States and uses a single rectangular bearing plate at each rod. A third system that has been used employs a steel plate that is continuous over several rods, but only preliminary performance data are available.

The field performance of anchorage systems has varied. In general, performance of the steel channel configuration, designed in accordance with Ontario Highway Bridge Design Code procedures, has been very good. Although more expensive than the plate configuration, the steel channel minimizes wood crushing so that it has very little effect on rod forces. Performance of the discrete-plate configuration has been mixed. When used on softwood lumber species (Douglas-fir and southern pine), the plates have caused crushing in the outside laminations. Typically, this crushing has averaged 1/4 to 3/8 in., which is acceptable in most situations; however, crushing of 1 in. or more has been observed on three bridges. This severe crushing occurred on some of the first stress-lam bridges built in the United States, and was attributable primarily to plate undersizing and a failure to reduce wood compressive stress for wet-use conditions. When properly designed, the discrete-plate configuration used on red oak laminations has demonstrated virtually no crushing and has performed well. Several bridges built recently in the United States have used the discrete plates successfully on bridges constructed of softwood lumber, with red oak outside (edge) laminations.
