U.S.D.A. FOREST SERVICE
RESEARCH PAPER
FPL 169
1972

APPALACHIAN HARDWOODS FOR PALLETS

CORRELATION BETWEEN SERVICE AND LABORATORY TESTING

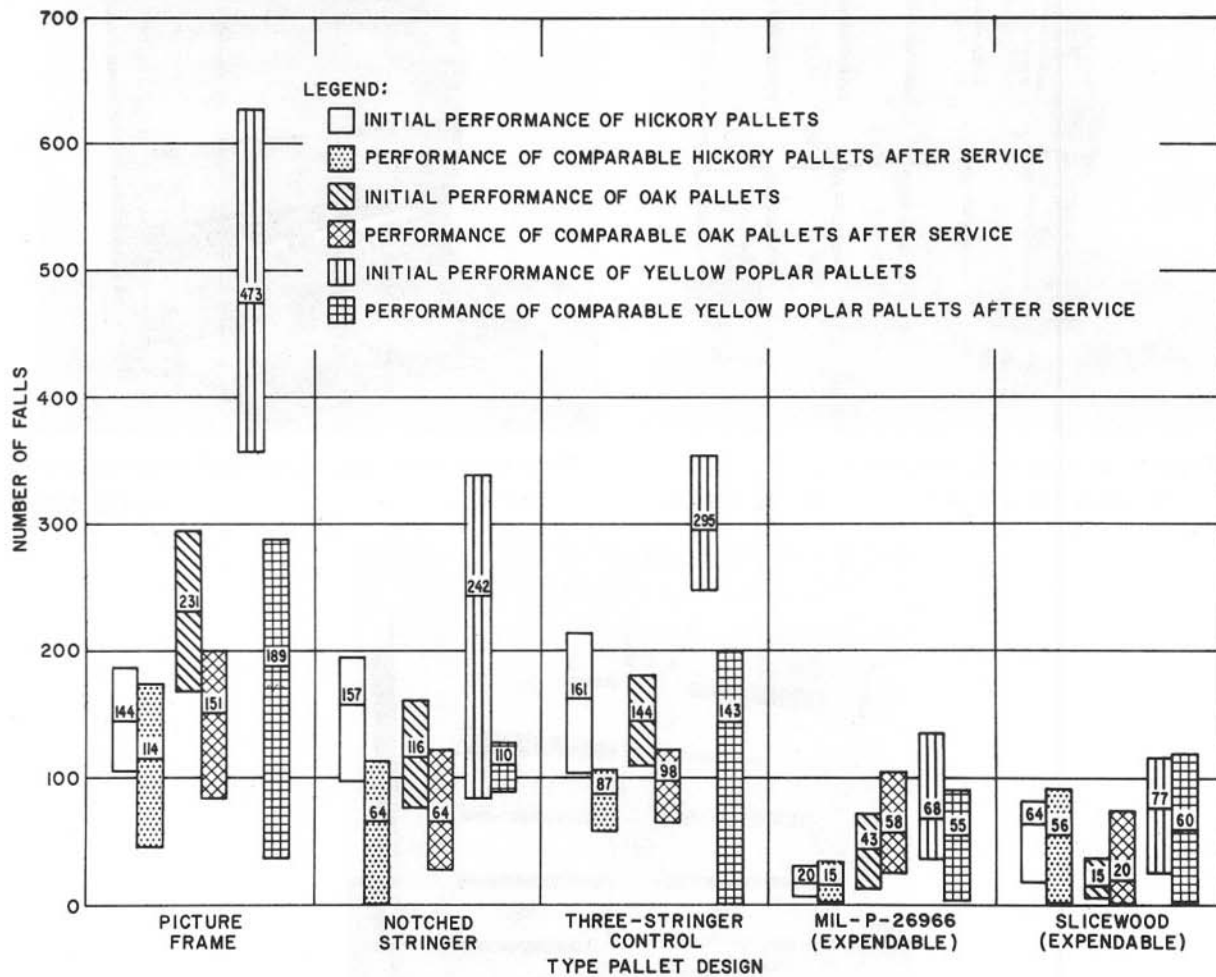
A graphical summary of data obtained for the individual groups, as presented in table 1, is shown in figure 15.

Figure 15.--A comparison of pallet performance before and after 4 years of service. The length of each bar indicates the range in performance for that group. The number corresponding to the horizontal line inside each bar indicates the average number of falls for the group. (M 139 779)
