STUDIES OF COMPRESSION FAILURES AND THEIR DETECTION IN LADDER RAILS

No. 1733

FOREST PRODUCTS LABORATORY
MADISON 5 WISCONSIN

MAXON Y. PILLOW, Wood Technologist

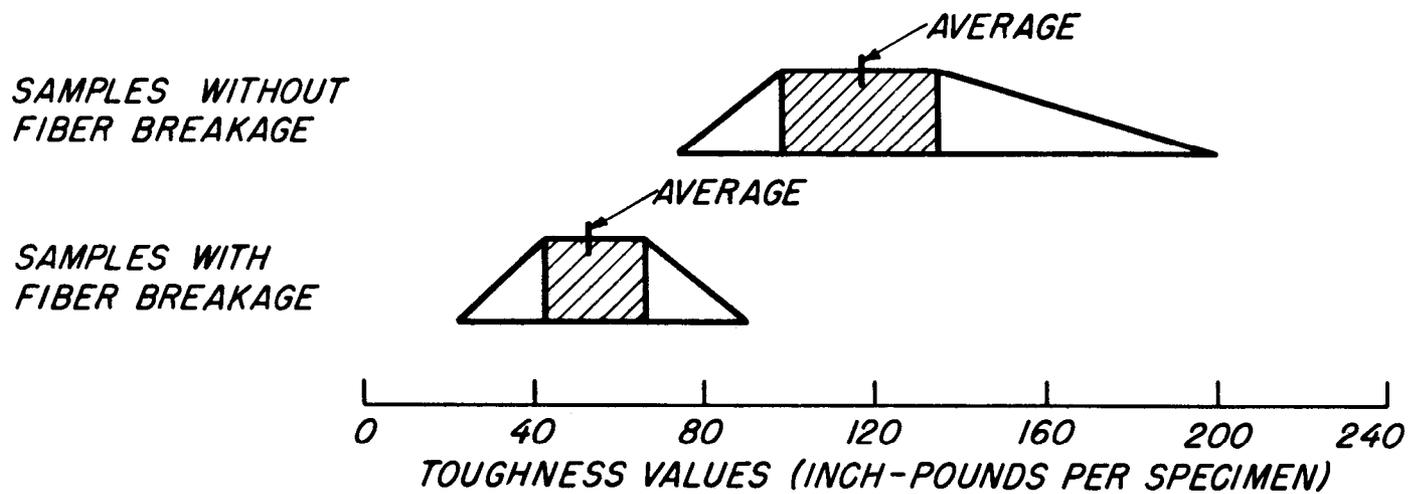
Toughness.--Toughness-test values were determined for three specimens from each of the samples obtained from the ladder rails available for this study. The average value for all of the specimens from samples having fiber breakage was less than one-half of that of specimens from the samples without this characteristic, namely, 53.7 and 117.4 inch-pounds per specimen, respectively (table 1). The ranges of these values overlapped slightly; but, nevertheless, they differed significantly (fig. 9). This overlapping of the ranges resulted because the low specific gravity of three specimens from one sample without fiber breakage caused moderately low toughness values and several specimens with relatively high specific gravity caused about the same toughness values, even though fiber breakage and compression failures were present in the

Figure 9.--Total range, range of the middle two-thirds of the specimens (cross-hatched), and average of toughness-test values of specimens obtained from samples of ladder rails, some that showed fiber breakage on end-grain surfaces and, also, other samples without this characteristic.

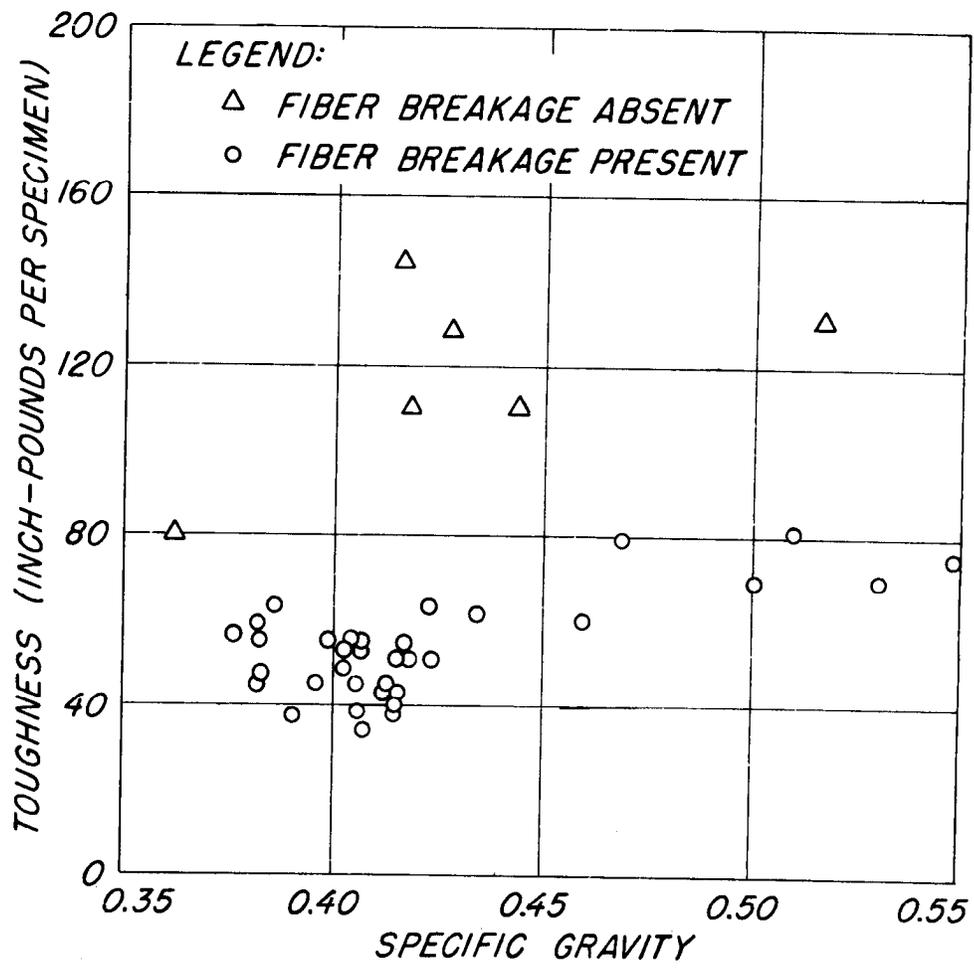
samples. The average toughness value of three specimens from each sample having fiber breakage was considerably lower in relation to average specific gravity of the specimens than that of the other specimens from samples without fiber breakage (fig. 10). Thus, for wood of the same density, fiber breakage on end-grain surfaces is identified with seriously lower toughness-test values than is wood without this characteristic, which is caused by the presence of compression failures.

Figure 10.--Relation of average toughness-test values to specific gravity of three specimens from each sample with fiber breakage in comparison to similar values of specimens from samples without fiber breakage.
 ZM 80320 F
