WOOD STRUCTURES SURVIVE HURRICANE CAMILLE'S WINDS

U.S.D.A. FOREST SERVICE
RESEARCH PAPER
FPL 123
OCTOBER 1969

U.S. Department of Agriculture
Forest Service
Forest Products Laboratory
Madison, Wis.

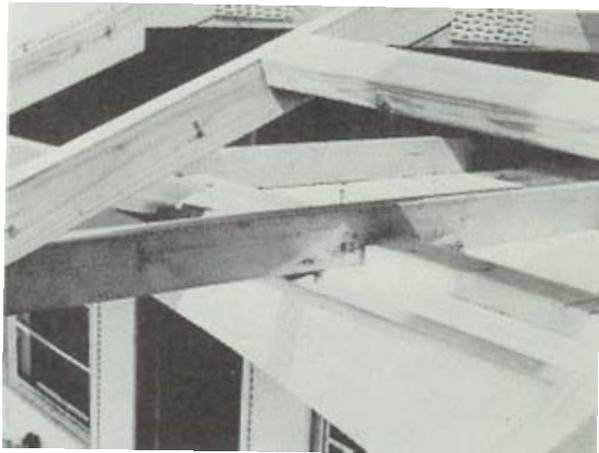
C

Figure 9.--Typical new construction in the hurricane area: A, trusses over wood-frame wall with fiberboard sheathing, partially damaged by wind; B, metal anchors tying roof to top plate used in a few cases; C, trusses nailed to top plate with three sixteenpenny nails.

Typical new residential construction in the Gulf area is concrete slab and wood frame with roof trusses (fig. 9). Fiberboard sheathing is used with let-in 1- by 4-inch diagonal bracing at each corner. The soleplate is usually nailed to the concrete slab with hardened nails at 4 feet on center. Roof trusses are toenailed with three sixteenpenny nails at each bearing point. In one case, a metal anchor was used to tie the truss

to the top plate (fig. 9,B), buty this practice did not appear to be common in the area observed. The roof is usually asphalt shingles over 3/8- or 1/2-inch plywood sheathing. siding is often a combination of wood siding and brick veneer.
