Research
Paper
FPL-RP-551

Field Performance of Timber Bridges

8. Lynches Woods Park Stress-Laminated Deck Bridge

July 1996

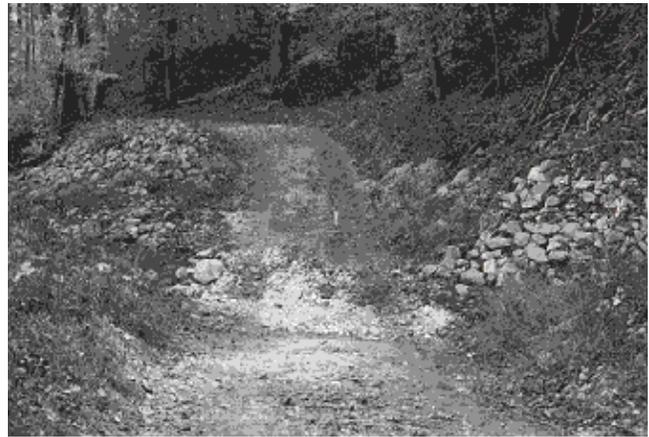
Figure 2—Prior to bridge construction, the Lynchess Woods Park bridge site was a low-water crossing.

Before replacement in 1990, the crossing at the Rocky Branch river consisted of a 20-ft-long, nail-laminated lumber deck, supported by a timber substructure. During the spring of 1988, the Rocky Branch river flooded and the bridge superstructure was washed out. Because of this washout and extensive damage to the timber abutments, a temporary low water crossing was installed until a new bridge could be designed and constructed (Fig. 2). Based on an evaluation of alternatives for the replacement structure, it was determined

that the new bridge would be a timber deck superstructure, supported by concrete abutments. It was further determined that the length and elevation of the replacement structure would be increased from those of the original structure to provide increased hydraulic capacity.
