In: American Society of Civil Engineers, Proceedings of the 2005 Structures Congress, April 20-24, 2005, New York, NY. 2005.

Kings Covered Bridge Rehabilitation, Somerset County, PA

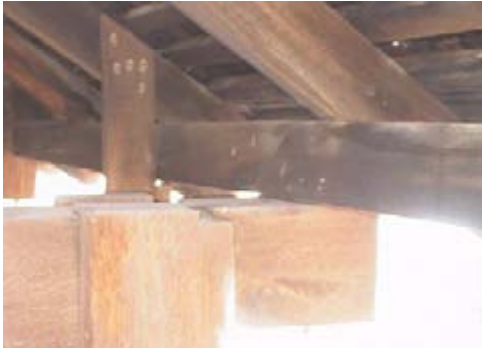
Figure 2 – Assembly of truss posts and upper chords, tie beams, and rafter / sills

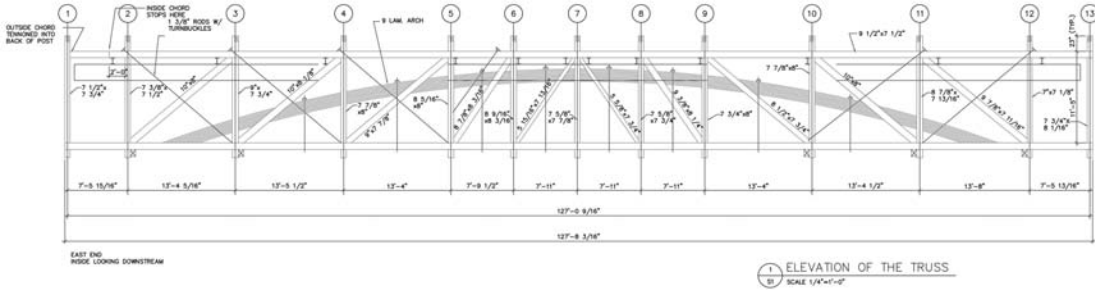
Trusses – The length of truss bays between posts are not identical. See Figure 7. The spans between posts at the center of the bridge are unusually longer than the bays near both ends. Several hand-hewn posts remain in the trusses, but most members are sawn. Tie beams are dropped into slots at tops of posts and pinned. The outrigger ends of the tie beams bear rafter sills. See Figure 2. Knee braces are framed between the tie beams and posts. Horizontal x-bracing is alternately nailed and "let in" between the tie beams of each bent. Lower "needle" beams were added later to the posts, below the lower chords, suspended from the arches for supplemental support.

Structural Documentation – DCF prepared CAD construction documents for the stabilization design that were used to map the existing conditions and actual dimensions of the bridge. See Figure 7.

Figure 7 – CAD Drawings - Frame elevation (by DCF)
