James D. Katsaros<sup>1</sup> and Charles G. Carl<sup>2</sup>

## Extreme Exposure Fenestration Installations—The Florida Challenge

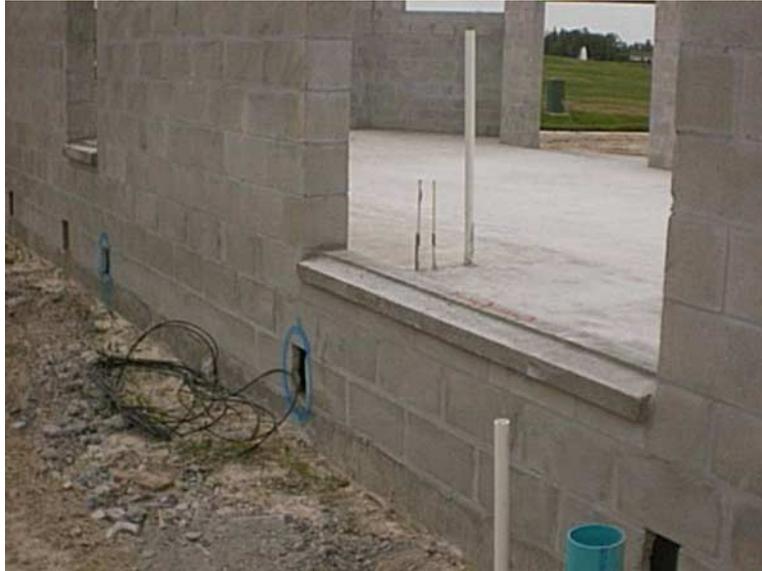
FIG. 2—*Pre-cast concrete sill. The sill shown protrudes past the outer face of the block wall.*

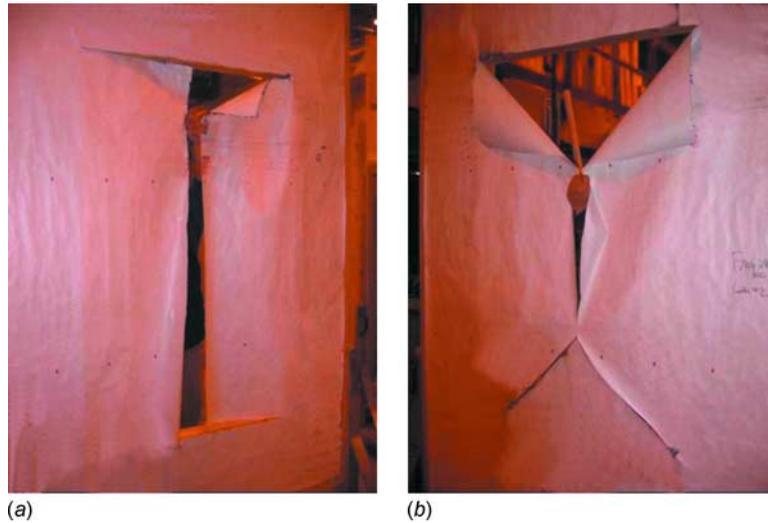
FIG. 4—Cuts in water resistive barrier for FMA/AAMA 100 installations. Full I-cut used in Wall #1 (a) and modified-I cut used in Wall #2 (b).

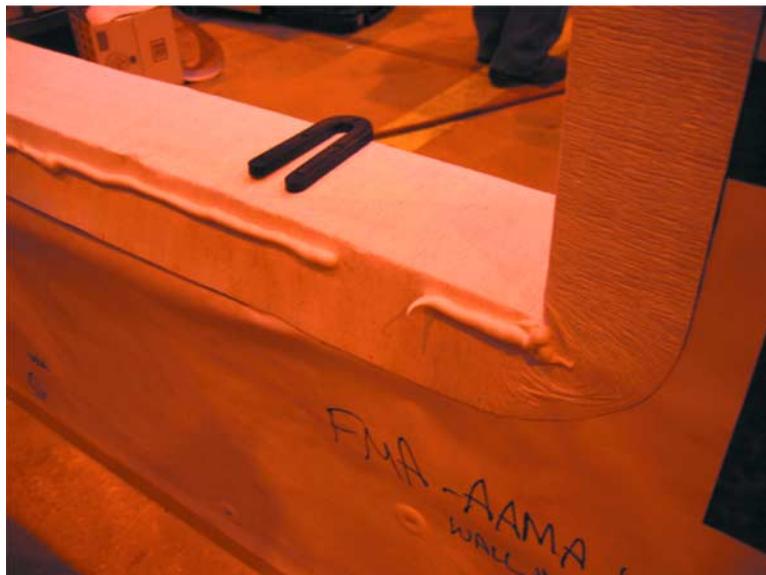
FIG. 5—Extendable sill flashing used in both Wall #1 and Wall #2 for FMA/AAMA 100 installations, with discontinuous bead of sealant at sill (can also be applied to back of the flange).

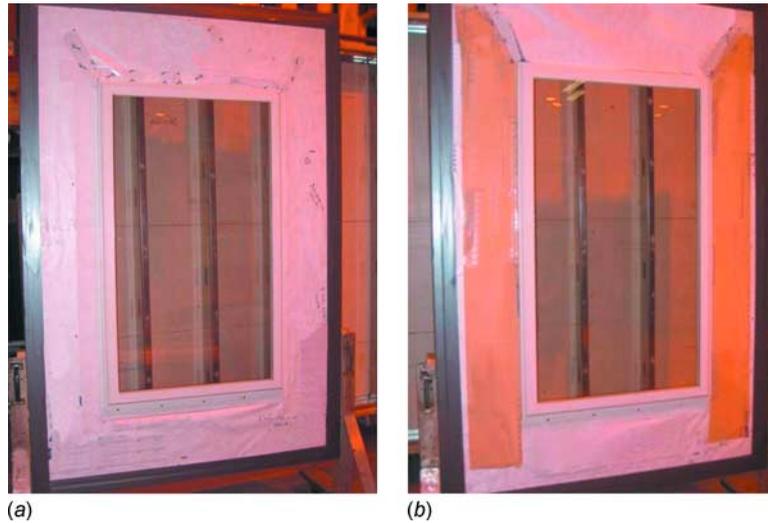
FIG. 6—FMA/AAMA 100 completed installations, Wall #1 with 4 in. self-adhering flashing used at jambs and heads (a); Wall #2 with 9 in. mechanically attached flashing used at jambs and head (b).

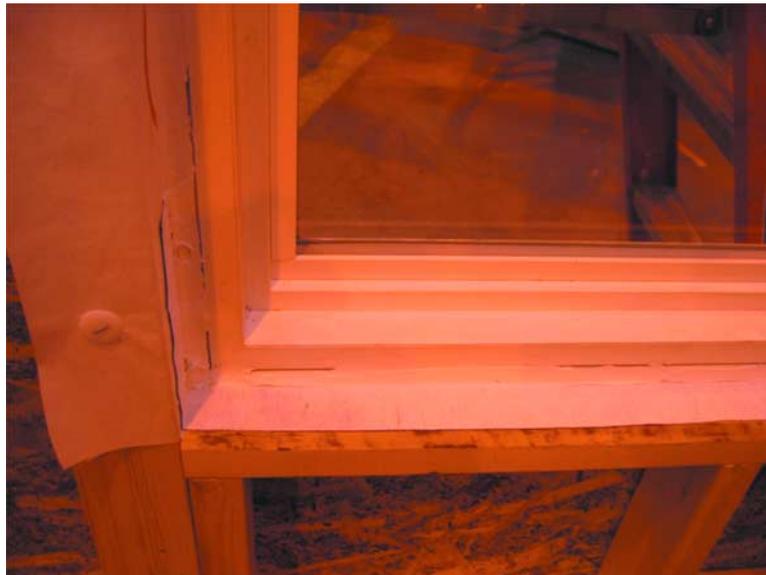
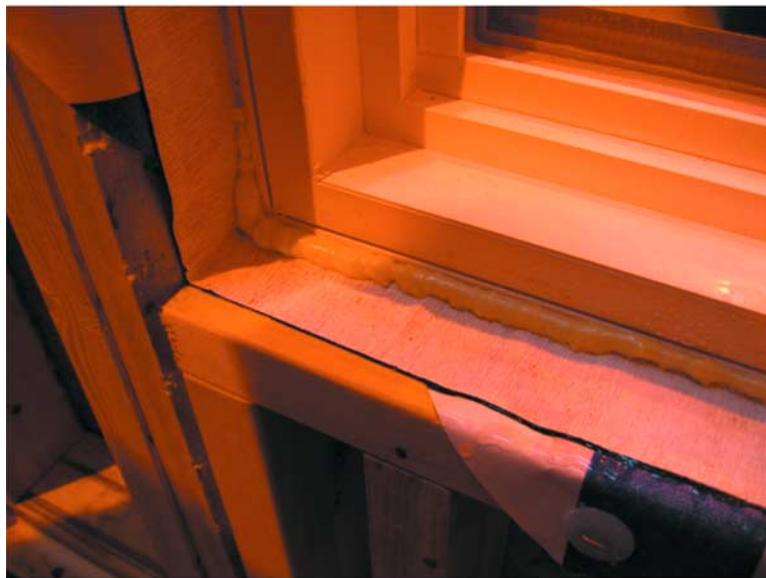
*Results of FMA AAMA 100 Wall #1 Test*—In the first round of testing of this wall assembly, water leakage was not observed until air pressure differential, reached 540 Pascal (11.29 psf), as shown in Fig. 8. At that 540 Pascal, leakage was observed between the sill pan and the sealant that served (along with backer rod) as the air seal (and the pan back dam) below the window unit's sill. It was noticed that the

sealant had not fully cured; it was still wet/sticky to the touch. A spot or “patch” repair was made with additional sealant. The assembly was retested after seven days to allow the sealant to fully cure. During retesting the wall was taken directly to 440 Pascal (9.2 psf) pressure differential (the 145 and 290 Pa differential set-points were skipped). Within eleven minutes at 440 Pa, a leak was observed at the same area as before, and the leak was again between the pan flashing and the sealant. Upon inspection, two conclusions were drawn:

1. There was poor interfacial adhesion between the polyurethane hybrid sealant and the flashing topsheet—the sealant could be easily pulled away from the topsheet. This resulted in an insufficient bond to hold water back against the pressure differential (the back dam would leak at the higher differential pressures).
2. Since the leak occurred at the same location as the first test, it was also concluded that the repair “patch” was ineffective.

FIG. 7—FMA/AAMA100 interior air/water seals: Wall #1 with backer rod and polyurethane hybrid sealant in (a); Wall #2 with low expansion polyurethane aerosol foam sealant in (b).

Given the conclusions drawn above, the polyurethane hybrid sealant was removed at the sill area of the installation and a short distance up the jambs and replaced with pure polyurethane sealant. It was known from previous experience that the topsheet of this flashing adhered effectively to pure polyurethane sealants.

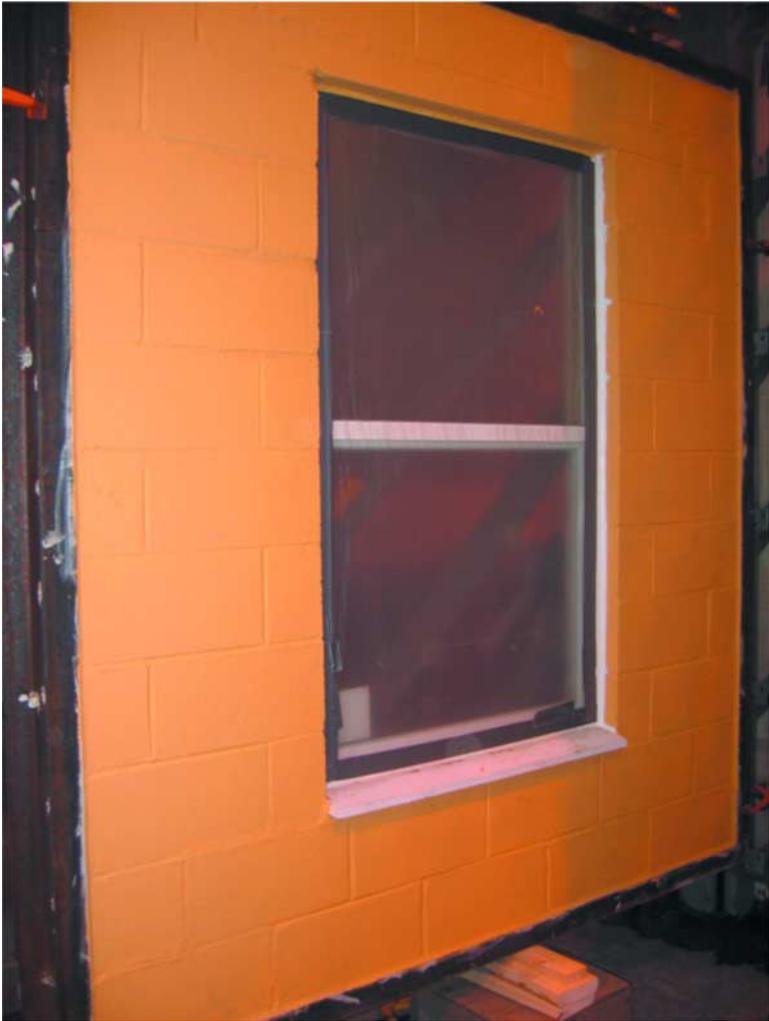
*FMA/AAMA 200 Tests Results*—All the blocks in the first of the two assemblies were sealed with a block sealer that is commonly used in the region. This included the rough opening return and the pre-cast concrete sill. The concrete sill in the assembly protruded beyond the face of the block wall. Figure 9 shows this assembly prior to spray testing.

The first testing of the assembly was performed during the fall of 2006. In that testing, leakage was observed between the concrete sill and the CMU wall below the sill without application of an air pressure differential (the only driving force being the momentum of the water droplets, imparted by the spray nozzles). A second application of sealer was made in January 2007. The assembly was then exposed to spray testing in February and March 2007.

FIG. 9—FMA/AAMA 200 setup for first test wall prior to wall testing in March 2007.

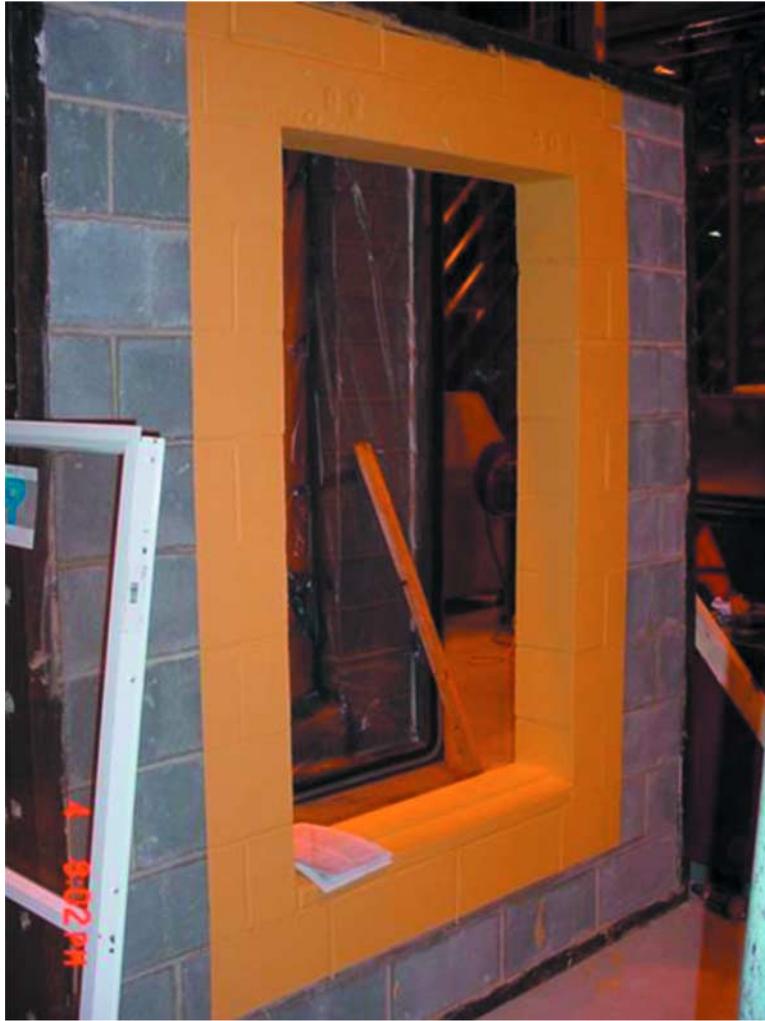
A second assembly conforming with FMA/AAMA 200 was constructed. This assembly was tested in May 2007. In the second assembly, only 230 mm (9 in.) of the exterior perimeter face of the block was sealed (as directed in the AAMA/FMA 200 draft specification). Figure 14 shows the 230 mm (9 in.) coverage of the sealer, as well as the rough opening return and pre-cast sill. In this case, the pre-cast sill was flush with the block wall below the window. A flush sill is more common in actual field installations in Florida. The installation followed the detailed steps of FMA/AAMA 200.

FIG. 14—Wall treatment for second FMA/AAMA 200 wall test, showing 230 mm (9 in.) sealant application around exterior perimeter and return of rough opening.

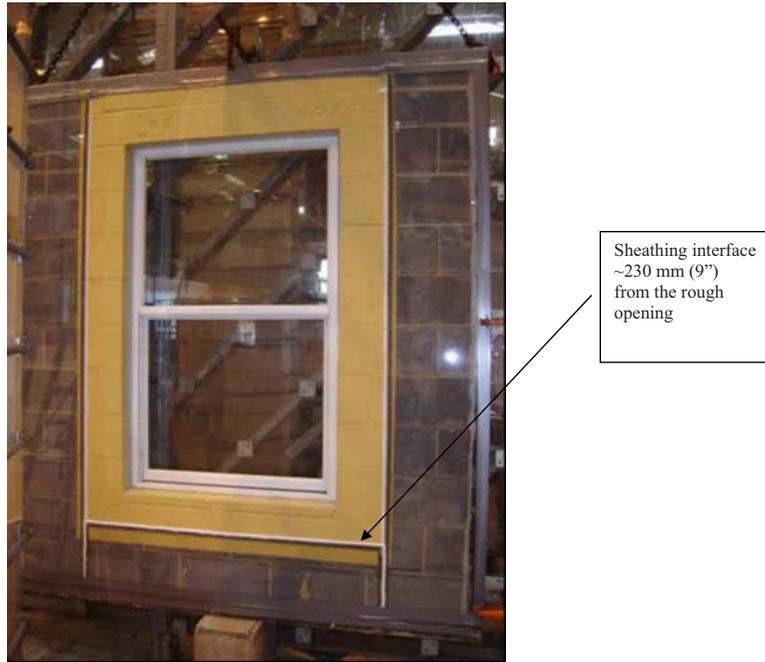
Testing of this second assembly was conducted in two phases. First, water was applied only to the sealed area of the block, which is 230 mm around the exterior perimeter of the rough opening, in order to test the robustness of the sealed area and interface. Figure 15 shows the method used to mask the unsealed portion of the wall; the method used an acrylic sheet and sealant. In the second phase of testing, the test was repeated, with the mask removed (with the entire wall exposed, as shown in Fig. 16). The test results are summarized in Table 4.

| FMA/AAMA 200 Wall Test Descriptor | Initial ASTM E331 Water Test Results | Comments/Observations |
|--|---|---|
| Tested around sealed area of exterior perimeter only | Passed (no leakage observed) at 575 Pascal (12 psf) | Water leakage through window glazing was noted, but not around installation |

FIG. 15—FMA/AAMA 200 wall test with unsealed area blocked by clear acrylic sheet and sealed.

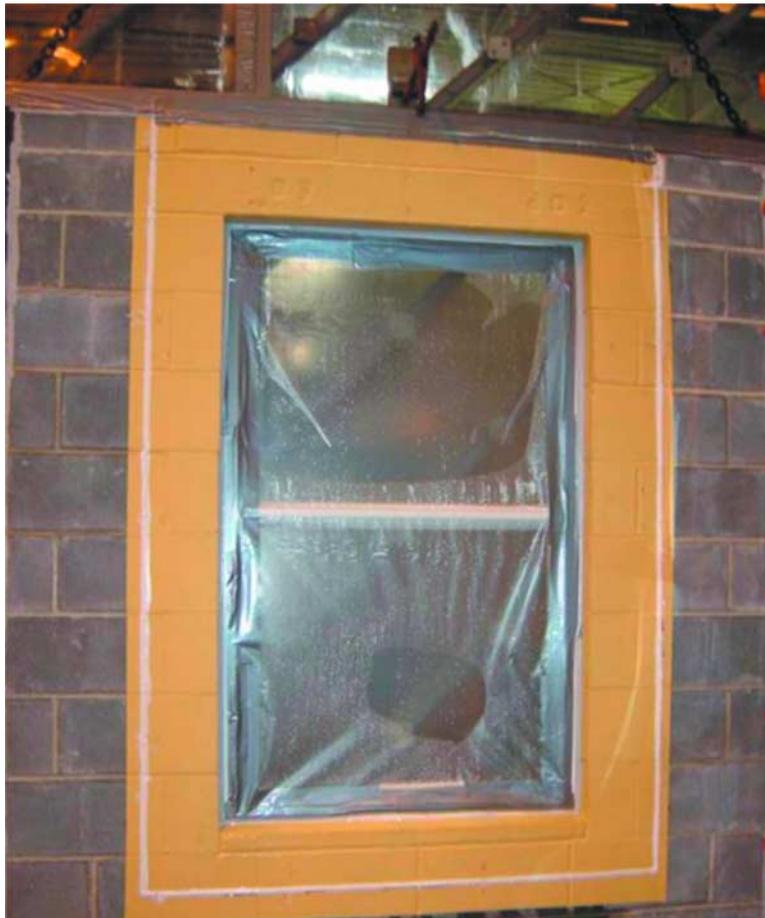
When the masking was removed and the entire CMU wall was exposed to water spray, water seepage to the interior occurred at the lowest pressure differential included in the test protocol (Table 4). Figure 17 shows the water penetration through the interior side of the unsealed area, but not the sealed area of the block. Unsealed portions of the CMU wall system were thus notably incapable of meeting the FMA/AAMA 200 criterion. Additional testing has shown that water seepage through block walls occurs readily in the absence of any air pressure differential. A “whole wall” approach to water management is thus justified. This, incidentally, was recognized in the report (dated January 2005) by Lstiburek [4]. It will be a key challenge for the FMA Installation Committee going forward.

| FMA/AAMA 200 Wall Test Descriptor | Initial ASTM E331 Water Test Results | Comments/Observations |
|--|---|---|
| Tested entire wall | Failed (seepage observed) at 145 pascal (3.13 psf)—14 minutes into test | Water seepage through block was observed in unsealed area |

FIG. 16—FMA/AAMA 200 wall test with full wall exposure, both sealed and unsealed areas (second phase).
