# GROUND-PENETRATING RADAR INVESTIGATION OF SALVAGED TIMBER GIRDERS FROM BRIDGES ALONG ROUTE 66 IN CALIFORNIA<sup>1</sup>

**Abstract.** This study describes assessment of the internal conditions of timber bridge structural members along Route 66 in California. These timber bridges were exposed to desert climate conditions for several decades, which can lead to a variety of deterioration. Overtime, the deterioration may cause loss of structural integrity within the bridges and lead to potentially hazardous conditions for the motoring public. Members from dismantled bridges were brought to the Forest Products laboratory in Madison, WI. Strength-reducing features including decay, splits and cracks, insect attack, and corrosion of metal components were initially identified using visual inspection. Further assessment was then performed using several nondestructive testing technologies including ground-penetrating radar (GPR). GPR was used, among other nondestructive techniques, to identify and locate internal features and defects within the timbers. The tomographic output of the GPR, known as radargrams, revealed deterioration. Based on the information contained within the radargrams,

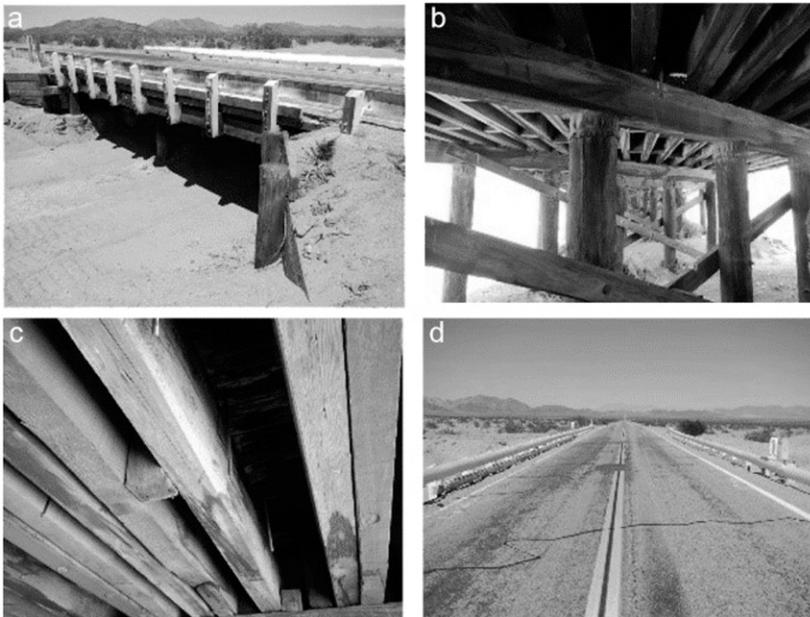
Figure 1. (a) Overview of the bridge structure, (b) underside view, (c) stringers, and (d) concrete deck with asphalt covering.

nail-laminated deck. After WWII, the bridge was widened. In the early 1950s, a concrete deck was added and then covered with asphalt (Fig 1).

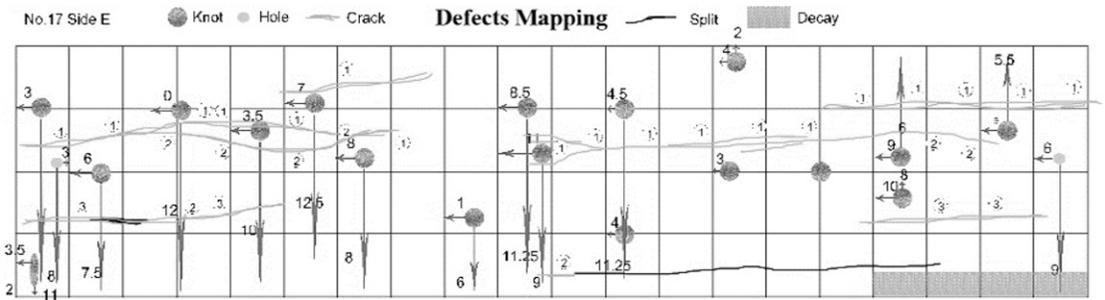
Figure 10. Defect mapping.

two seated the probe firmly. The last three were recorded and averaged for TOF values. Last, the location, size, and nature of visible surface defects were recorded as shown in Fig 10. This process is referred to as defect mapping in this report.

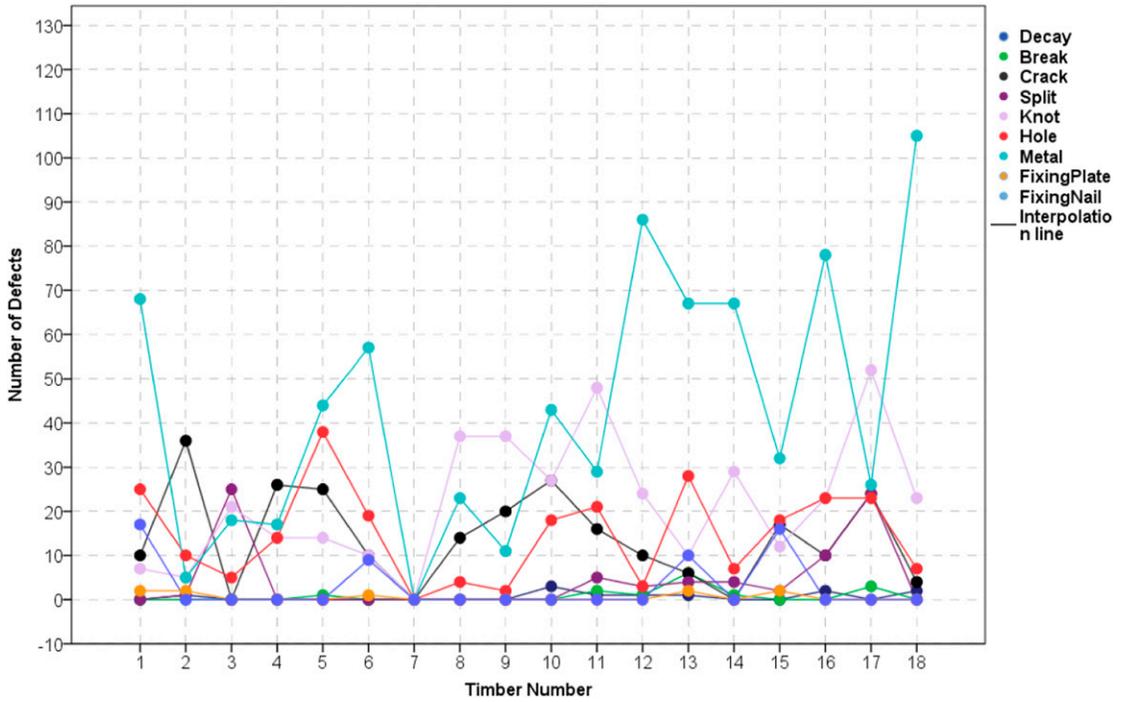
Figure 12. Defect account of 18 timbers.

through visual inspection. The number of characteristics identified through visual inspection of the timbers are given in Table 2 and Fig 12. Characteristics include decay, breaks, cracks, holes, knots, steel bars, steel nails, and fixed plates. Among the 18 timbers, No.7 was unsuitable for the radar test because of the presence of a break through the entire length of the timber. The radargrams revealed some timbers with greater numbers of particular defects. Among them, four timbers (Nos. 5, 9, 17, and 18) had the highest numbers of cracks, knots, holes, and steel nails. The information from the acoustic tests supports the radargram identification of defects within the timbers. Timber No. 5 had the highest number of holes (38) distributed across four sides. In addition, 64 cracks were present. Timber No. 9 had the highest number of cracks (86) and a high number of knots (37). Timber No. 17 had the highest number of knots (52) and a high number of cracks (72). Timber No. 18 had 105 steel nails scattered along the top side. In addition to GPR scans,

acoustic tests, and field visual inspections, photographs recorded the locations of the characteristics along the timbers. There were 25 cracks, 14 knots, 38 holes, and 44 nails or bars visible on the surface of the timbers. Different visible features can be found in the radargrams. The condition of two sides, Faces C and D, on No. 5 is shown in Fig 13. Comparing the defect-mapping data, the photographs, and the GPR images is a valuable way to locate defects. They clearly and accurately reflect the visible condition. The highlighted reflected waves inside the red square (Fig 13[c]) are between 12.7 cm to 177.8 cm and 279.4 cm to 431.8 cm, and correspond to cut sample No. 1 (Fig 13). They can be detected on the three-dimensional image as shown in Fig 13(e).
