WATER REPELLENTS
IMPROVE PERFORMANCE
OF DROP SIDING

U.S. FOREST SERVICE
RESEARCH PAPER

FPL 4
MAY
1963

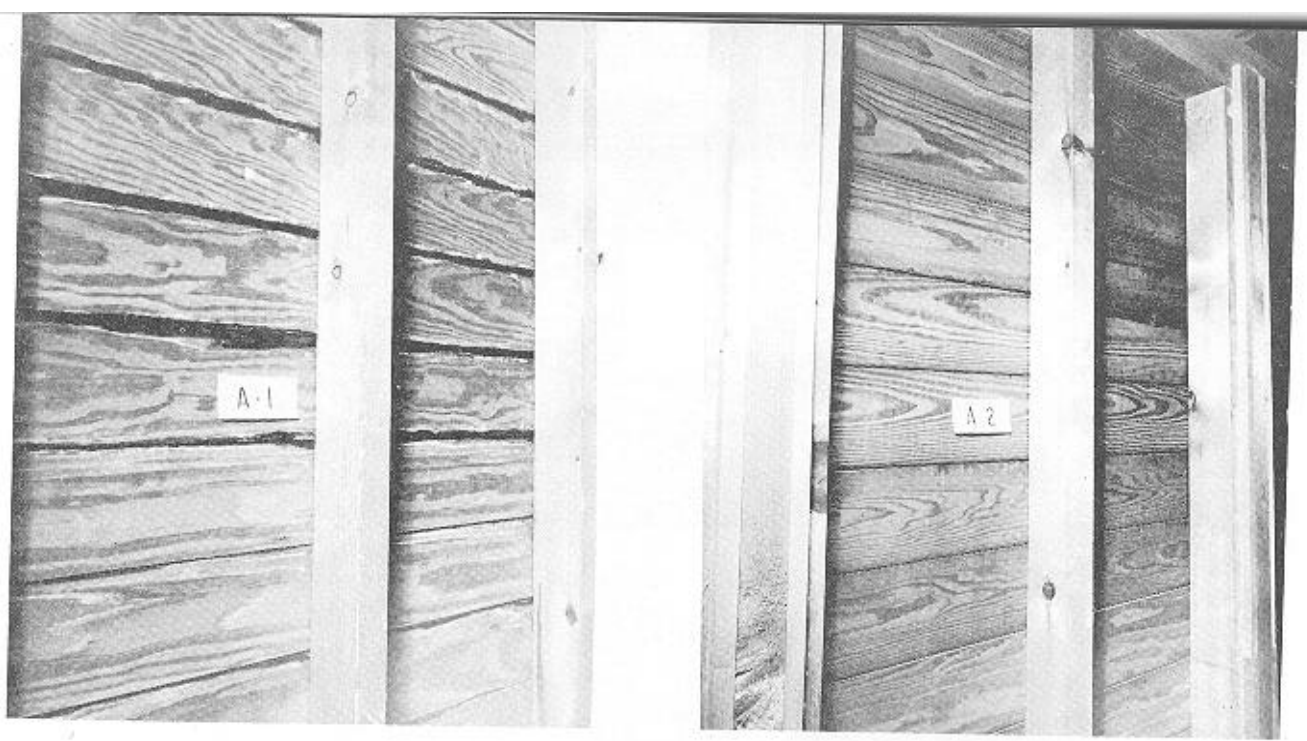
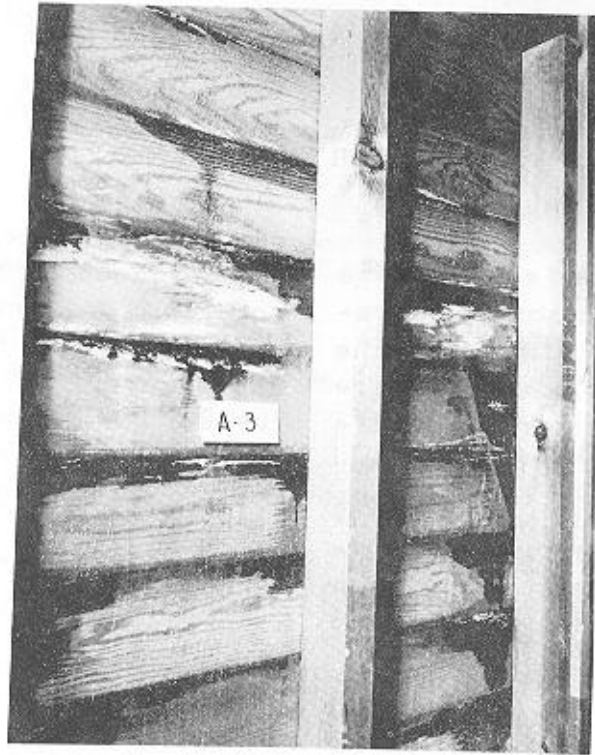
Figure 3. --Inside view of panels A-1, A-2, and A-3 after a rainfall. Panel A-1 (southern yellow pine drop siding, rabbeted pattern, not treated) shows water entry that was from the lap, usually extending on each side of the horizontal joint. On panel A-2 (southern yellow pine, rabbeted pattern drop siding, dip treatment in water-repellent preservative), no moisture was noted on the back face during the entire 5-year outdoor exposure period or during the initial laboratory spray exposure. On panel A-3 (southern yellow pine, rabbeted pattern, untreated drop siding with a polyethylene cover), moisture entered at the horizontal siding joints. White portions are indications of mold. Note: The use of polyethylene permitted accumulation of the observed amount of condensed moisture.

Readings were taken near the end or shortly after rainfalls that occurred during the normal work week. Figures 3, 4, and 5 show the interior of the panels after a rainfall.

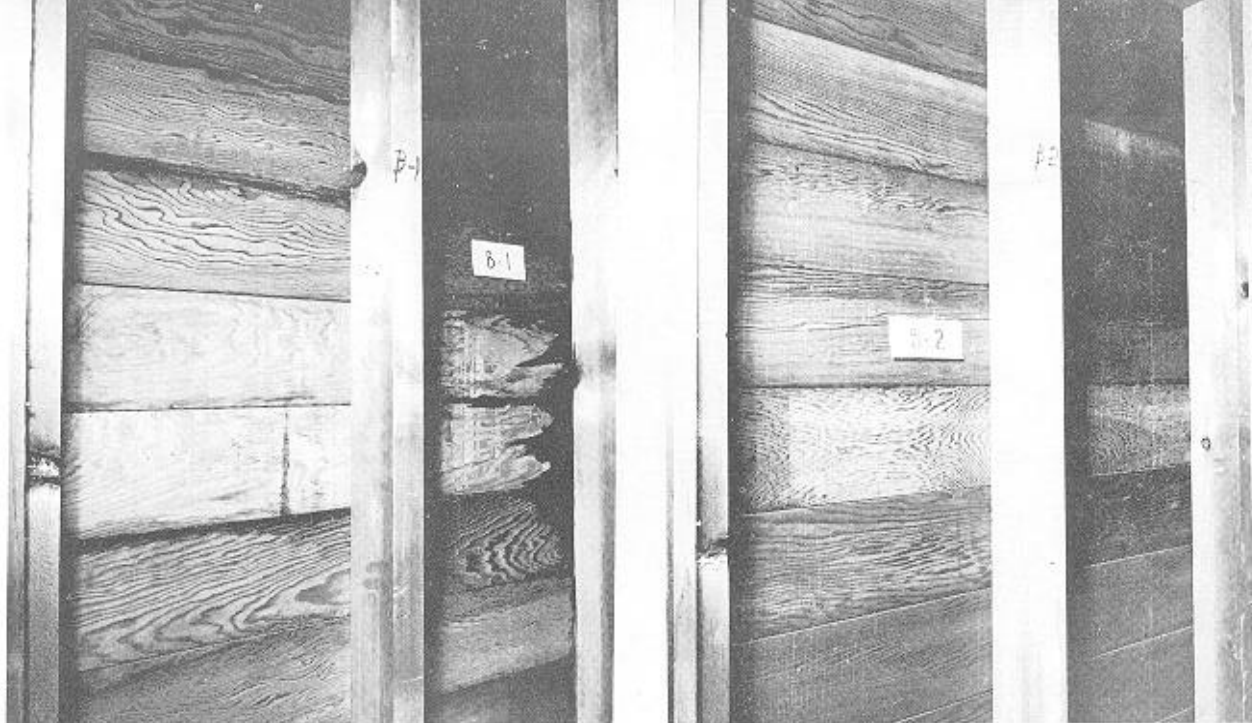
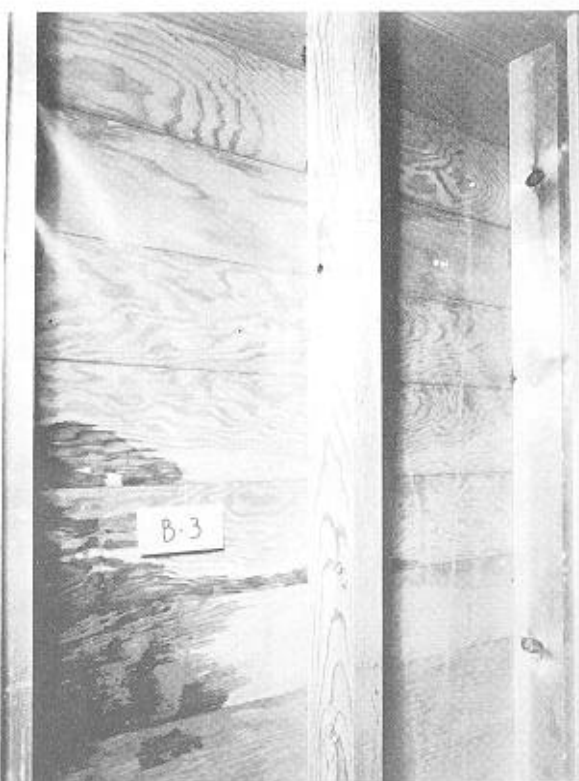
Figure 4.--Inside view of panels B-1, B-2, and B-3 after a rainstorm. On panel B-1 (Douglas-fir, matched pattern drop siding, untreated), water entered at lap joints and spread along inside faces of siding. Note flat grain of siding. On panel B-2 (Douglas-fir, matched pattern, treated), the back face of the panel was free of moisture. On panel B-3 (Douglas-fir, matched pattern, untreated, polyethylene cover), rainwater entered through siding laps and was retained long after similar panels without covering had dried off.

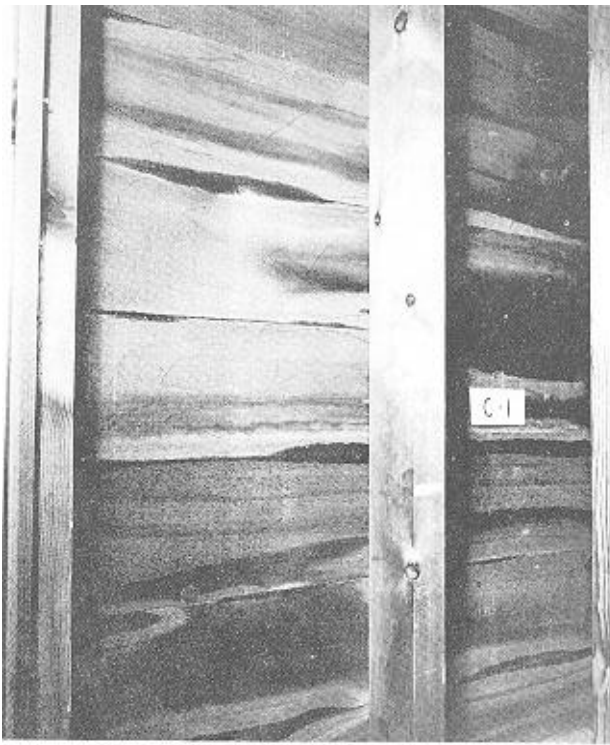
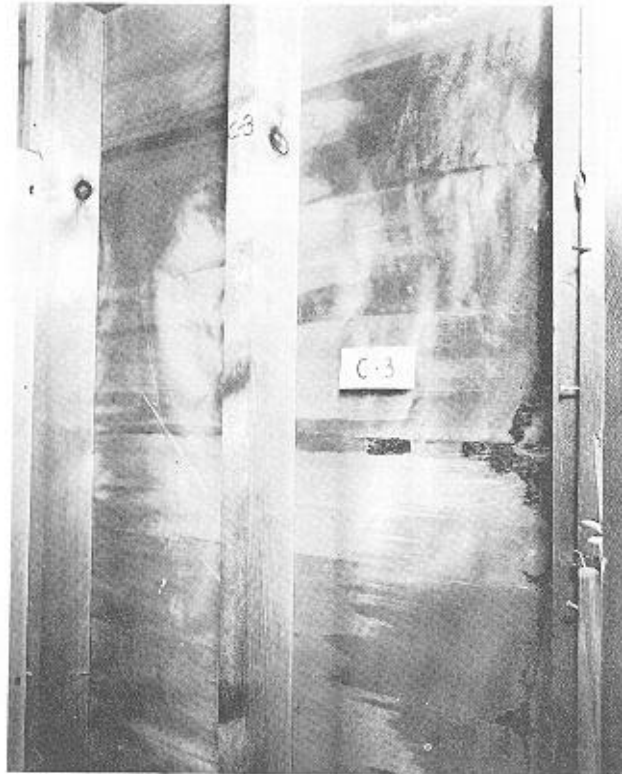
Figure 5. --Inside view of panels C-1, C-2, and C-3 after a rainfall. After long rains, the back face of panel C-1 (western redcedar, rabbeted pattern, untreated) had large wetted areas. No moisture was present on the back faces of panel C-2 (western redcedar, rabbeted pattern, treated). On panel C-3 (western redcedar, rabbeted pattern, untreated, polyethylene cover), the wetted areas can be noted under the film.

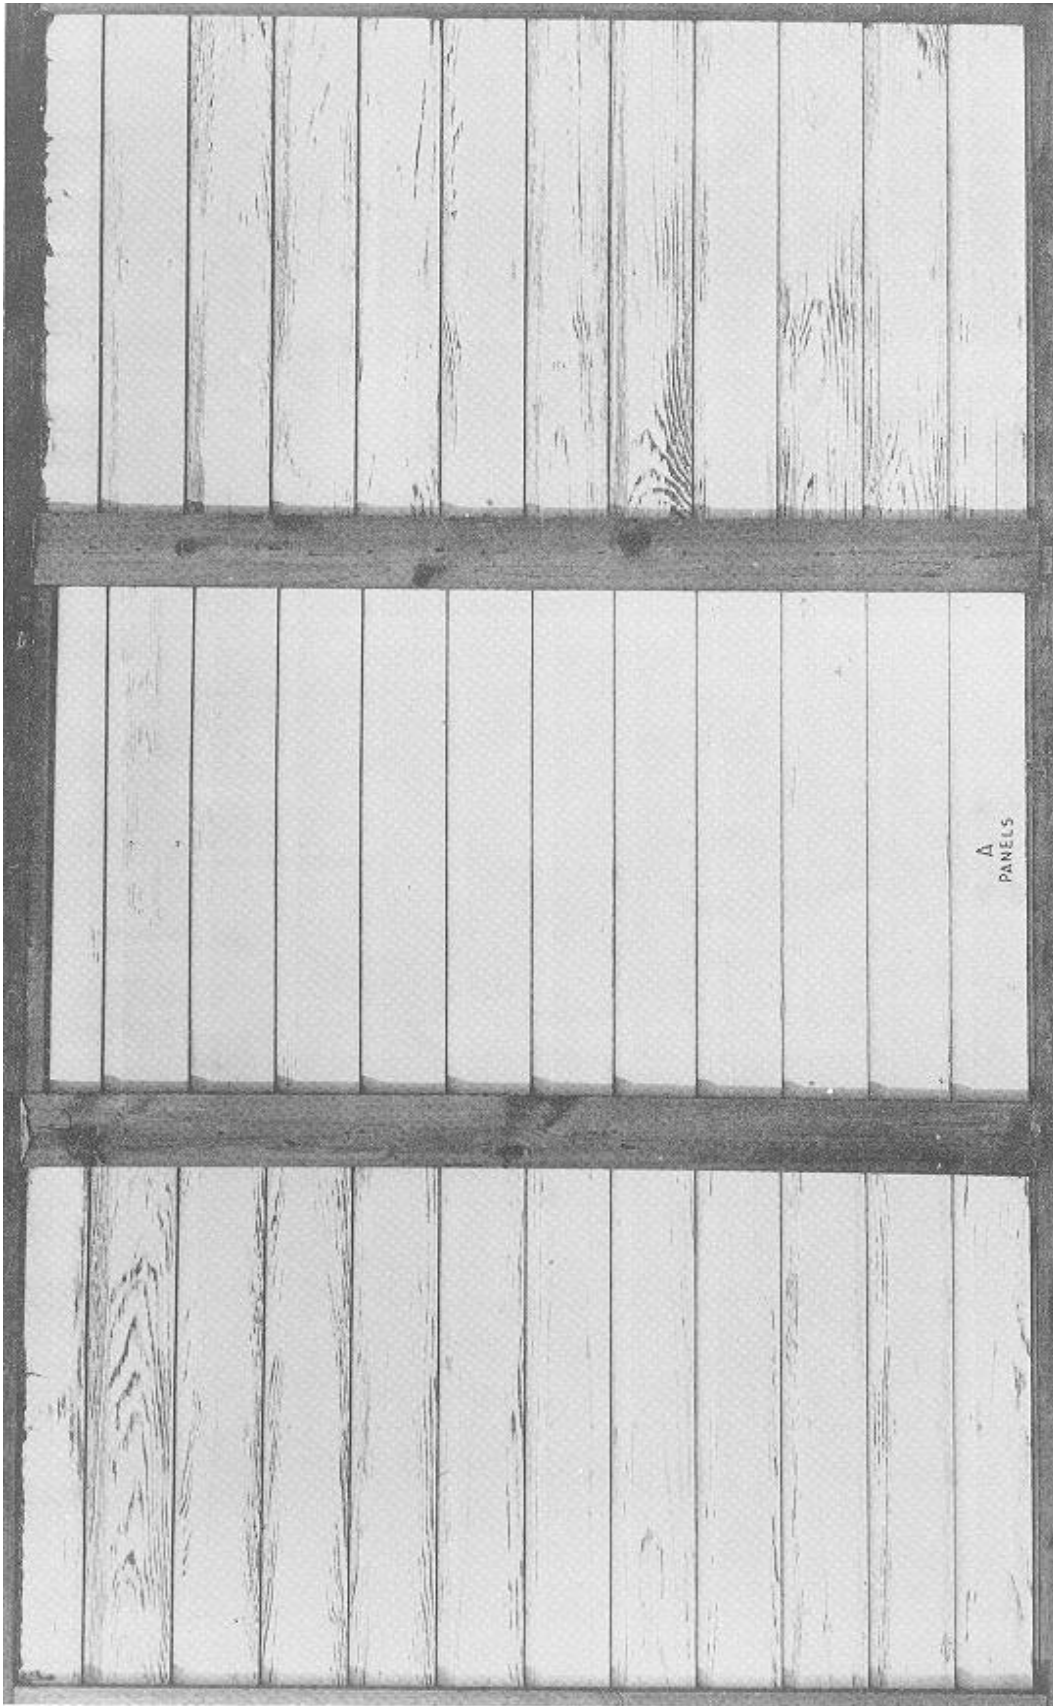
M 118 667

Figure 6. --Exterior view of panels A (southern yellow pine) (left A-1, center A-2, and right A-3) Center panel was treated and end panels were untreated. The difference in paint retention can be noted. All siding was flat-grained. Panels had been exposed for 3 years

Not originally a part of the project, some data were obtained on the value of the water-repellent preservative in holding the paint on the dense summerwood of certain species. This is evident on the southern yellow pine panels, figure 6. The center panel was treated and end panels, A-1 and A-3, were untreated. There was somewhat better retention on the treated Douglas-fir panel B-2, in the center of figure 7, than on the ad-
