# Service Life of Finishes on Smooth-Planed and Saw-Textured Western Redcedar Bevel Siding

by R. Sam Williams<sup>†</sup>—  
USDA Forest Service, Forest  
Products Laboratory\*  
and  
William C. Feist—Retired

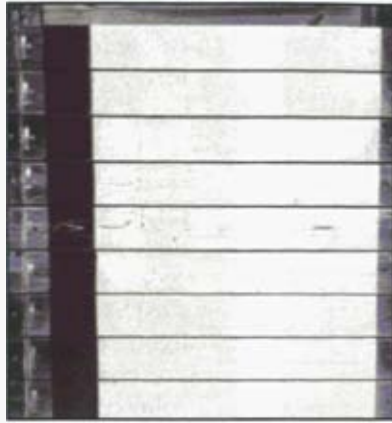
Figure 1—Paints and two-coat solid-color stains (Group D) after 10 years outdoor exposure near Gulfport, MS.

was a ¼-in. (6 mm) gap between each board. Nine boards were placed in each section of the fence (Figure 1).

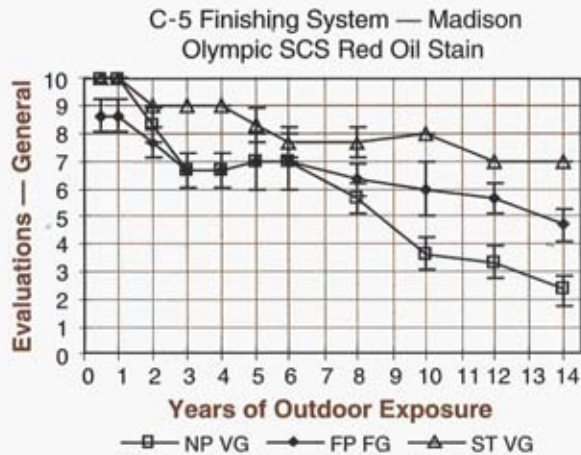
Figure 2—General appearance evaluations for a red 55% solids oil-based solid-color stain (SCS, C-5, Table 1) exposed near Madison, WI (NP VG: newly planed vertical-grained; FP FG: factory-planned flat-grained; ST VG: saw-textured vertical-grained).

**DATA REDUCTION**—The data for each of the finish systems were plotted to show performance over the 14-year exposure on each of the three different surfaces (newly planed vertical-grained (NP VG); factory-planned flat grained (FP FG); and saw-textured vertical-grained (ST VG)). The plots showed the average and standard deviation of the three observations for each of the finish systems on each of the surfaces. For example, the general-appearance ratings over 14 years for a red 55% solids oil-based solid-color stain (Group C, finish C5) exposed near Madison is shown in Figure 2. The standard deviations are the bars at each average point in the plots.

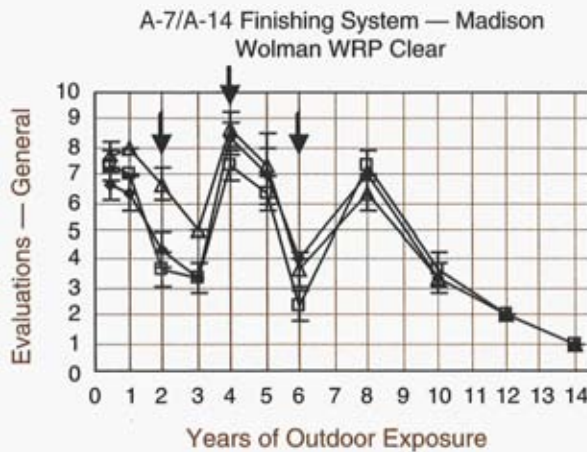
Figure 3—General appearance evaluations for a clear 67% solids repellent-preserved (WRP, A-7, Table 1) exposed near Madison (NP VG, newly planed vertical-grained; FP FG: factory-planned flat-grained; ST VG: saw-textured vertical-grained). Boards were refinished after 2, 4, and 6 years (arrows).

General appearance ratings for finish system A-7 (A-14) show considerable difference over the 14 years (Figure 3). The initial finish application lasted less than 18 months, and the boards were refinished after two, four, and six years. The finish was not evaluated after refinishing at two years. Not evaluating the finish systems immediately after they were refinished was an oversight because in many cases the ratings fell below "5" within six months of refinishing. To compare the ratings among the various finish systems, the information on the various plots (such as shown in Figure 3) is tabulated for each of the finishes on each of the substrates. The times (years) that it took for the rating to drop below "5" are tabulated (Table 3A (Madison) and

3B (Gulfport)). The values extracted from *Figure 3* are shown in bold type in *Table 3A*. These tables are not the raw data from the evaluations; they contain the finished analysis of data taken from numerous evaluations over many years. The values in the tables are the service life determined from the "General Appearance" evaluation.

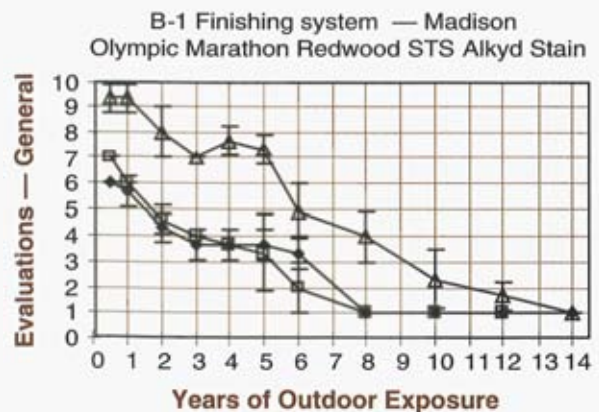
Figure 4—General appearance ratings for a redwood color 24% solids alkyd-modified acrylic waterborne semitransparent stain (STS, B-1, Table 1) exposed near Madison (NP VG: newly planed, vertical-grained; FP FG: factory-planned flat-grained; ST VG: saw-textured vertical-grained).

A typical example of the plots of finish general appearance ratings compared with time for the three types of substrate is shown in Figure 4. The bars indicate the standard deviation for the three replicates for each type of substrate. As with the Group A finishes, the service life was extracted from these plots and tabulated (Table 4). For example, values extracted from Figure 4 are shown in bold type in Table 4. Twenty-seven additional plots were used to obtain performance data on these seven finishes and are summarized in Table 4. Erosion and general appearance are shown in Table 4. It is inter-

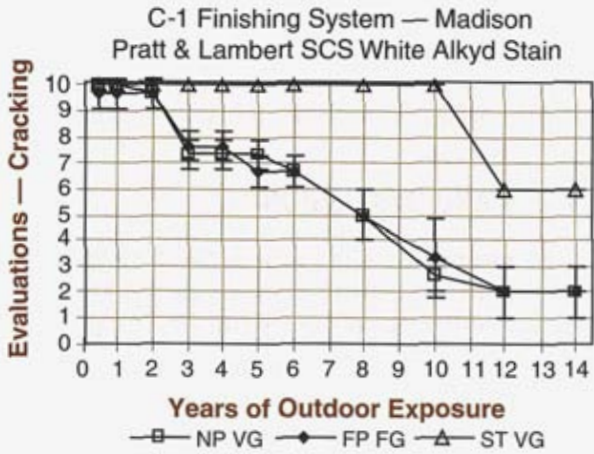
Figure 5—Finishing tracking ratings for a white 78% solids oil-based, solventborne solid-colorstain (SCS, C-1, Table 1) exposed near Madison (NP VG: newly planed vertical-grained; FP FG: factory-planned flat-grained; ST VG saw-textured vertical-grained),

A typical example of the plots (Figure 5) and the service life (Table 5) for this group of finishes shows that the performance is excellent on the saw-textured

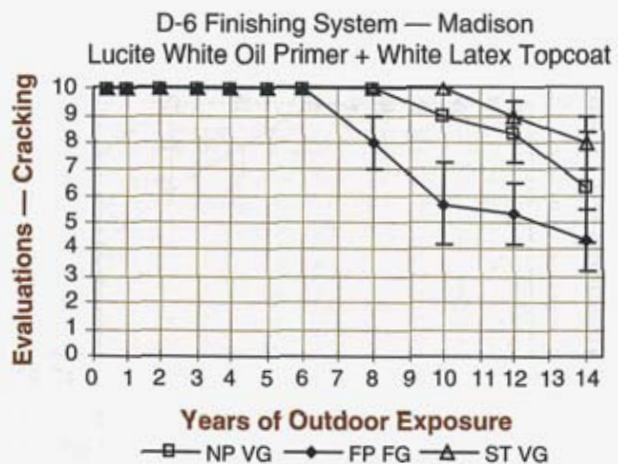
Figure 6—Paint tracking ratings for a white 77% solids alkyd primer and 57% solids acrylic topcoat (D-6) exposed near Madison (NP VG: newly planed vertical-grained; FP FG: factory-planned flat-grained; ST VG: saw-textured vertical-grained).

Although Group D is labelled paints, D-1 and D-2 were solid-color stains. They were two-coat systems and thus had application rates similar to the paint systems (D-4–D-6) (Table 2). Figure 6 shows the paint cracking

The finishes used in Group F were the same as those used in Group D, except that a WRP was applied to all 4-ft boards prior to applying the finishes. This is illustrated by comparing the WRP/alkyd primer/acrylic topcoat (F-6, *Figure 8*) with the same primer and topcoat without the WRP (D-6, *Figure 6*). In general, the performance of all finishes on all substrates was about the same for those 4-ft boards treated with the WRP pretreatment (Group F, *Table 8*) and those without the WRP pretreatment (Group D, *Table 6*) for both sites. This is in agreement with a previous study that showed little benefit from a WRP pretreatment on western redcedar, but did show considerable benefit for difficult-to-paint species, such as southern pine.<sup>9</sup>

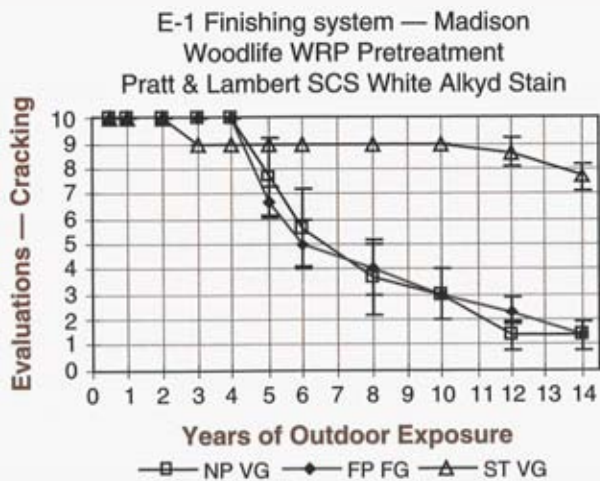
Figure 7—Painttacking ratings for white 78% solids oil-based solid-color stain (E-1) with a solventborne water-repellent preservative (WRP) pretreatment exposed near Madison (NP VG: newly planed vertical-grained; FP FG: (factory-planned flat-grained); ST VG: saw-textured vertical-grained).

The solid-color stains used in Group E were the same as those used in Group C, except that a WRP was applied to all 4-ft boards prior to applying the solid-color stain. For example, the performance of an oil-based solventborne solid-color stain with the WRP pretreatment (E-1, *Figure 7*) can be compared with the same solid-color stain without the pretreatment (C-1, *Figure 5*). The service life for all finish systems obtained from the "cracking" and "general appearance" ratings show that the performance of all finishes on the saw-textured bevel siding was about the same for Group C (no WRP, *Table 5*) and Group E (with WRP, *Table 7*). The results for the smooth-planed siding were quite different. In general, the service life was less for the Group E finish systems than for the Group C finish systems. This was quite surprising, as we expected better performance with the WRP pretreatment. The only explanation we can offer is that the amount of finish accepted by the planed surface following the WRP pretreatment was considerably less for many of the solid-color stains (*Table 2*). Little apparent difference was evident between the WRP-treated and untreated for the newly planed vertical-grained siding and the factory-planed flat-grained siding.

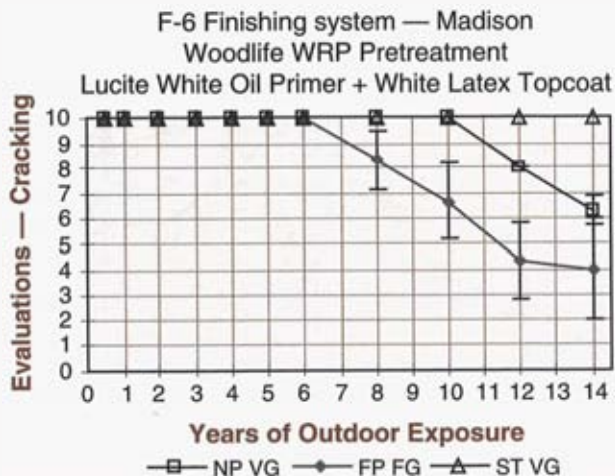
Figure 8—Painttacking ratings for a white 77% solids alkyd primer and 57% solids acrylic topcoat (F-6) with a solventborne water-repellent preservative (WRP) pretreatment exposed near Madison (NP VG: newly planed vertical-grained; FP FG: factory-planned flat-grained; ST VG: saw-textured vertical-grained).
