Effect of Flakeboard Manufacturing Variables on Composite Properties: Part 1. Effect of Resin Content, Wax Content, Pressing Conditions, and Edge Treatments on Paint Performance

**R. Sam Williams
Jerrold E. Winandy**

U.S. Forest Service, Forest Products Laboratory
Madison, Wisconsin

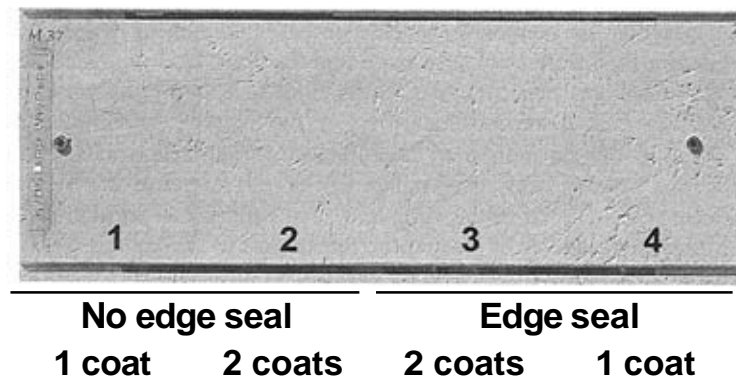
Figure 1. Single board showing four sections: 1. One coat of paint, no edge seal; 2. Two coats of paint, no edge seal; 3. Two coats of paint, edge seal; 4. One coat of paint, edge seal.

Half the length of the drip edge of all boards was painted with an edge-seal. Each 140- by 403-mm (5½- by 15 7/8-inch) board was marked (but not cut) into four 140- by 101-mm (approximately 5½- by 4-inch) paint-exposure zones designated as 1, 2, 3, and 4 when viewed from left to right along the 403-mm (15 7/8-inch) length of the board (**Figure 1**). Each of the two boards per flakeboard panel intended for finishing and subsequent outdoor exposure was edge-sealed with a commercial OSB edge seal on both side edges, the top edge and one-half of the bottom edge (Sections 3 and 4). The remaining two sections (1 and 2) were not edge-sealed along the bottom edge.

The middle half of each board (Sections 2 and 3) was finished with a latex primer and after 24 hours, the entire board (Sections S1-S4) was finished with a single top-coat of a high-quality latex paint. The back side of all boards was finished with a single coat of latex-based primer. After a week of drying, boards were stickered, bundled, and placed in the 30% RH/80°F (27°C) room for conditioning before installation at the two test sites (Madison, WI, and Gulfport, MS).

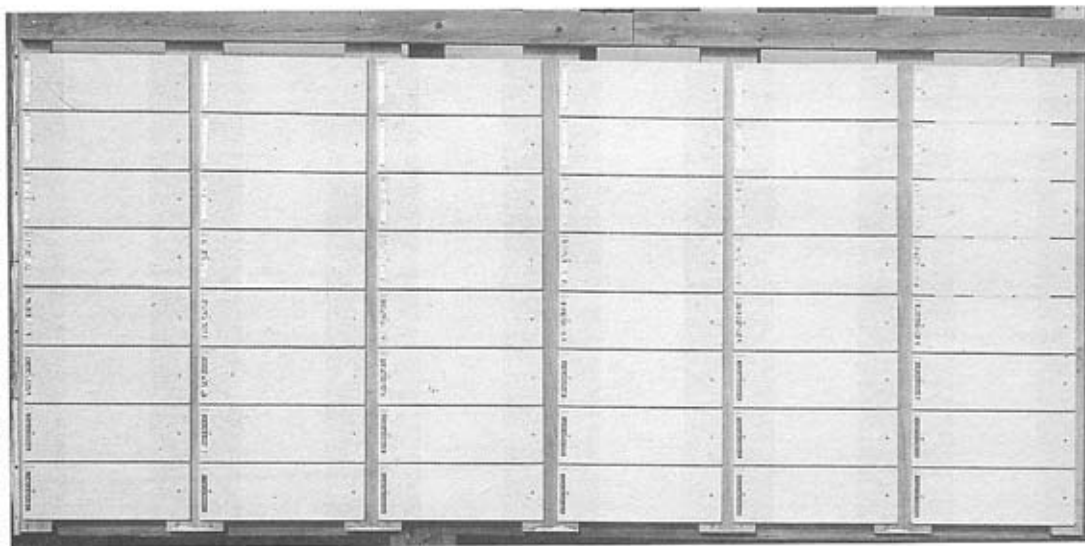
Figure 2. Painted boards mounted on test fence facing south, Madison, Wisconsin, soon after installation.

Painted specimens were placed on test racks vertically facing south at the FPL outdoor test sites located 5 km southwest of Madison, Wisconsin, (**Figure 2**) and 15 km north of Gulfport, Mississippi. The photograph was taken shortly after the boards were placed on the test fence.

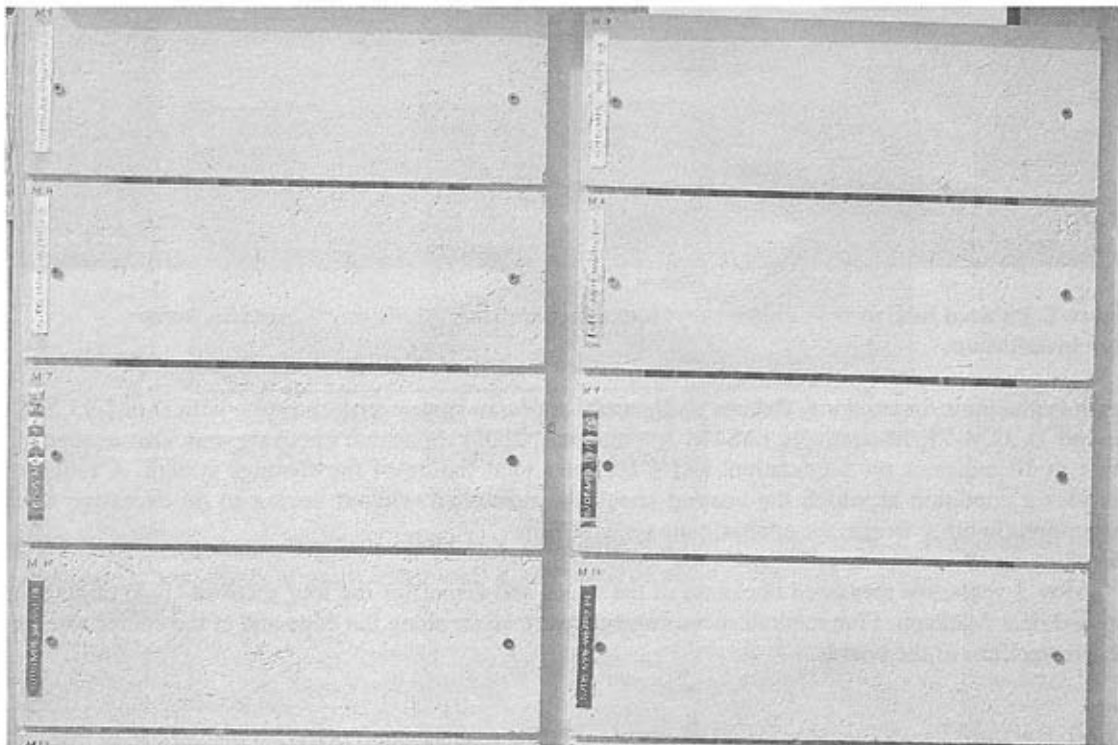
Figure 3. Close-up of several boards just after installation on the test fence near Madison, Wisconsin.

Figures 3 and 4 show the change in specimens exposed for 3 years near Madison, Wisconsin. The boards are typical of the other boards exposed at this site. Inspection of the painted flakeboard boards after 3 years exposure clearly shows a difference in performance of the one- and two-coat paint systems. Each of the boards has four sections (Sections 1-4 (labeled left to right), **Figure 1**). Ends of boards 1 and 4 have one coat (latex top-coat), and the center (Sections 2 and 3) has two coats of paint (latex primer and top-coat). The drip edge of the left half (Sections 1 and 2) has no edge sealer and the right half (Sections 3 and 4) has an edge sealer. Other than the obvious difference in performance of the one- and two-coat paint system, there appears to be little difference in performance between the edge sealed and non-edge sealed (**Figure 4**) specimens. The single coat of paint failed and there was considerable debonding of flakes. The dimensional change of surface flakes often telegraphed through the two-coat paint system.

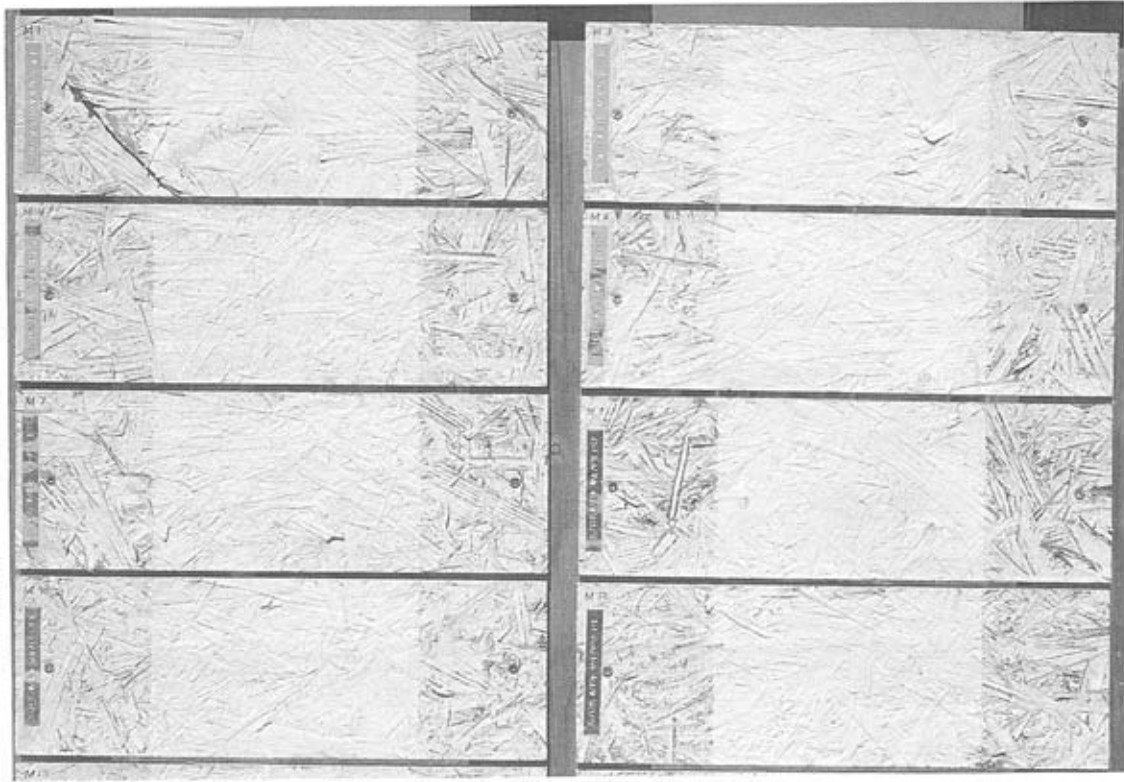
Figure 4. Close-up of the same boards as shown in Figure 3 after 3 years on the test fence near Madison, Wisconsin.

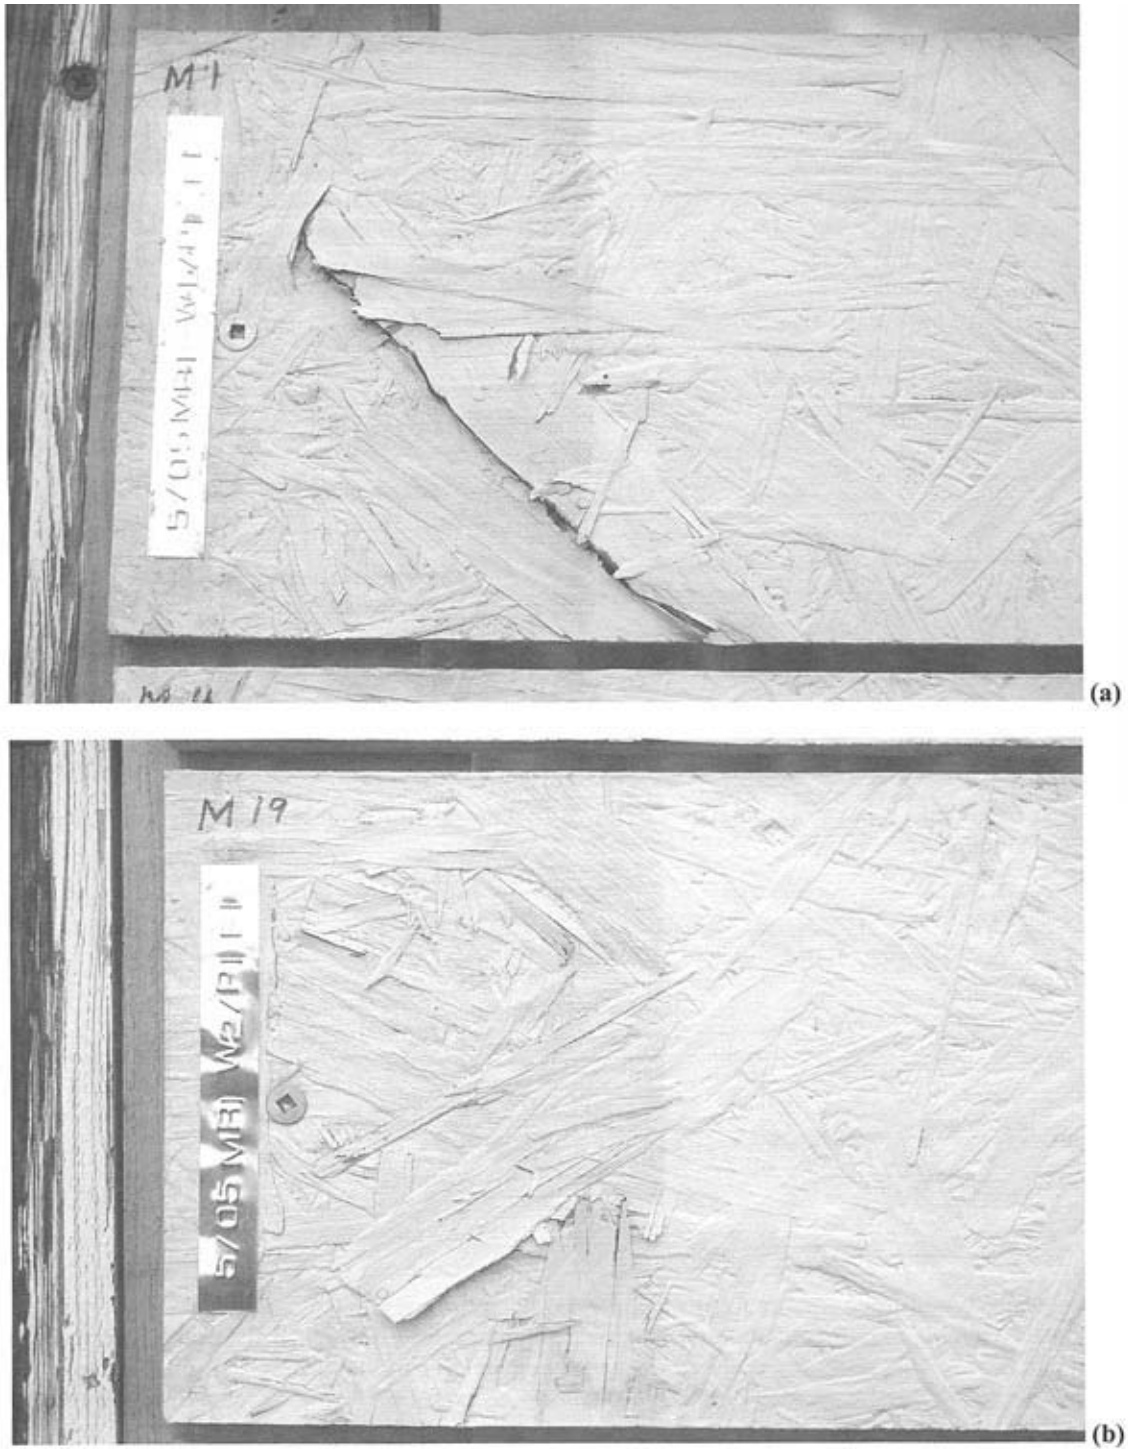
Figure 5. Close-up of boards on the test fence near Madison, Wisconsin, showing deterioration at the edges of large surface flakes.

We evaluated substrate condition (S) for checking, flake curling, and debonding and the paint for paint cracking (C), flaking (F), discoloration (D), and general appearance (G). Large flakes near the surface of the painted boards were generally problematic, as they tended to curl and debond (**Figure 5a and b**). The random orientation is quite apparent in this close-up. As mentioned previously, single-layer mat formation with random flake orientation presents the worst-case scenario for moisture-induced surface movement with few fines in the outer surfaces. Grozdits and Bibal (1983) reported that fines on the surface decreased surface degradation. In our study, this surface movement was more serious under a single coat of paint for the edge-sealed and non-edge-sealed sections of the boards than for the two-coat paint system. In some cases, debonding extended into the two-coat portion of the board (**Figure 5a**).

Figure 6a and b are typical of the change in the boards at the Gulfport test site. As with boards exposed near Madison, the boards having a single coat of paint had failed. In our subjective judgment, telegraphing of the two-coat paint system was slightly worse near Gulfport than near Madison. In general, boards having one coat of paint had severely cracked paint with the flakes debonding. This debonding was more pronounced with larger flakes (**Figure 5**).

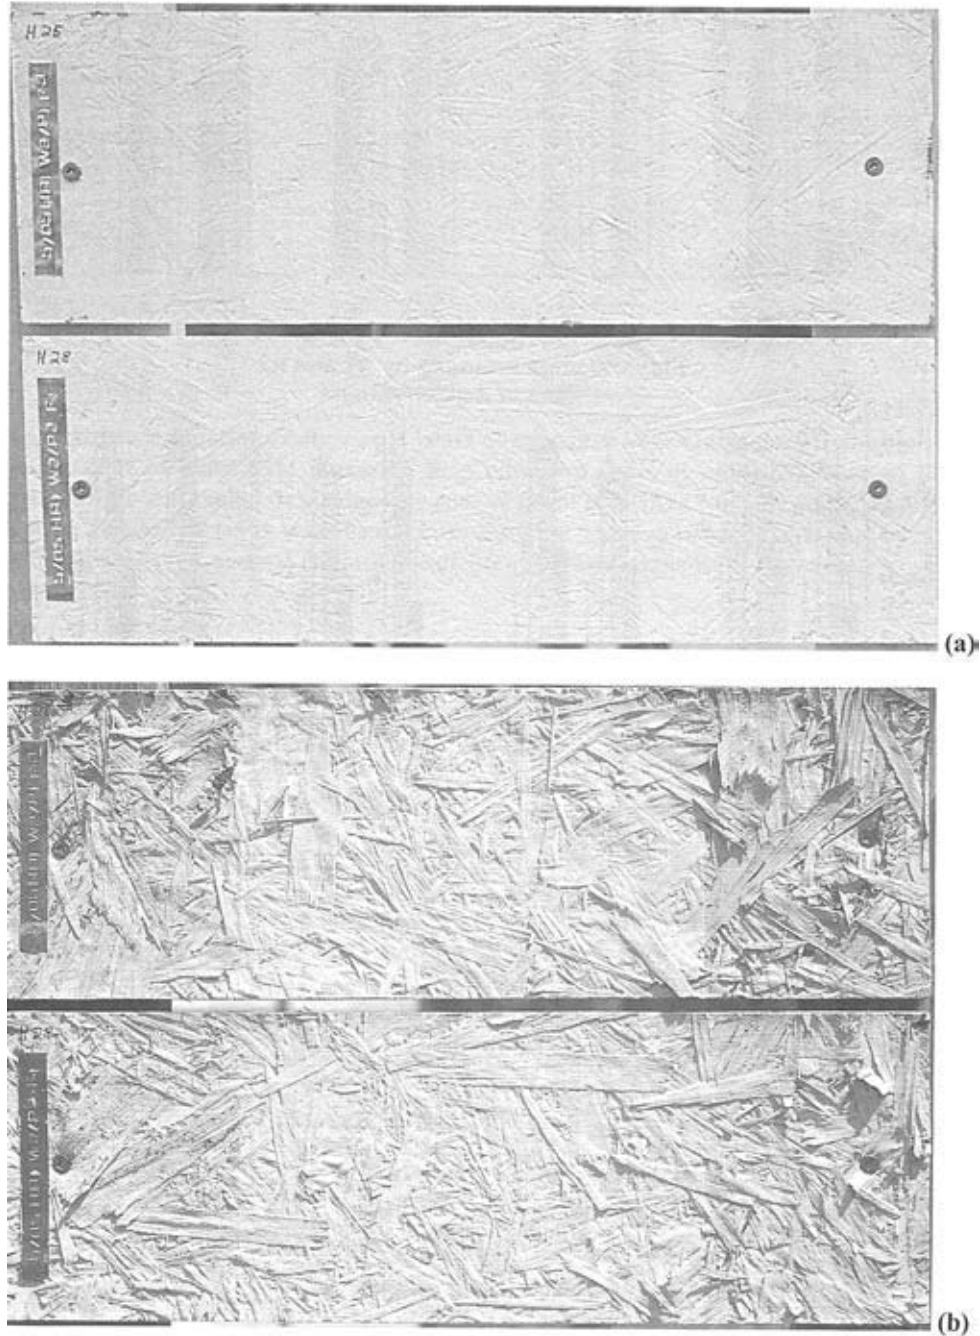
Figure 6. Close up of two boards just after installation (a) on the test fence near Gulfport, Mississippi, and following 3 years of exposure (b).

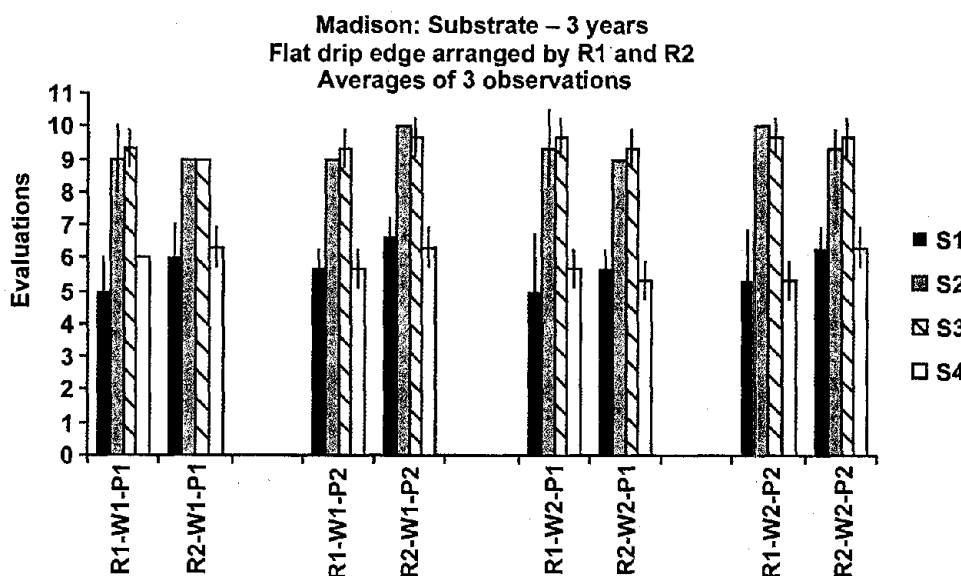
Figure 7. Substrate evaluations following 3 years of exposure near Madison., Wisconsin, for unsealed drip edge/one coat of paint (S1); unsealed drip edge/two coats of paint (S2); sealed drip edge/two coats of paint (S3); and sealed drip edge/one coat of paint (S4). R1 is 2.0% resin, R2 is 3.5% resin, W1 is 0.75% wax, and W2 is 1.5% wax. Error bars indicate \pm one standard deviation from mean. Lack of a line indicating first standard deviation indicates all evaluations were the same.

We evaluated the data for the effect of edge-seal, bevel- or flat-drip edge, and manufacturing parameters (resin, wax, and press closure) for boards exposed near Madison and Gulfport. Location had the largest effect and amount of resin had the second largest effect on board performance (Figure 7). Figure 7 shows the condition of the substrate (S evaluation) for non-edge sealed (S1 and S2) and edge sealed (S3 and S4) for flat-drip edges for boards exposed near Madison. Bars are first standard deviation of averages of three observations. The most notable effect is for the one- and two-coat paint systems.

Two coats of paint and 3.5 percent resin in the boards improved paint performance, but the paint evaluation data revealed few other differences among experimental parameters (Figures 7 and 10). Statistical analysis provided a clearer picture of significant differences for the composite manufacturing parameters. The data were analyzed for edge-sealed compared with non-edge-sealed, bevel- compared with flat-edge, location, and manufacturing parameters (resin and wax content and press closure). There was no obvious effect for edge sealing or the type edge (bevel compared with flat). For statistical analysis, both the variability and the level of experimental redundancy affected the actual limits of significance. For this experiment, the limiting differences in means at the $p = 0.05$ and $p = 0.10$ levels of significance would be $0.58 \times SD$ and $0.49 \times SD$, respectively.

Significant substrate and finish-cracking effects for location, resin, wax, and press closure for the flat- and bevel-edge boards are shown in Table 1. The significant effects listed in Table 1 can be compared with the results in the various figures. For example, the difference between R1 and R2 can clearly be seen in Figures 7–10.

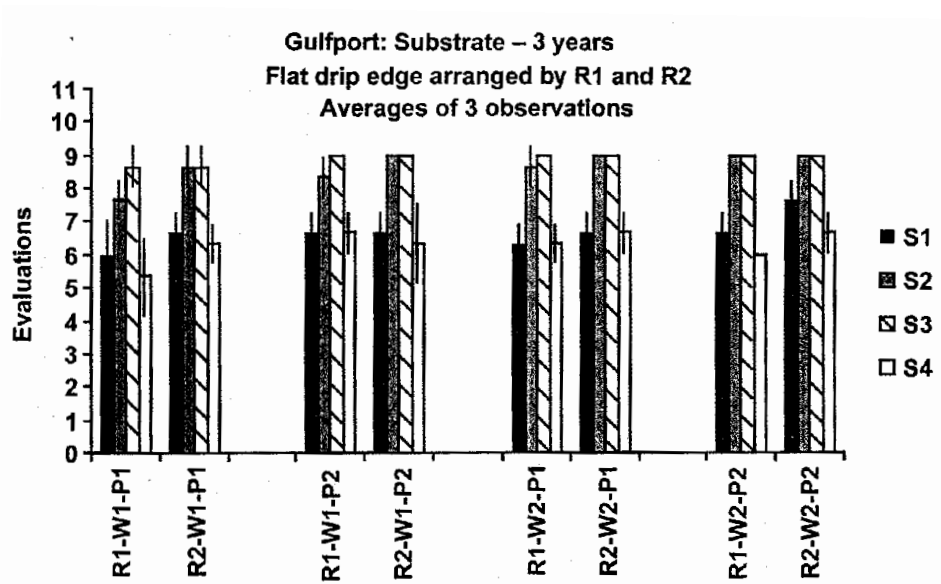
Figure 8. Substrate evaluations following 3 years of exposure near Gulfport, Mississippi, for unsealed drip edge/one coat of paint (S1); unsealed drip edge/two coats of paint (S2); sealed drip edge/two coats of paint (S3); and sealed drip edge/one coat of paint (S4 R1 is 2.0% resin, R2 is 3.5% resin, W1 is 0.75% wax, and W2 is 1.5% wax. Error bars indicate \pm one standard deviation from mean. Lack of a line indicating first standard deviation indicates all evaluations were the same.

The next effect is for resin content; higher resin content improved performance. Boards exposed near Gulfport were similar (Figure 8). The paint cracking evaluations for Madison and Gulfport show similar trends (Figures 9 and 10).

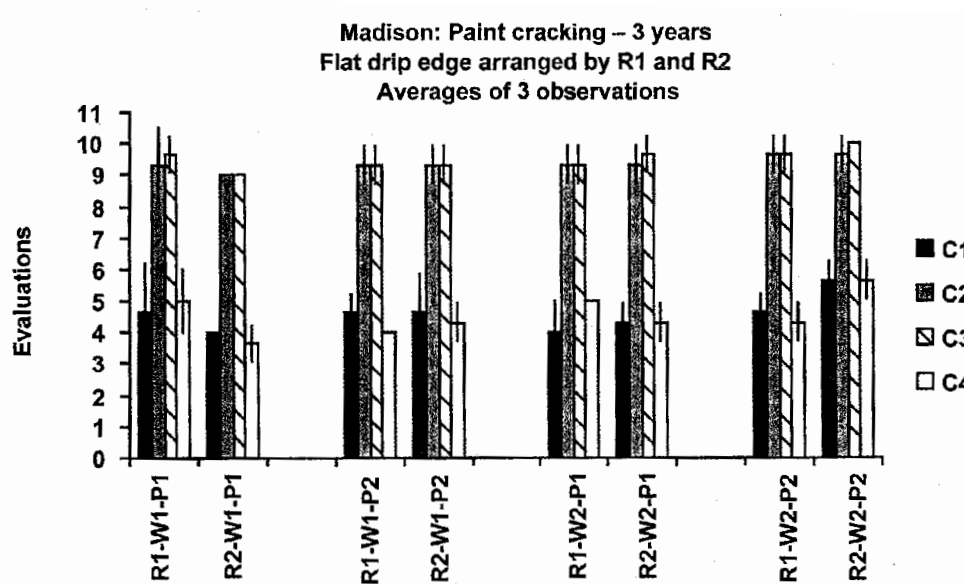
Figure 9. Paint cracking evaluations following 3 years of exposure near Madison, Wisconsin, for unsealed drip edge/one coat of paint (C1); unsealed drip edge/two coats of paint (C2); sealed drip edge/two coats of paint (C3); and sealed drip edge/one coat of paint (C4). R1 is 2.0% resin, R2 is 3.5% resin, W1 is 0.75% wax, and W2 is 1.5% wax. Error bars indicate \pm one standard deviation from mean. Lack of a line indicating first standard deviation indicates all evaluations were the same.

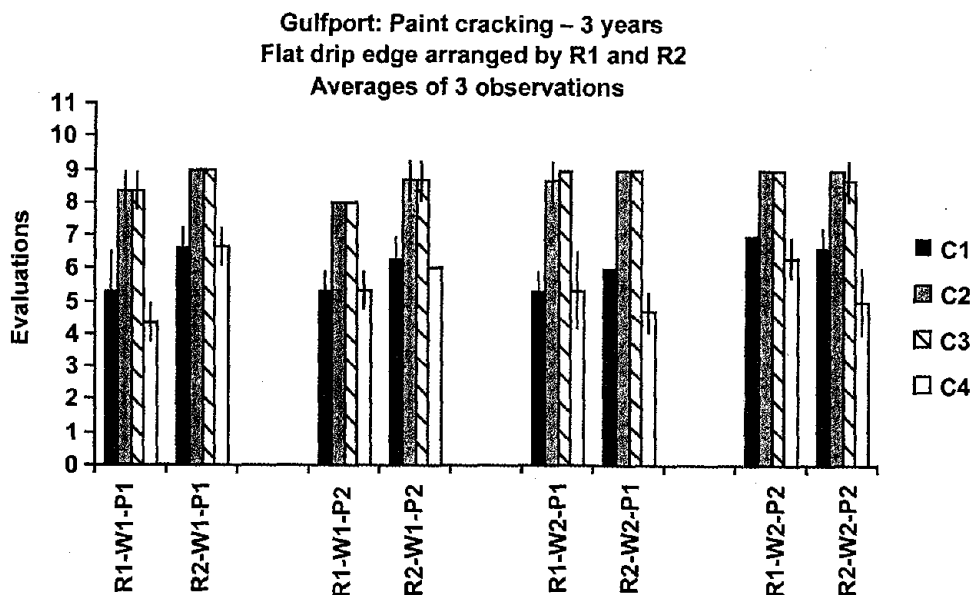
Figure 10. Paint cracking evaluations following 3 years of exposure near Gulfport, Mississippi, for unsealed drip edge/one coat of paint (C1); unsealed drip edge/two coats of paint (C2); sealed drip edge/two coats of paint (C3); and sealed drip edge/one coat of paint (C4). R1 is 2.0% resin, R2 is 3.5% resin, W1 is 0.75% wax, and W2 is 1.5% wax. Error bars indicate 5 one standard deviation from mean. Lack of a line indicating first standard deviation indicates all evaluations were the same.

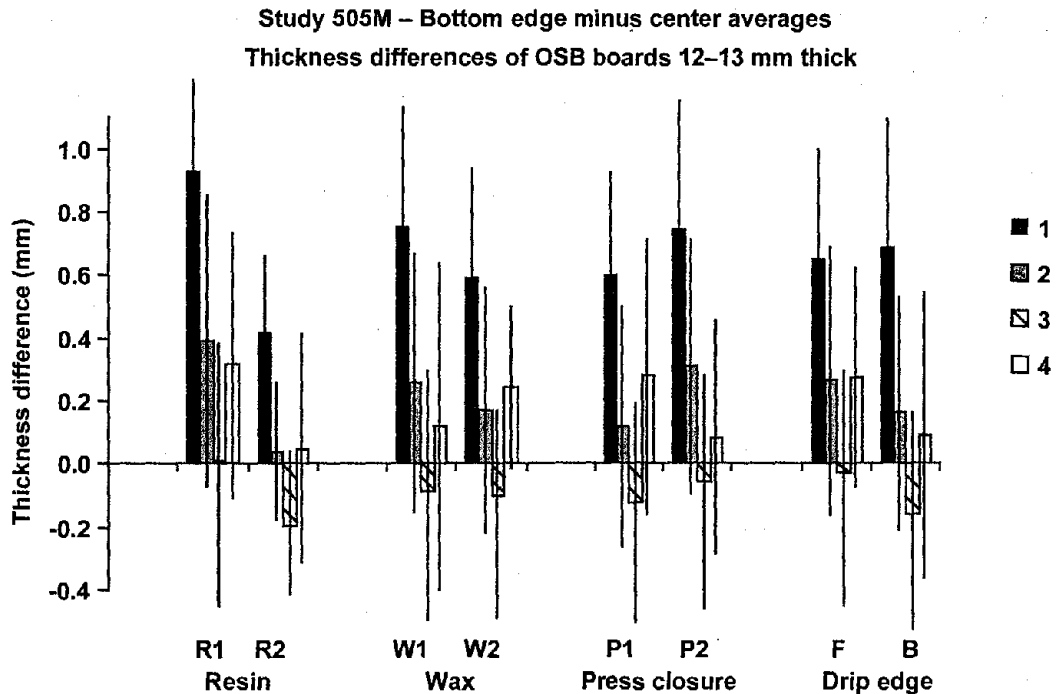
Figure 11. Thickness-swell difference between drip edge and center of board for: unsealed drip edge/one coat of paint (1); unsealed drip edge/ two coats of paint (2); sealed drip edge/two coats of paint (3); and sealed drip edge/one coat of paint (4). Lack of a line indicating first standard deviation indicates all evaluations were the same. R1 is 2.0% resin, R2 is 3.5% resin, W1 is 0.75% wax, and W2 is 1.5% wax. P1 is continuous press closure, P2 is two-stage press closure, F is flat edge, and B is bevel edge.

The original intent of the study was to assess paint performance. However, as the study progressed, it became apparent that substantial substrate degradation was occurring, particularly on the portions of the boards having one coat of paint. One method for quantifying the substrate degradation in a nondestructive manner is to measure thickness-swell. The results for the difference in thickness between the drip edge of the boards (measured approximately 3–5 mm from the drip edge) and the approximate center of boards showed substantial differences for the various experiment parameters (**Figure 11**). The most striking feature of this figure is the negative values for zones with two coats of paint over an edge-sealer. Edge seal decreased the thickness-swell for all paired comparisons (4<1, 3<2). The edges swelled less than the center of the board. In all cases, two coats of paint performed better than one coat (2<1, 3<4). The effects of resin content (R1/R2), wax content (W1/W2), press closure (P1/P2), and bevel- compared with flat-edge on thickness swell are similar to the results for the visually assessed paint performance (R2<R1, and W2<W1). We expected to observe a decrease in edge thickness-swell with an increase in resin and wax content, and our measurements confirmed this.

To analyze the unsealed compared with sealed effect, we considered the thickness difference between the edge and center for two sets of paired comparisons (1-4 and 2-3). For example, 1 and 4 are paired by being measured on the same strip from the same panel; both have one coat of paint (number 1 is not edge sealed whereas number 4 is edge sealed). In the other paired comparison (2 compared with 3), both have two coats of paint (number 2 is not edge sealed whereas number 3 is edge sealed). There are a total of eight [2 resins, 2 waxes, 2 presses], 3 replicates, 2 bevel-, flat-edge] = 48 measurements for 1 compared with 4 if we pool the bevel- and flat-edge measurements. The results for the pooled, bevel-, and flat-edge cases are presented in Table 2. The differences can clearly be seen in Figure 11.
