IMPACT RESISTANCE OF THREE CORE MATERIALS AND SIX SANDWICH CONSTRUCTIONS AS MEASURED BY FALLING-BALL TESTS

No. 1543

**UNITED STATES DEPARTMENT OF AGRICULTURE
FOREST SERVICE
FOREST PRODUCTS LABORATORY
Madison, Wisconsin**

K. H. BOLLER, Engineer

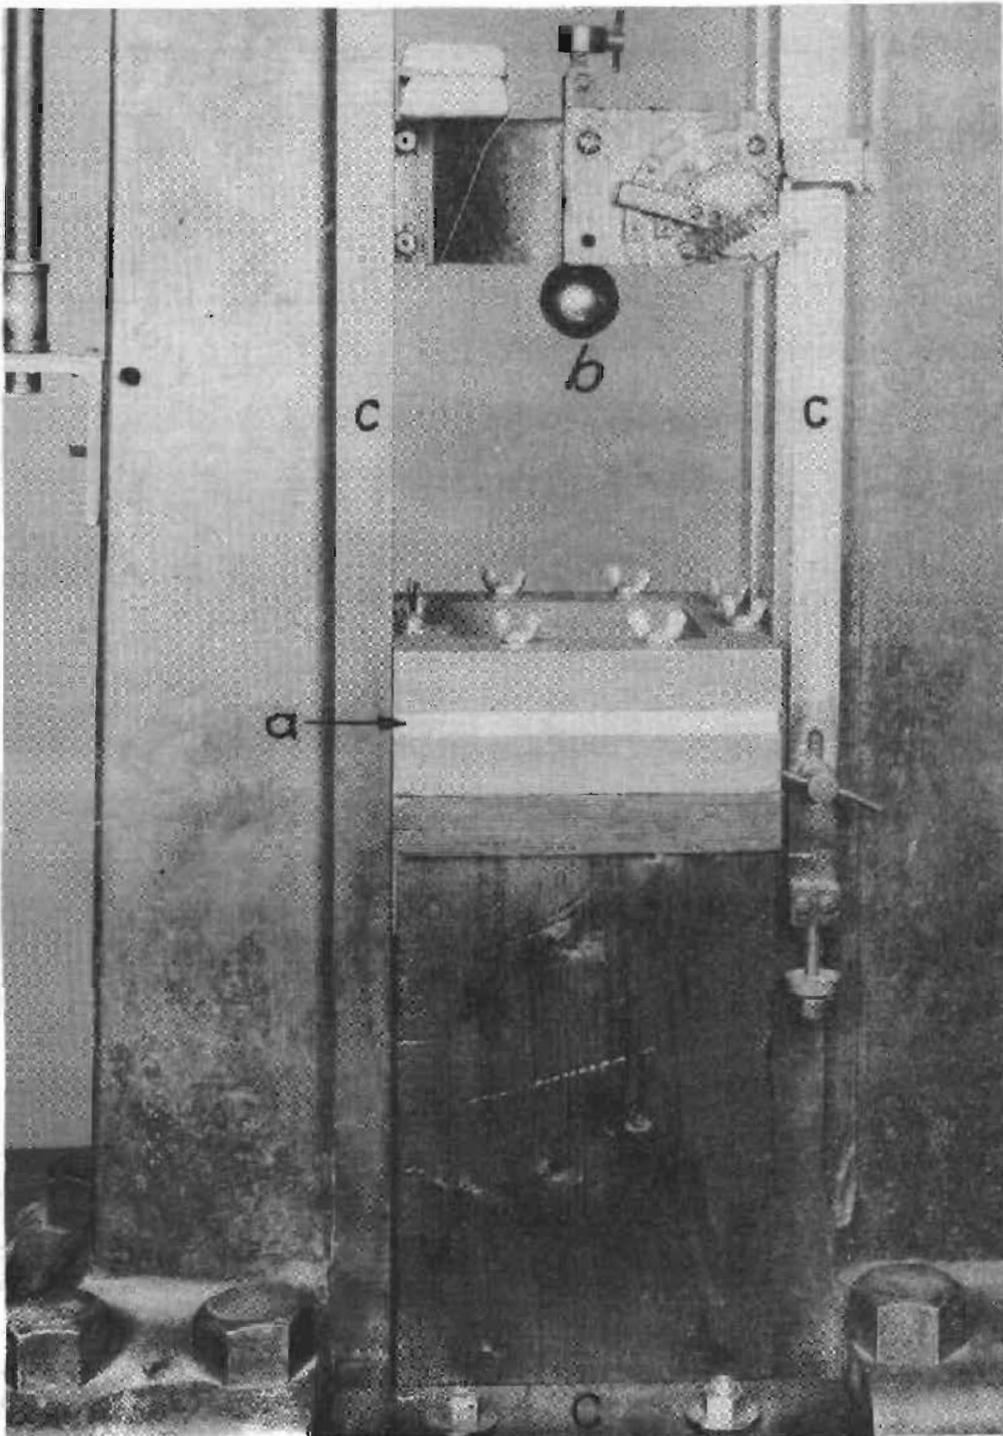
Figure 1.--Apparatus for impact test (falling ball), showing:
(a) test specimen in plywood frame; (b) 2-inch diameter steel ball held by electro-magnet; (c) base and vertical guide rails of machine normally used for impact-bending tests.

The dimensions of the impact test specimens were 9 by 10 inches. They were cut from the center of the 16- by 16-inch panels. The specimens were placed between two frames of 1-1/2-inch thick plywood, in each of which was a central opening 6 inches square. The specimens were securely clamped between the frames by eight 3/8-inch carriage bolts, equally spaced on a circle 8.6 inches in diameter. The specimen and frame were mounted for test, as shown in figure 1, in an impact machine which provided permanent centering and rigid support. A 2-inch diameter steel ball weighing 1.18 pounds was automatically released from the electromagnet at various heights.

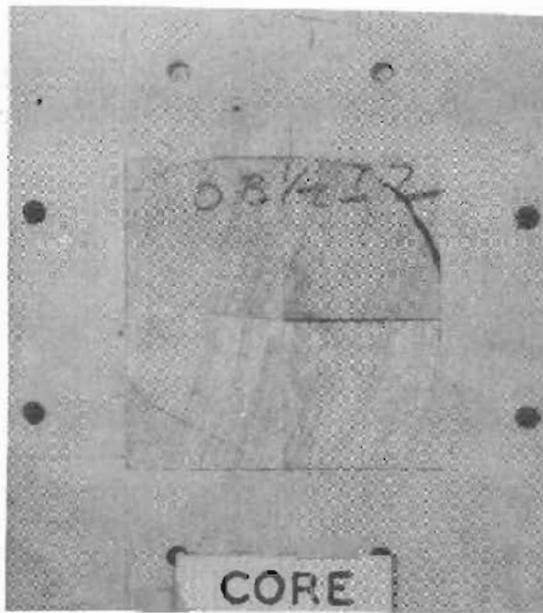
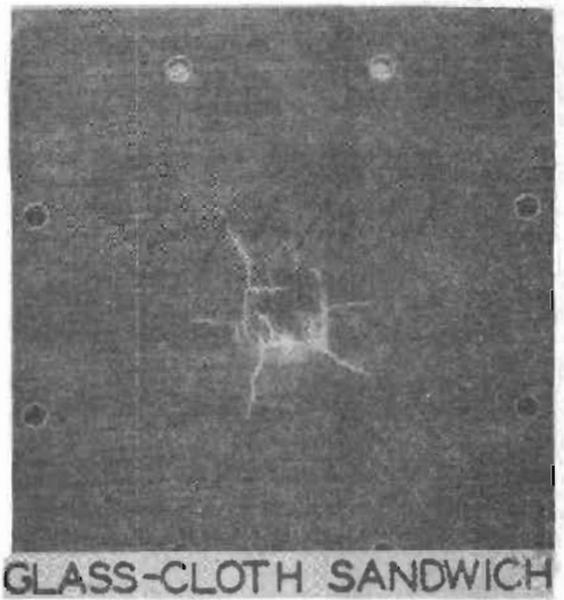
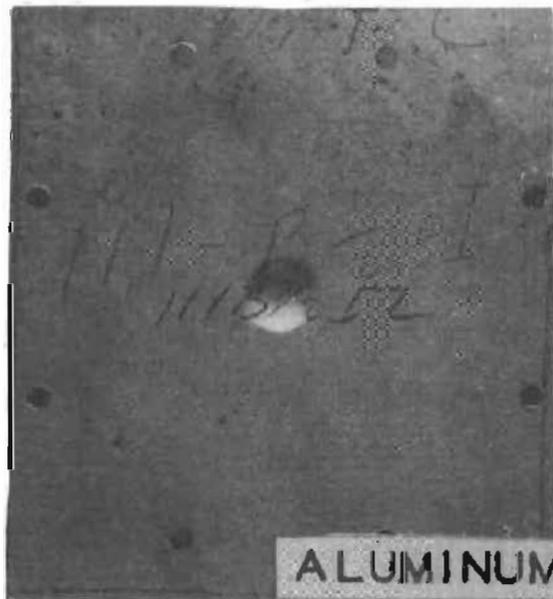
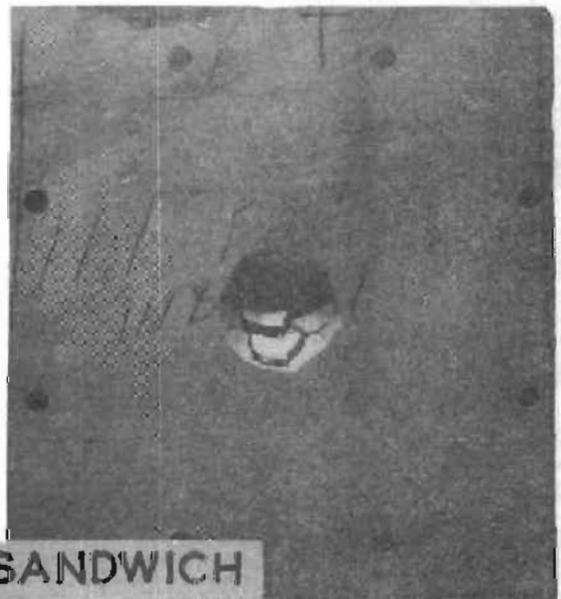
Figure 2.--Top view of impact specimens with balsa wood cores. A, failure of core without facings; B, cracks in the top face of glass-cloth sandwich; C, first cracks in aluminum sandwich; and D, additional damage to top face in aluminum sandwich.

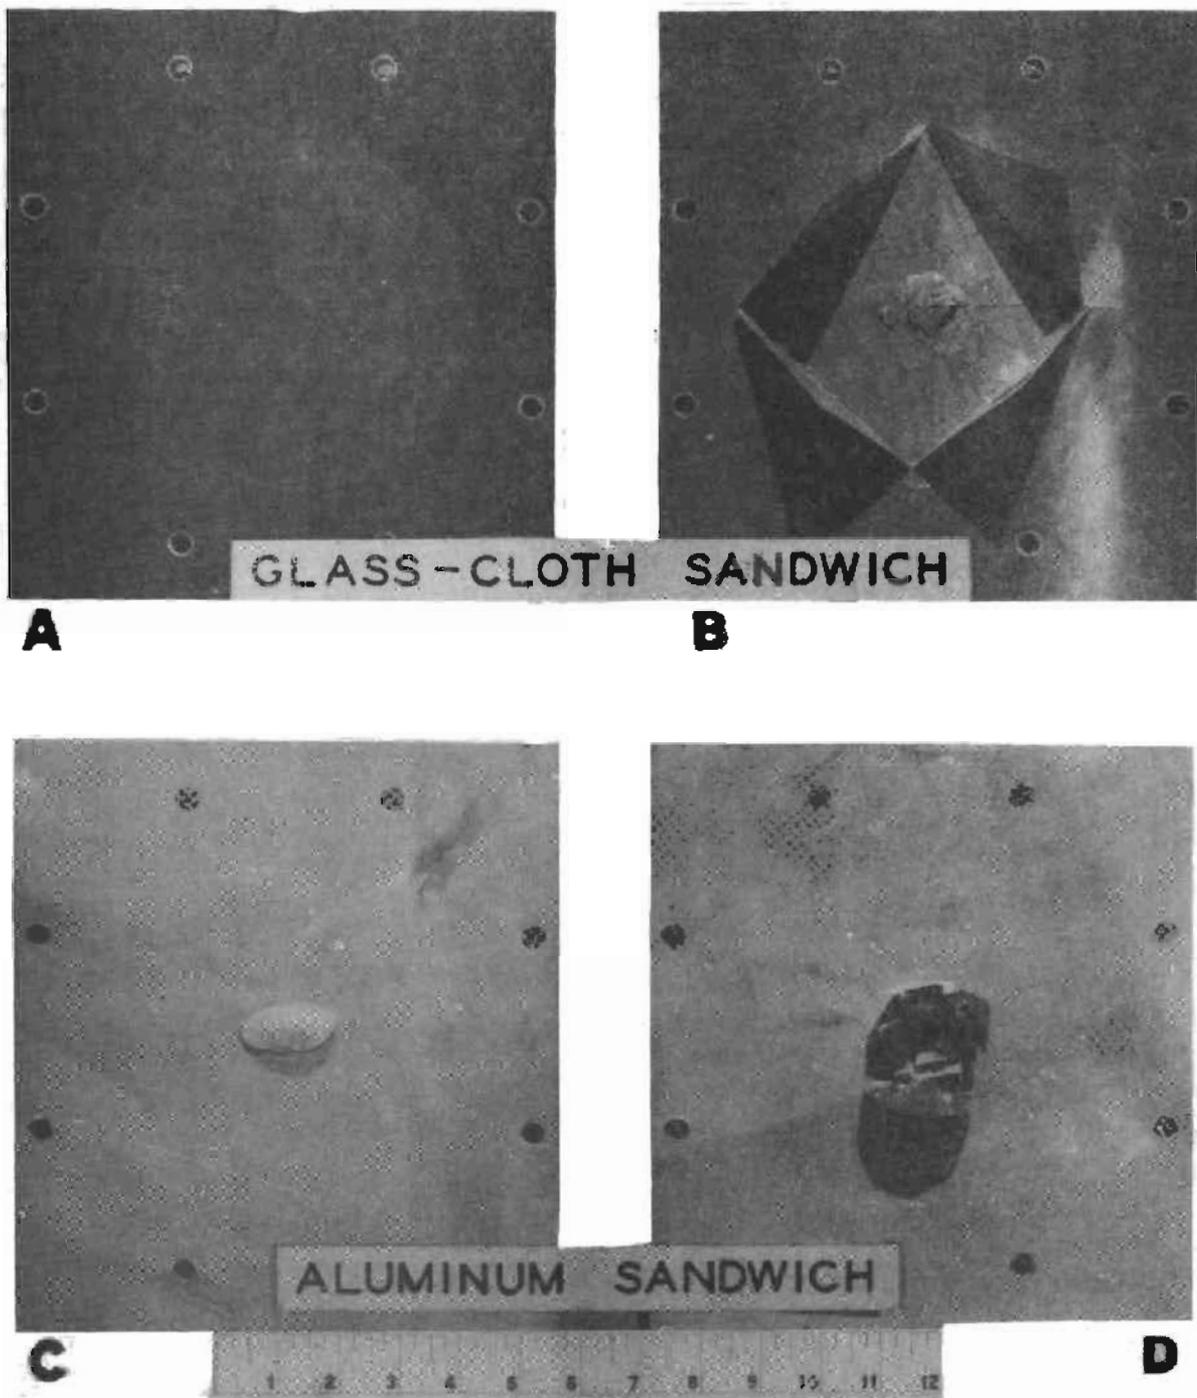
Figure 3.--Bottom view of impact specimens with balsa wood cores. A, separation of facing from core (light-colored circular area) of glass-cloth sandwich; B, core failure beneath a separation between glass-cloth facing and core; C, impression of first balsa plug and first crack on the aluminum face; and D, additional damage to bottom aluminum face.

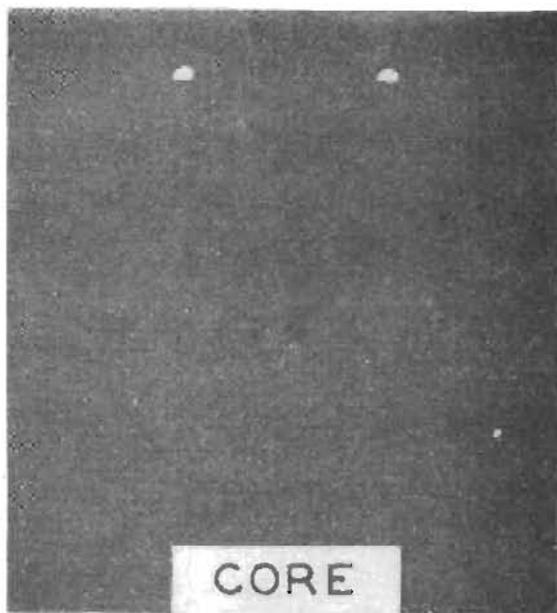
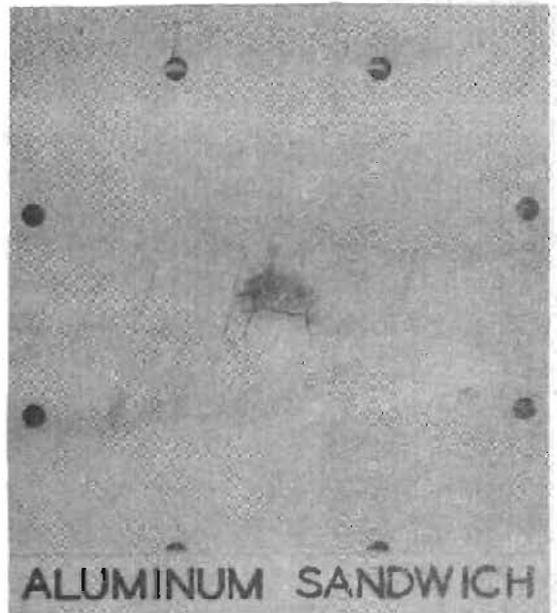
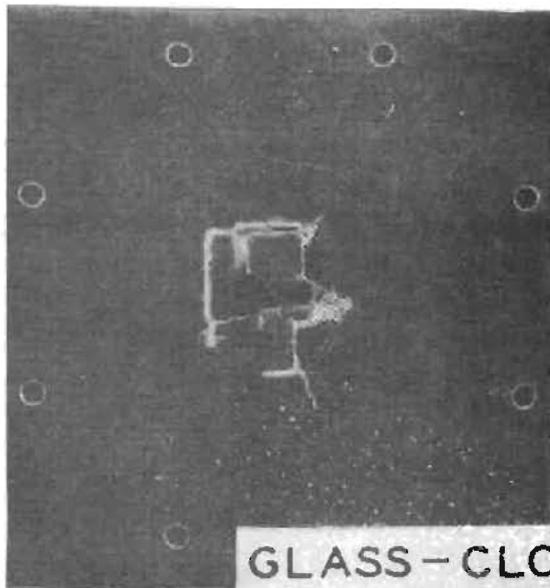
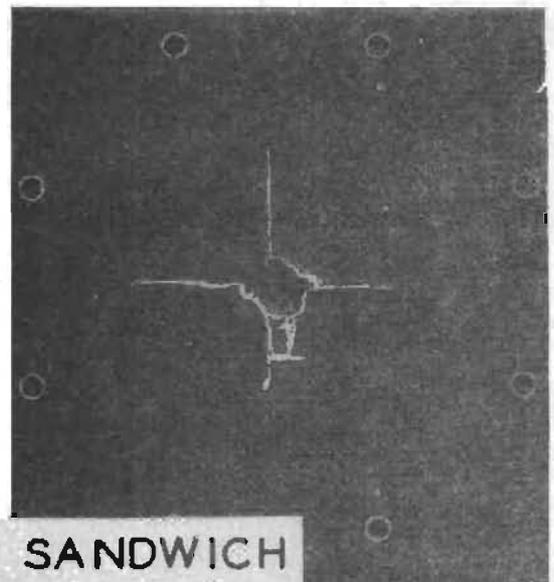
Figure 4.--Top view of impact specimens with hard sponge-rubber cores. A, pie-shaped failure of core without facings; B, first cracks in top face of aluminum sandwich; and C, D, cracks in top face of glass-cloth sandwiches.

In the tests on cores without facings, the first failure occurred in the material itself only in the hard rubber. This failure was in the form of cracks beginning at the center of the panel on the bottom side and extending outward to the frame. The cellulose acetate appears to be the toughest of the materials, but in test the glue bonds between the 2-1/2-inch wide strips failed first with later breakage of the material. The balsa likewise failed first at the glue lines between individual blocks and later along radial lines in the wood. Figures 2 through 7 show top and bottom views of samples of the various failures. The core material in the glass-cloth sandwiches is also shown by cutting away the bottom facing after the separation of the facing from the core had taken place.

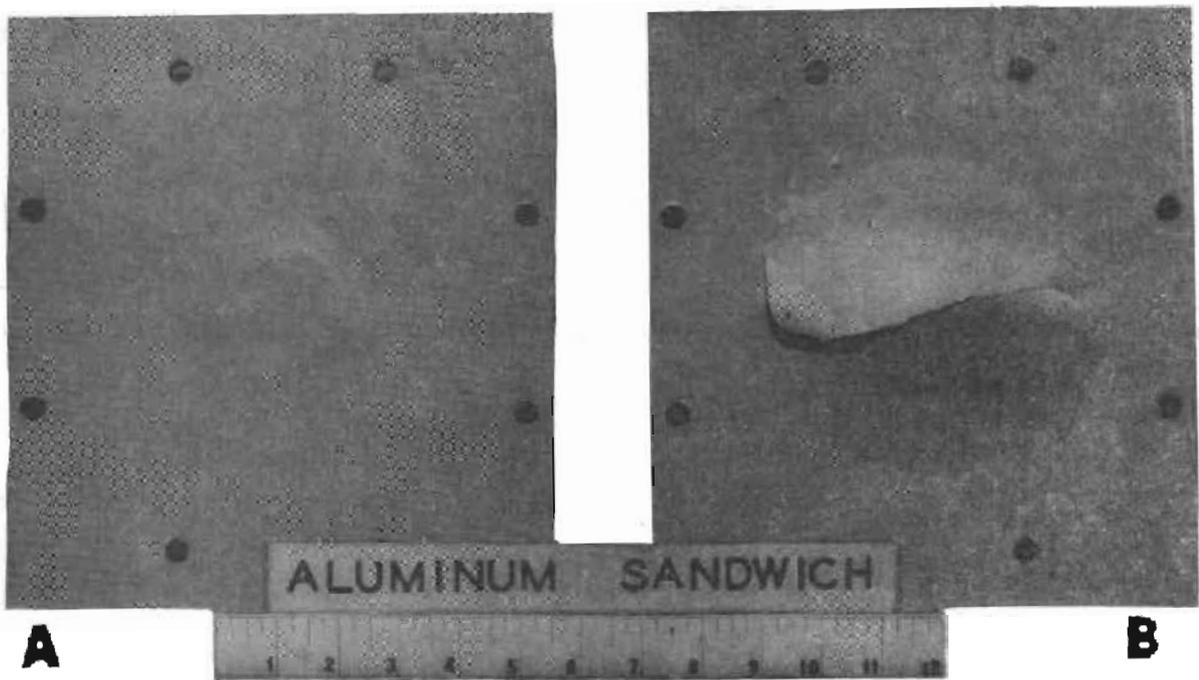
Figure 5.--Bottom view of impact specimens with hard sponge-rubber cores.
A, the impression of the core failure (circular plug) on the aluminum face; and B, aluminum failure.

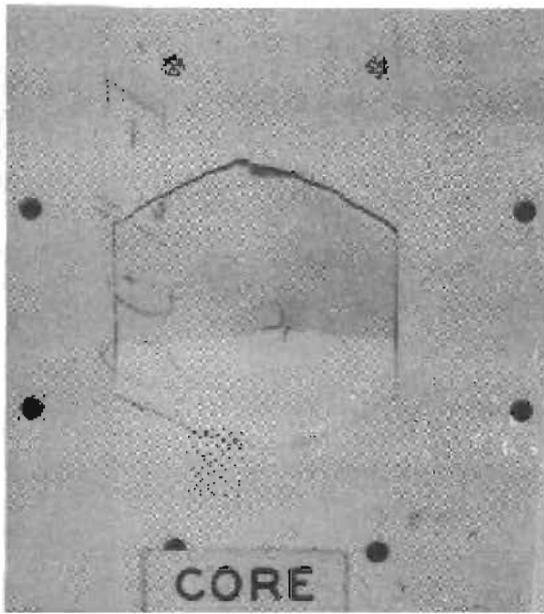
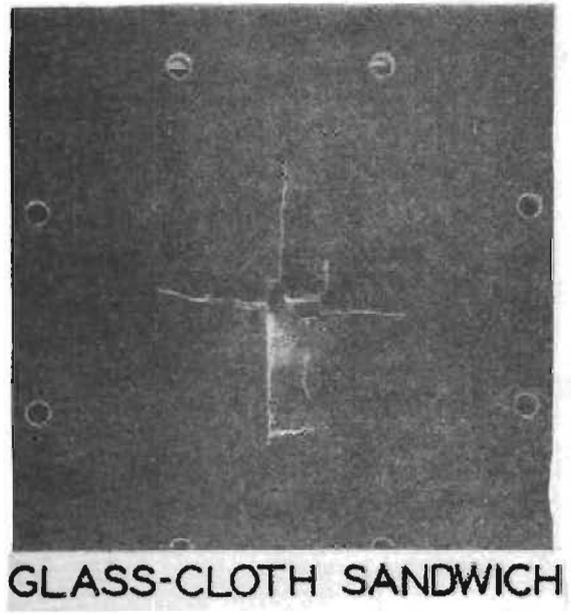
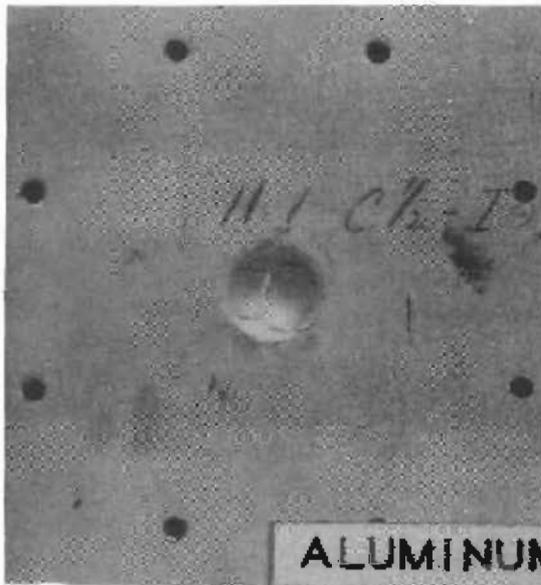
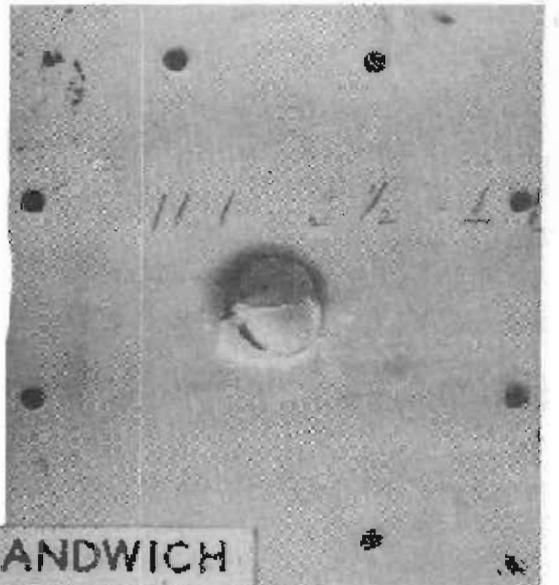
Figure 6.--Top views of impact specimens with cellular cellulose acetate cores. A, failure of core without facings; B, face cracks in glass-cloth sandwich; C, face crack in aluminum sandwich; and D, additional damage in aluminum sandwich.

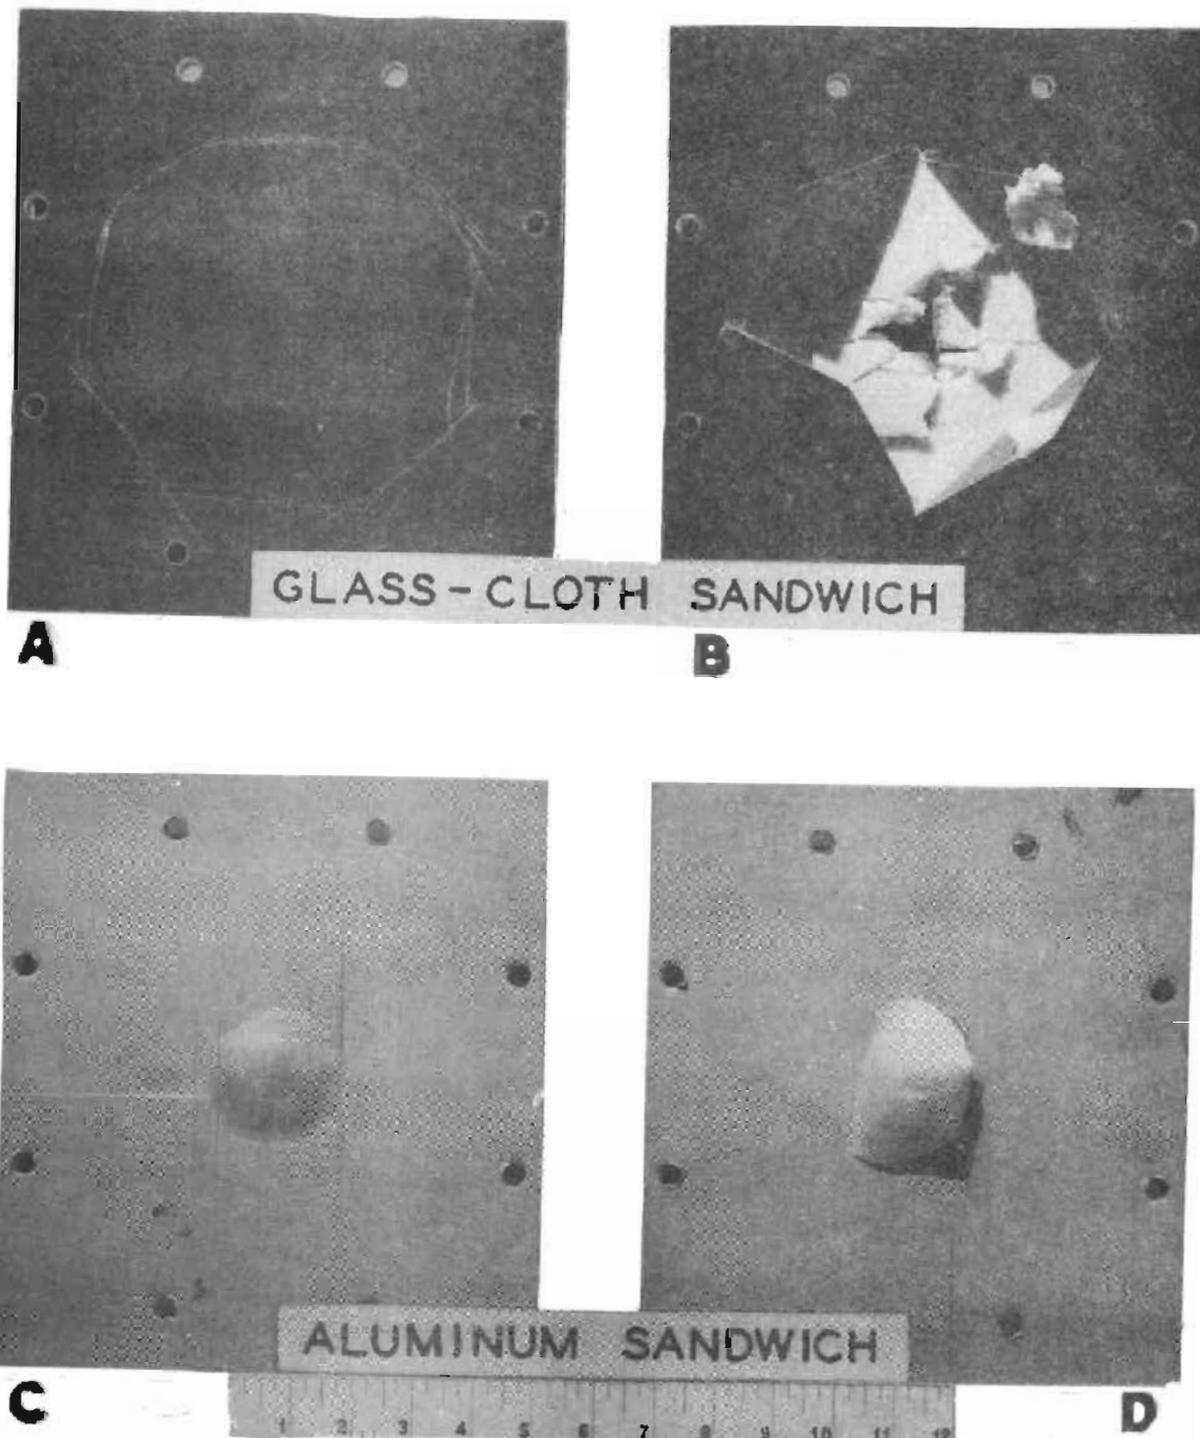
Figure 7.--Bottom view of impact specimens with cellular cellulose acetate cores. A, outline of bulge caused by the core failure in a glass-cloth sandwich; B, core damage in a similar sandwich; C, outline of bulge in an aluminum sandwich before a bottom crack appears; and D, failure in the aluminum face.

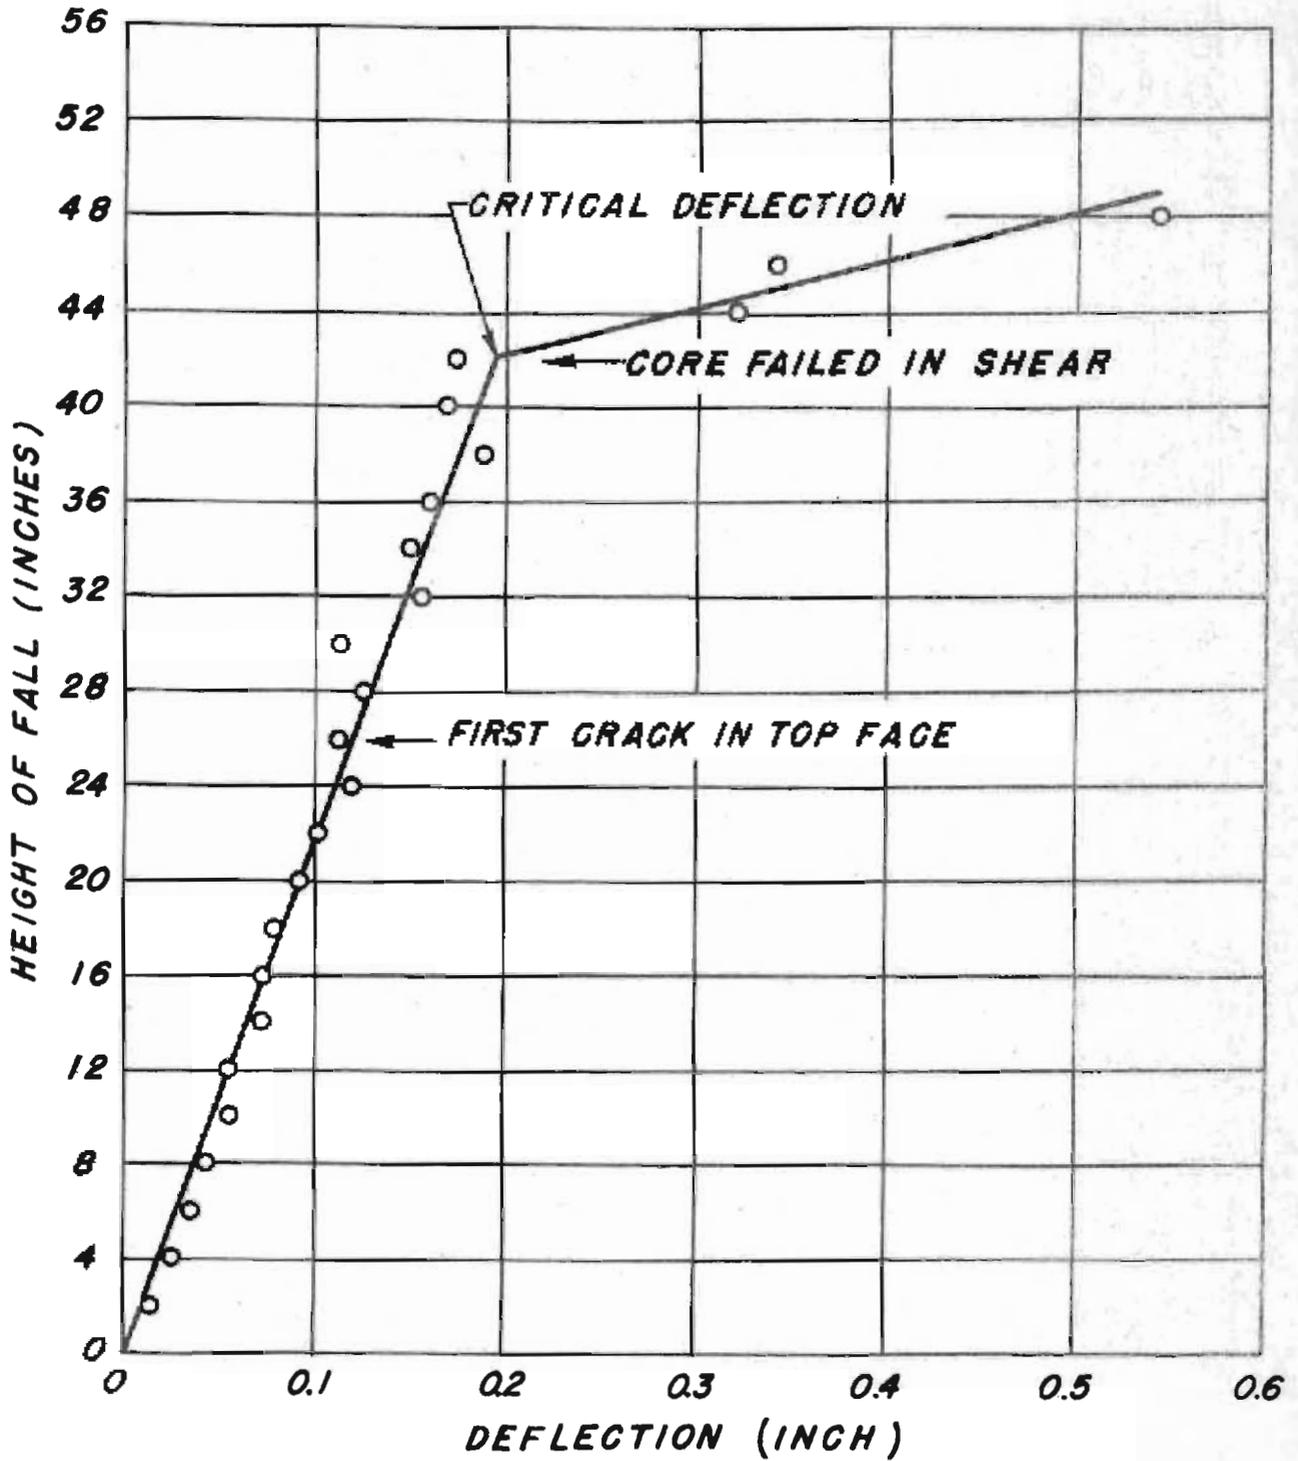
Figure 8.--Typical height-deflection curve as determined by impact of a falling ball on a sandwich panel.

increased much more rapidly. The height of drop at which this change occurred has been defined as the drop at critical deflection. Figure 8 is typical of such graphs.
